# The assessment of land stability at Panorama Heights Subdivision, Devonport

by P.C. Stevenson

This report is the latest of three reports on this subdivision. The first 'An examination of the Landslip Potential at the Panorama Heights Sub-division, Devonport' (Stevenson, 10 February 1972) raised doubts of the stability of the area on the evidence of trial pits and recommended measurement of soil strength properties and the calculation of a stability analysis.

This report applies the results of the calculations to the geological and climatic environment of the area, assesses the risk of landslip and proposes the boundary of a proclaimed landslip area.

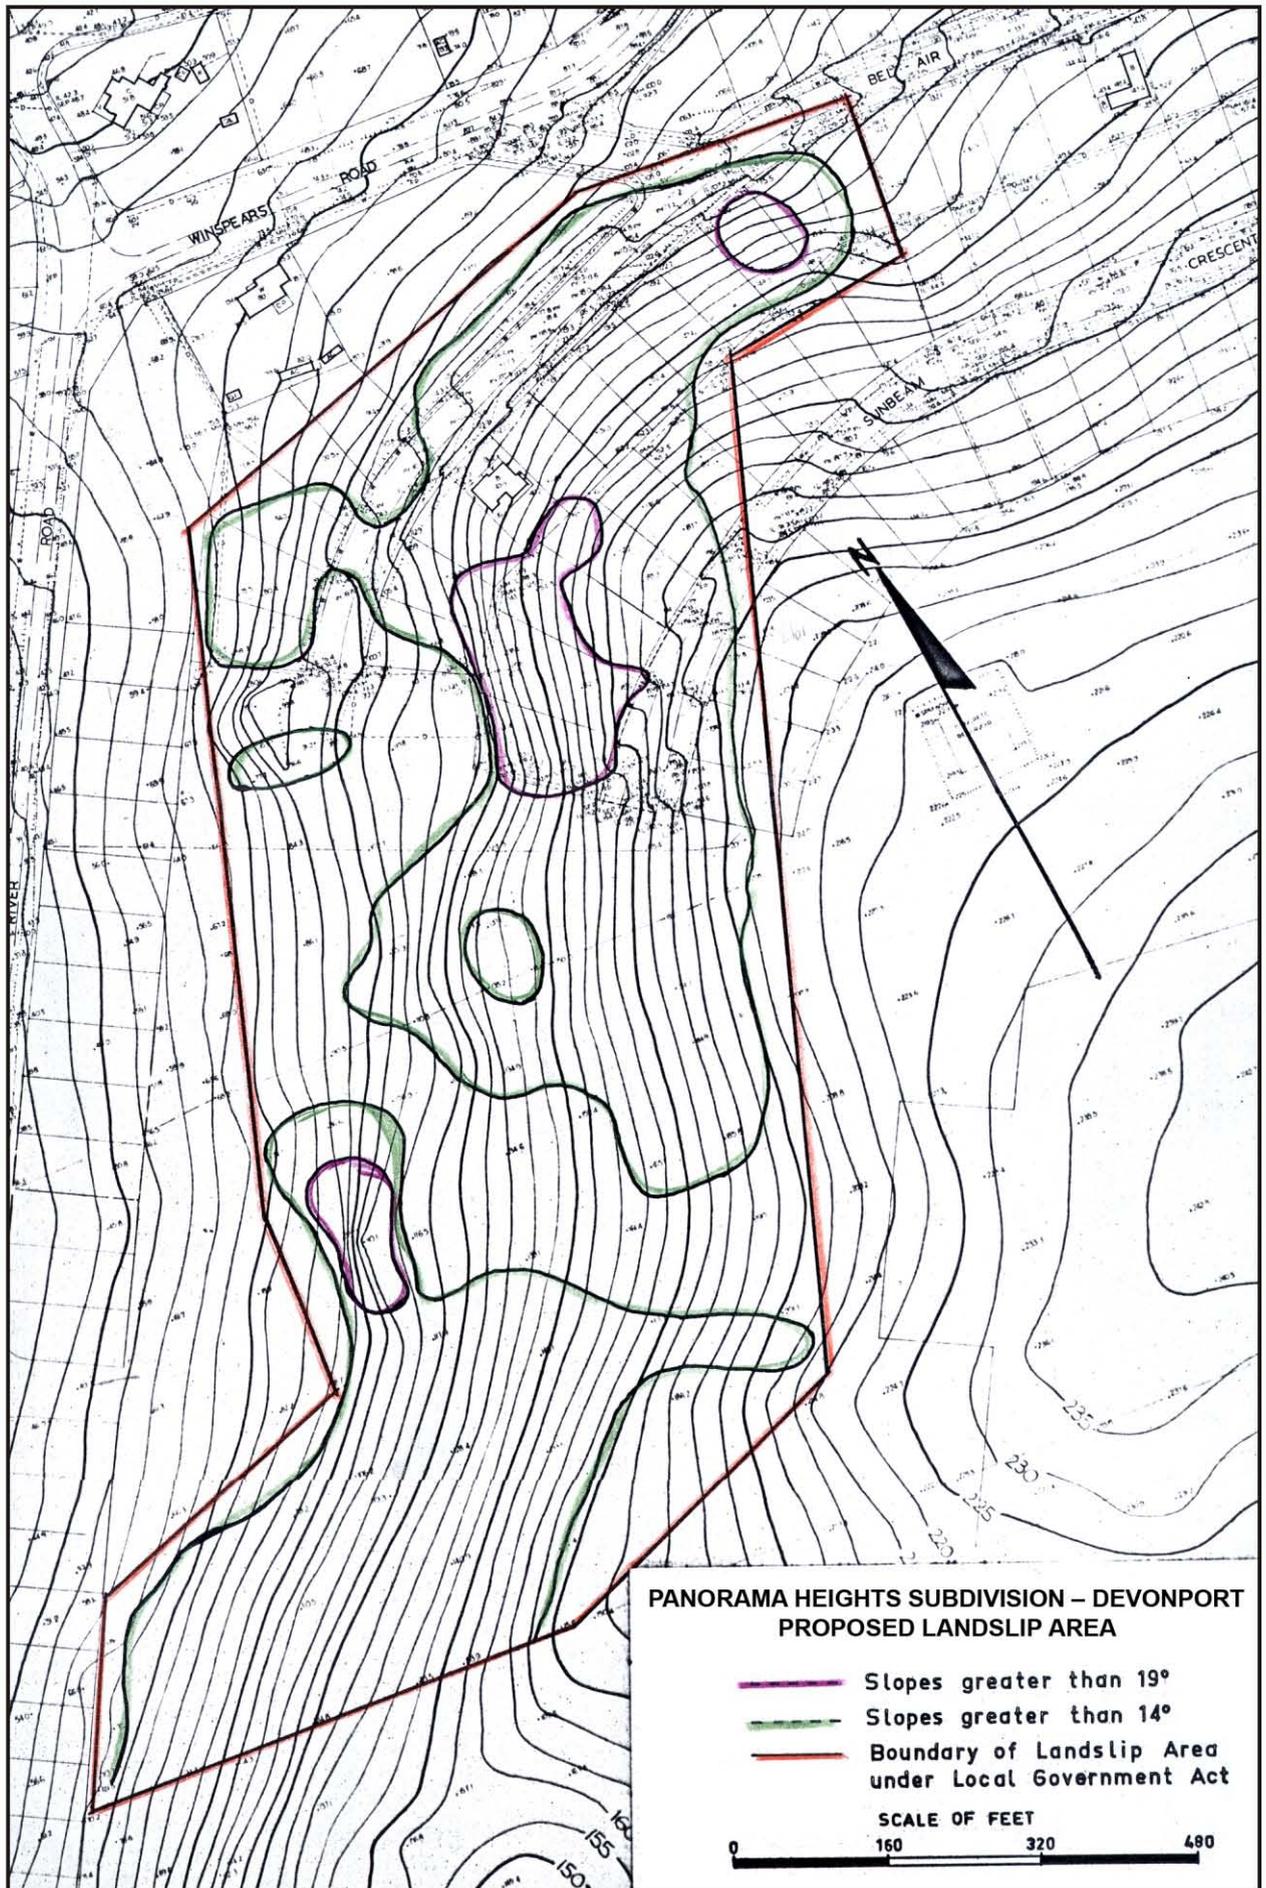
Figure 1

The attached drawing (fig. 1) illustrates a slope analysis of the area, based on contours supplied by the Devonport Council. The outer line contains all areas steeper than 14° while the inner line contains all areas steeper than 19°. The slope angles are those used in the stability analysis, and in view of the preceding discussion the area of 14° and steeper must be regarded as the area at risk. An apparent anomaly should be pointed out, that the area suspected of having failed already does not come within the risk area. This however, is logical, because the act of failure flattens the angle of slope and so increases the future stability.

It must be pointed out that landslips tend to migrate upslope, because the land immediately uphill from a slip is left oversteepened and under-supported. The risk area has therefore been rationalised to some extent and the area it is proposed to proclaim as a landslip area under Section 431A of the Local Government Act 1962 is indicated in Figure 1.

The land within the proclaimed area, if left undisturbed can be expected to remain stable for periods of some years, only becoming active after prolonged wet weather. A slip then taking place would be destructive of landscape and could menace houses downhill of the slope. It is recommended that trees be planted in the area as they are at all points the best means of landslip prevention. They provide shade and soil cover to prevent excessive dessication, remove excess moisture and mechanically bind the soil layers to considerable depth and have the advantages of lack of maintenance, cheapness and beauty. Physical reshaping of the ground by bulldozing should be avoided as the present slope will be one of at least temporary stability.

The same recommendations apply throughout the subdivision outside the proclaimed area. In addition sewer and stormwater pipes should be constructed so that slight local soil failures at high stress areas will not cause failures in tension.

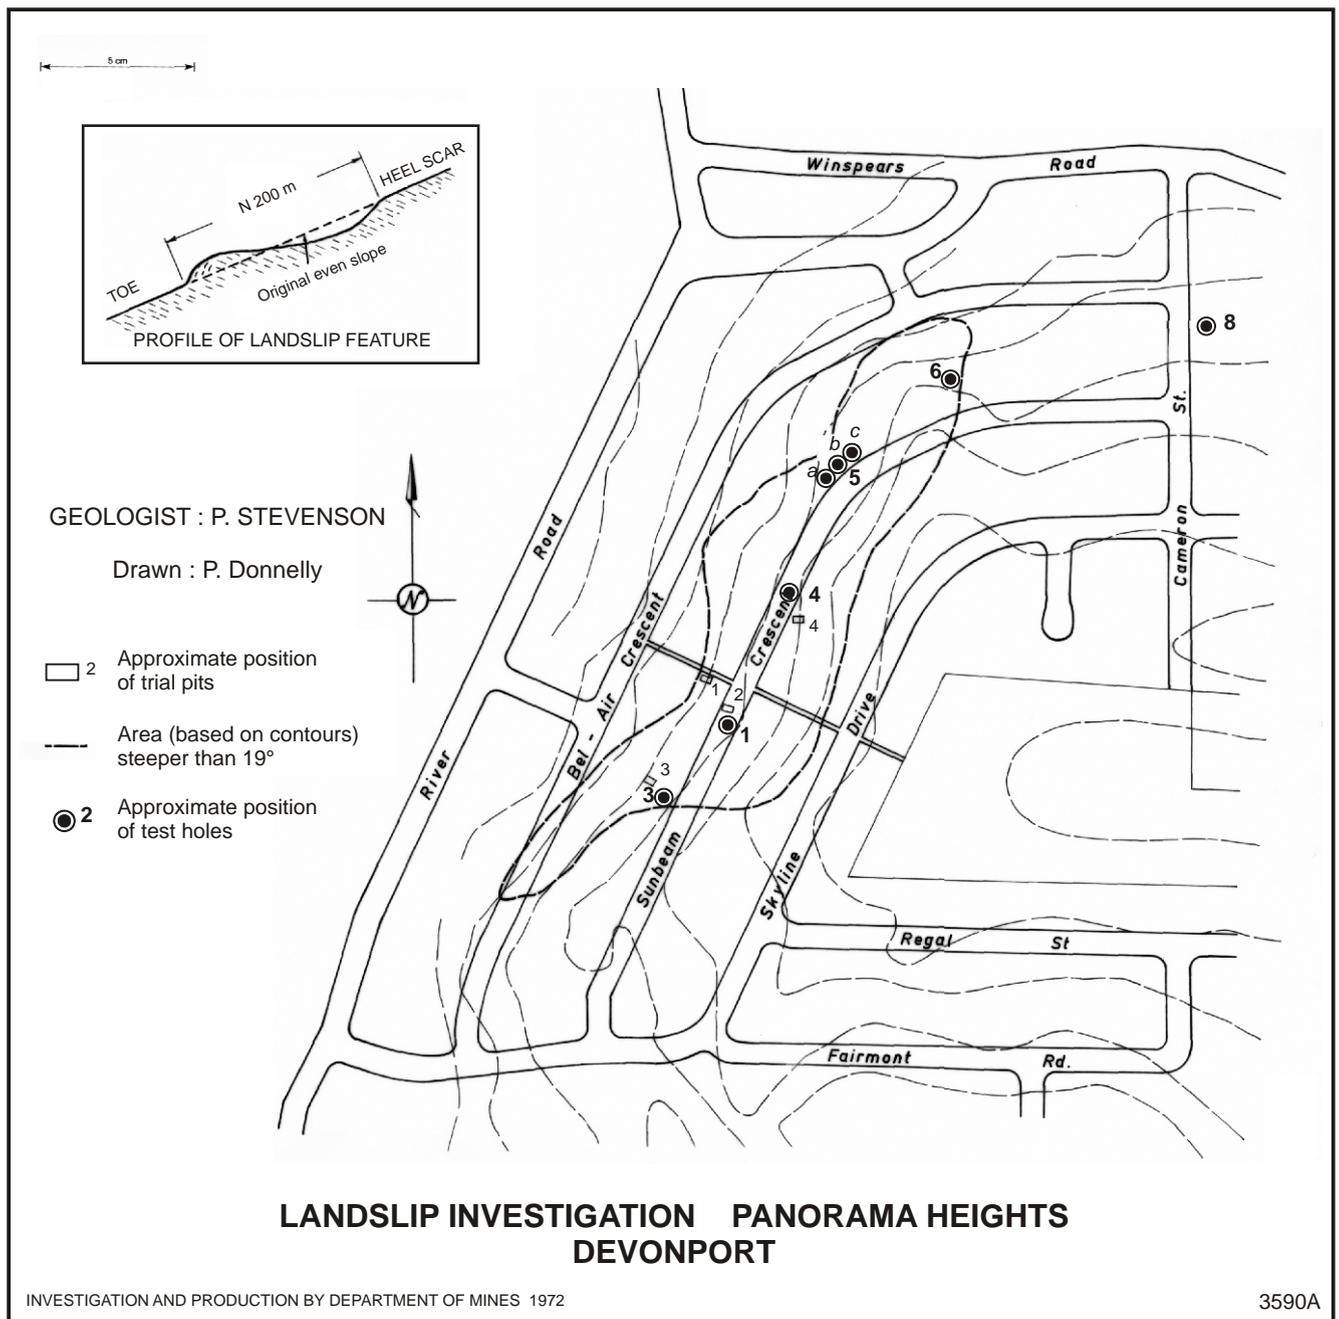
Figure 2

The locations of the test holes were selected by the writer in consultation with Mr P.C. Stevenson and are shown in Figure 2.
