## Land stability, Ambleside subdivision, East Devonport

W.L. Matthews

## PART 1. EXAMINATION OF THE AMBLESIDE SUBDIVISION.

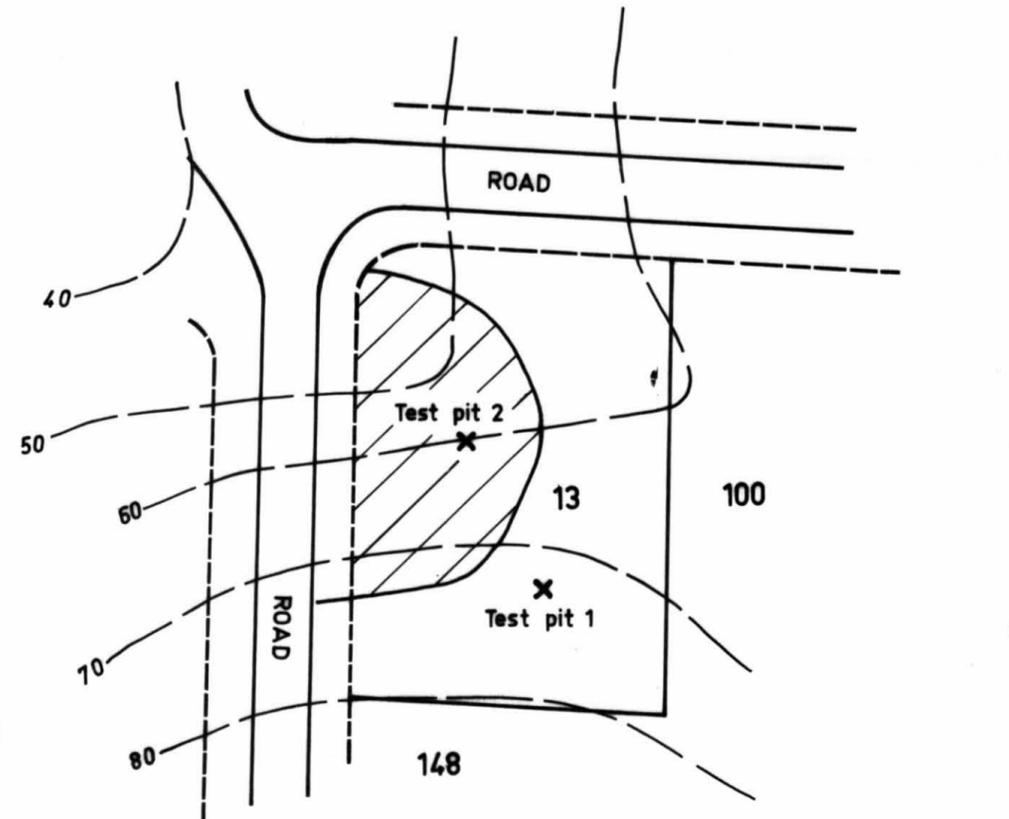
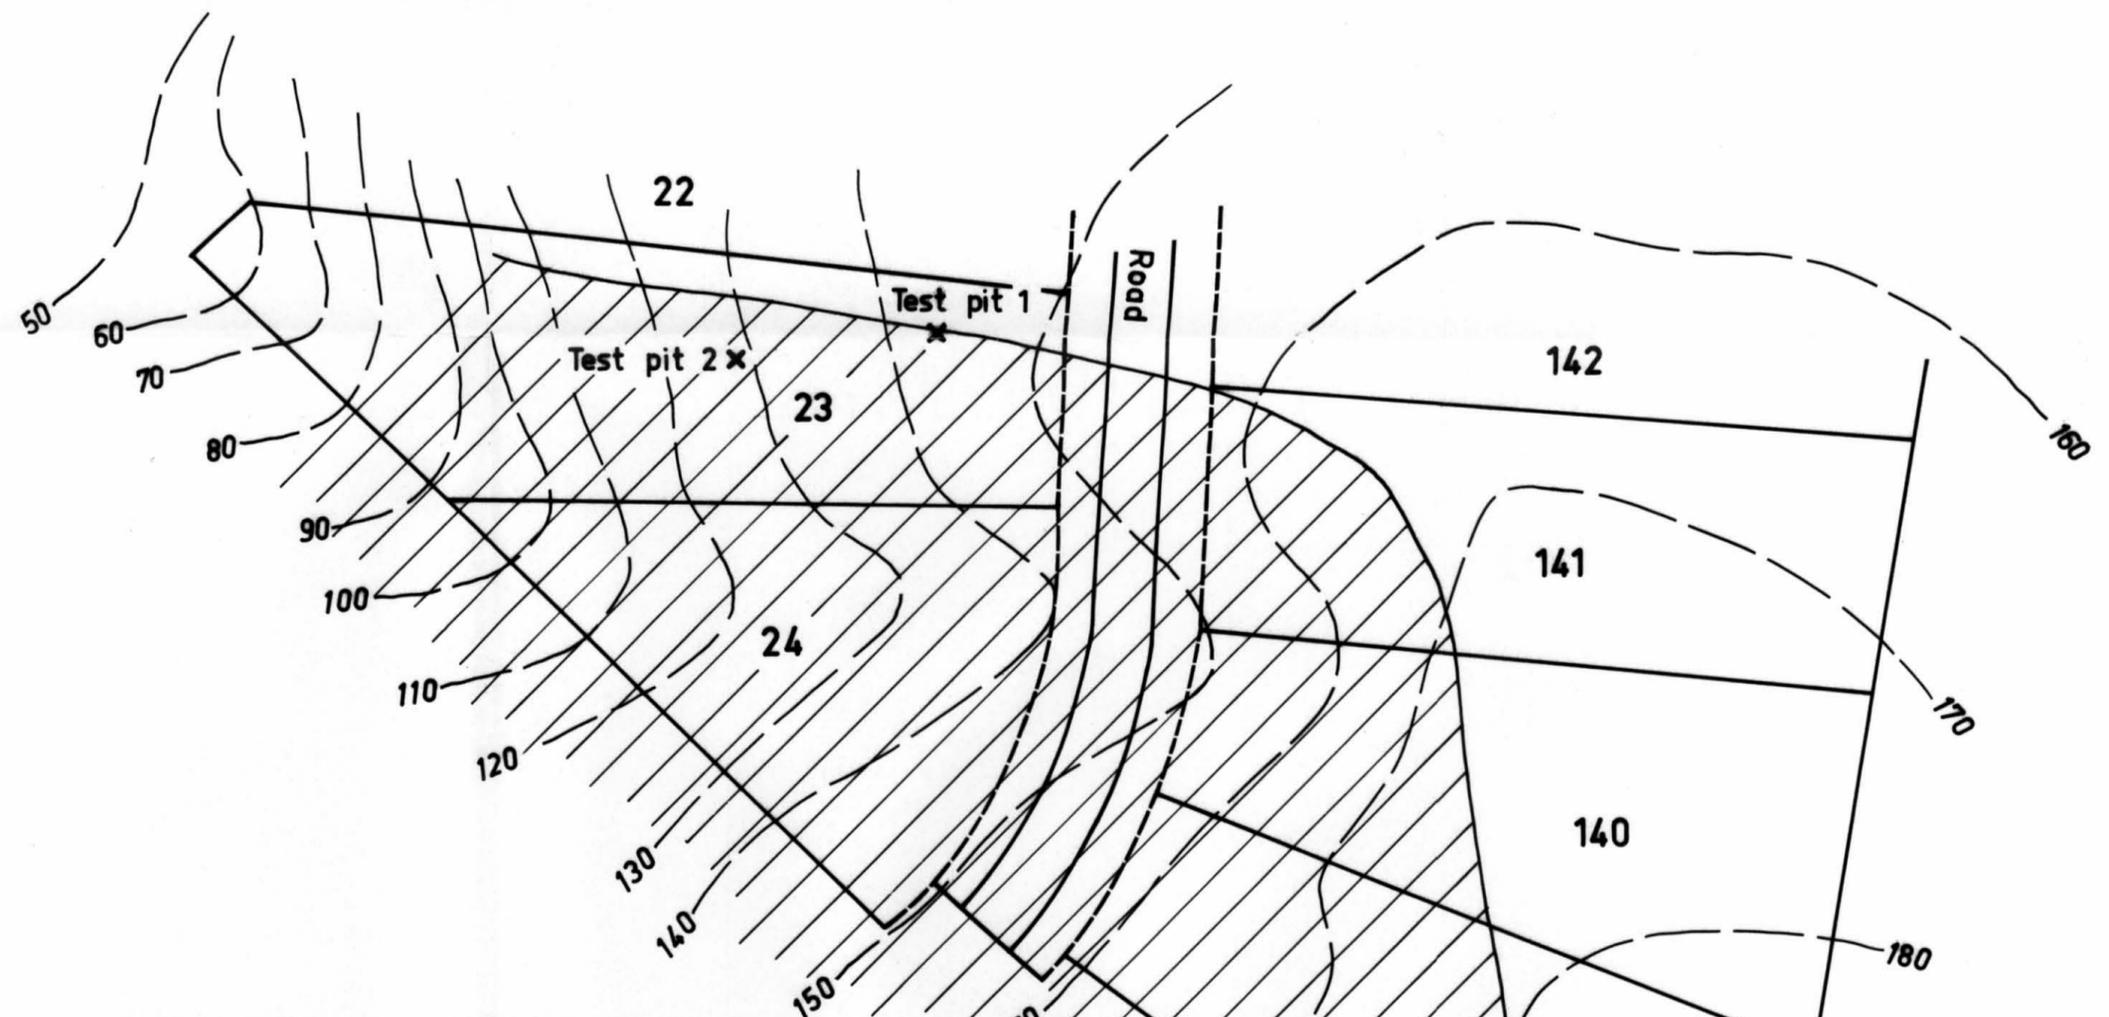
**AMBLESIDE SUBDIVISION**

Part or all of Blocks 141, 142, 139, 23 and 24 are underlain by clay and sandy clay which overlies weathered dolerite. The land surface is steep to fairly steep in the vicinity of these blocks and possible slip areas occur to the south on steeply sloping ground. For this reason, it was suggested that the steeply sloping areas should not be included in the development because unstable conditions could develop. Two test pits were excavated recently on the north-east side of Block 23 which indicated a considerable depth of clay and deeply weathered dolerite on or near steep slopes. Therefore, there seems no reason to change the boundary of the land regarded as potentially unstable from that shown on a previous plan with regard to Block 23. The boundary of the land that it is recommended should not be developed for housing is shown on the plan (fig. 1).

An error was made in the location of a previous test pit (test pit 10) in relation to some survey pegs, it being some 60-80 feet west of the point shown on a previous plan. Because of the material in this pit, it was suggested that Block 13 should not be developed for housing. However, on correcting the location of this test pit, it is apparent that part of Block 13 would not be covered by this area regarded as potentially unstable and two test pits have been dug to determine whether part of the block could be safely developed. Test pit 1 encountered clay and sandy clay over weathered dolerite and test pit 2 encountered weathered dolerite that could not be excavated with a back-hoe at shallow depth. On the basis of these two test pits, the area of Block 13 regarded as having some risk of instability, is shown on the plan (fig. 1).

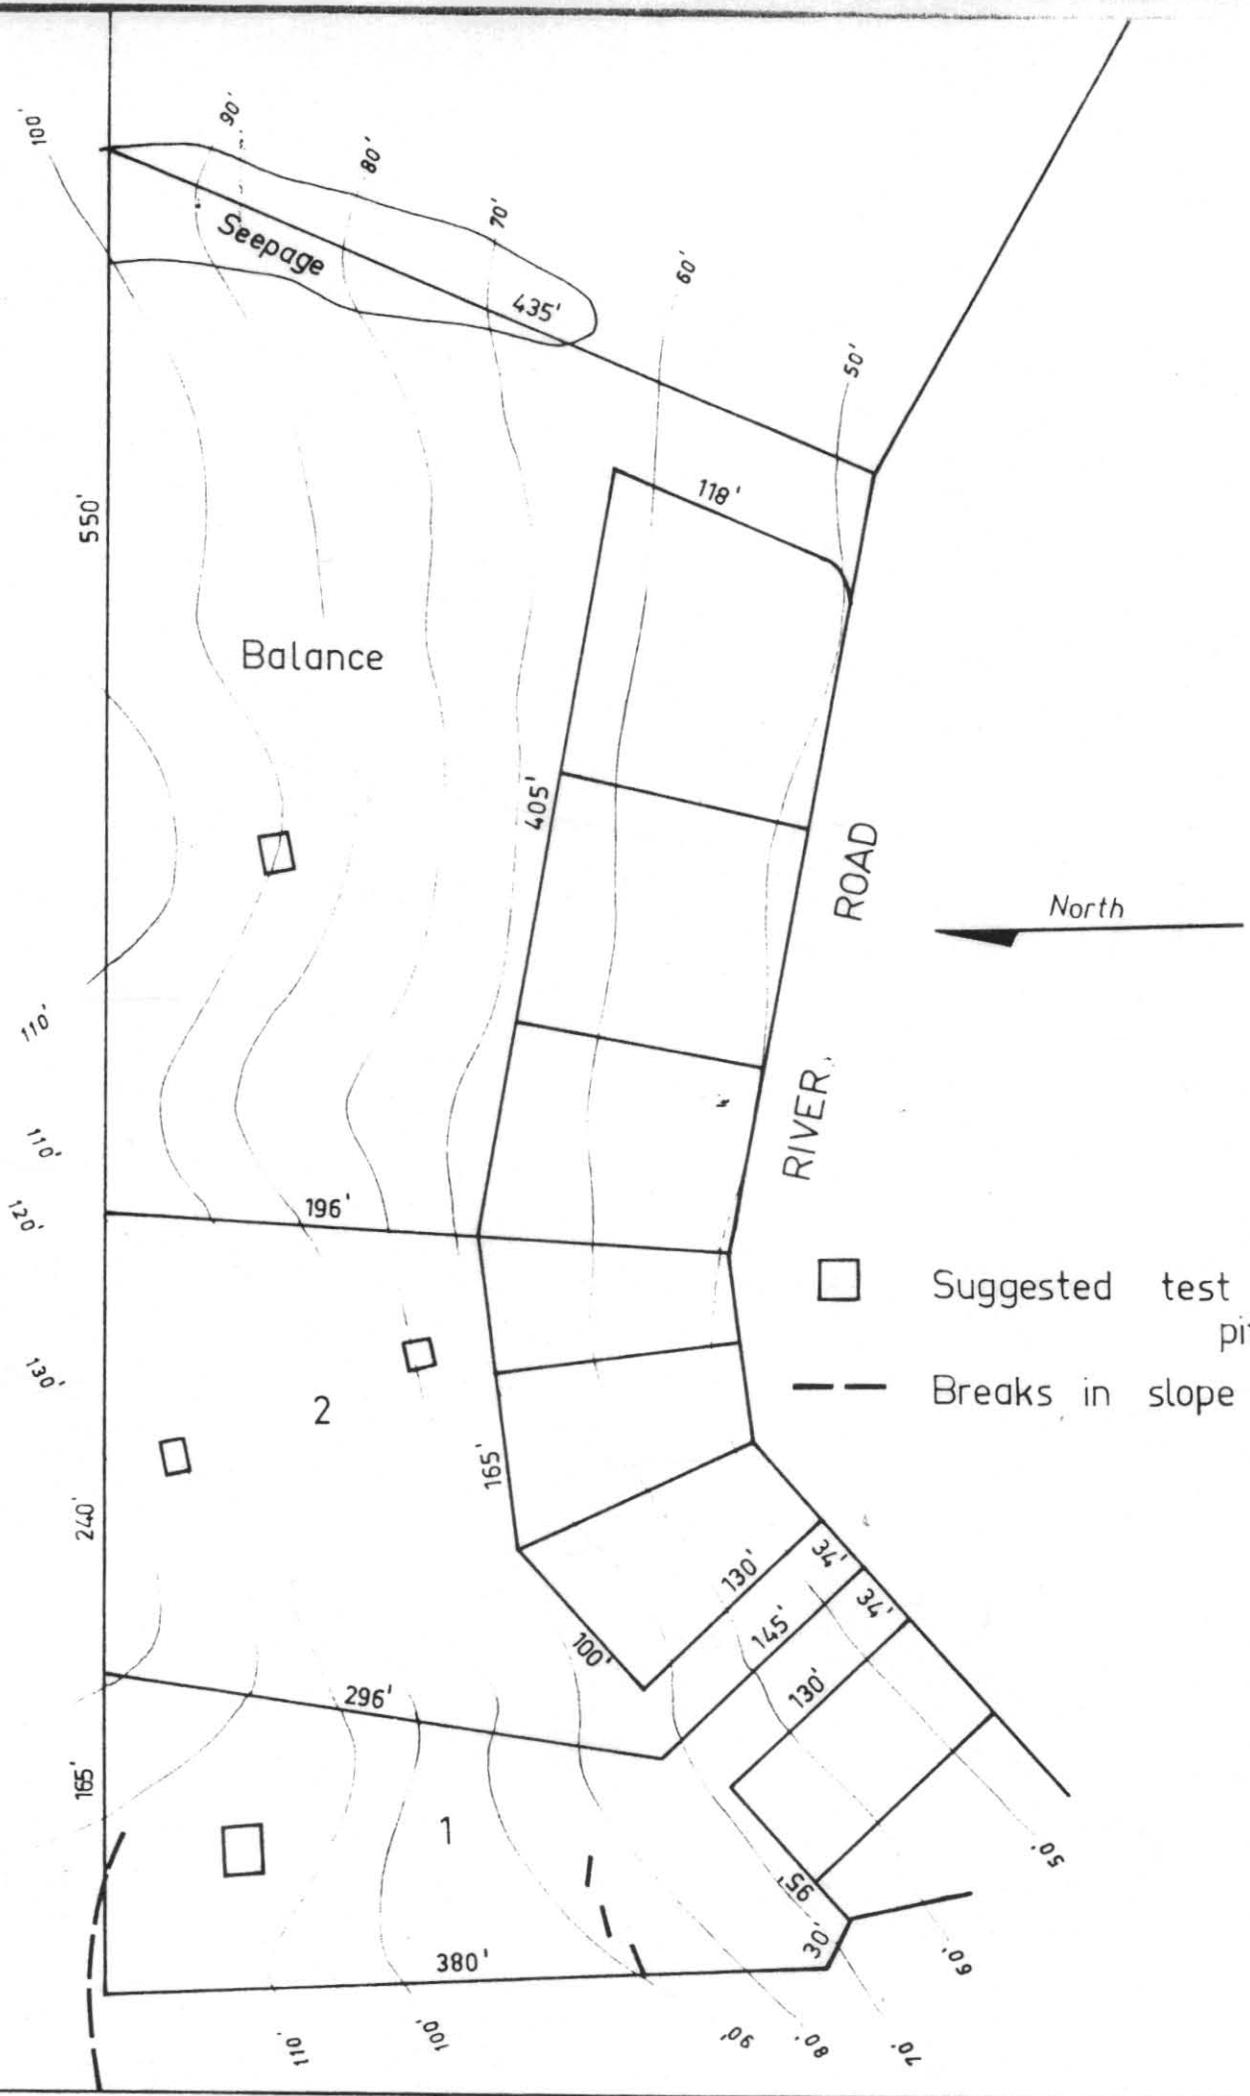
# T. J. McCall's Subdivision, River Road Ambleside, East Devonport

No definite slips, either active or old, occur on the land examined. One or two area where there are changes in slope on Lot 1 could represent very old slips but they could also be due to differential weathering and erosion of the dolerite. Apart from a large seepage on the southern boundary the area appears to be dry.

The property has particularly steep areas at some locations, parts of Lot 2 reaching angles of about 25°. In view of the steep nature of the area and the apparent deep weathering of the dolerite, more information on the subsurface material should be obtained before any assessment of the likely stability of the area could be given. It would be useful to obtain information on how deep the weathering of the dolerite has extended, the degree of weathering and also to determine the presence or absence of subsurface water or moisture in the weathered material. Four test pits in positions marked on the plan (fig. 2) dug with a back-hoe to about 12-14 would allow this information to be obtained.
