Proposed subdivision at Windermere

D.E. Leaman
P.C. Stevenson

A subdivision has been proposed at Windermere, on Windermere Farm owned by R.H. Harris (fig. 1). In accordance with landslip legislation doubtful risk properties must be closely examined in order that a recommendation for subdivision may be made. The property is located west of the Windermere to Swan Bay road at Windermere. The land slopes gently to the Tamar River but does have two distinct benches within the boundaries of the property.

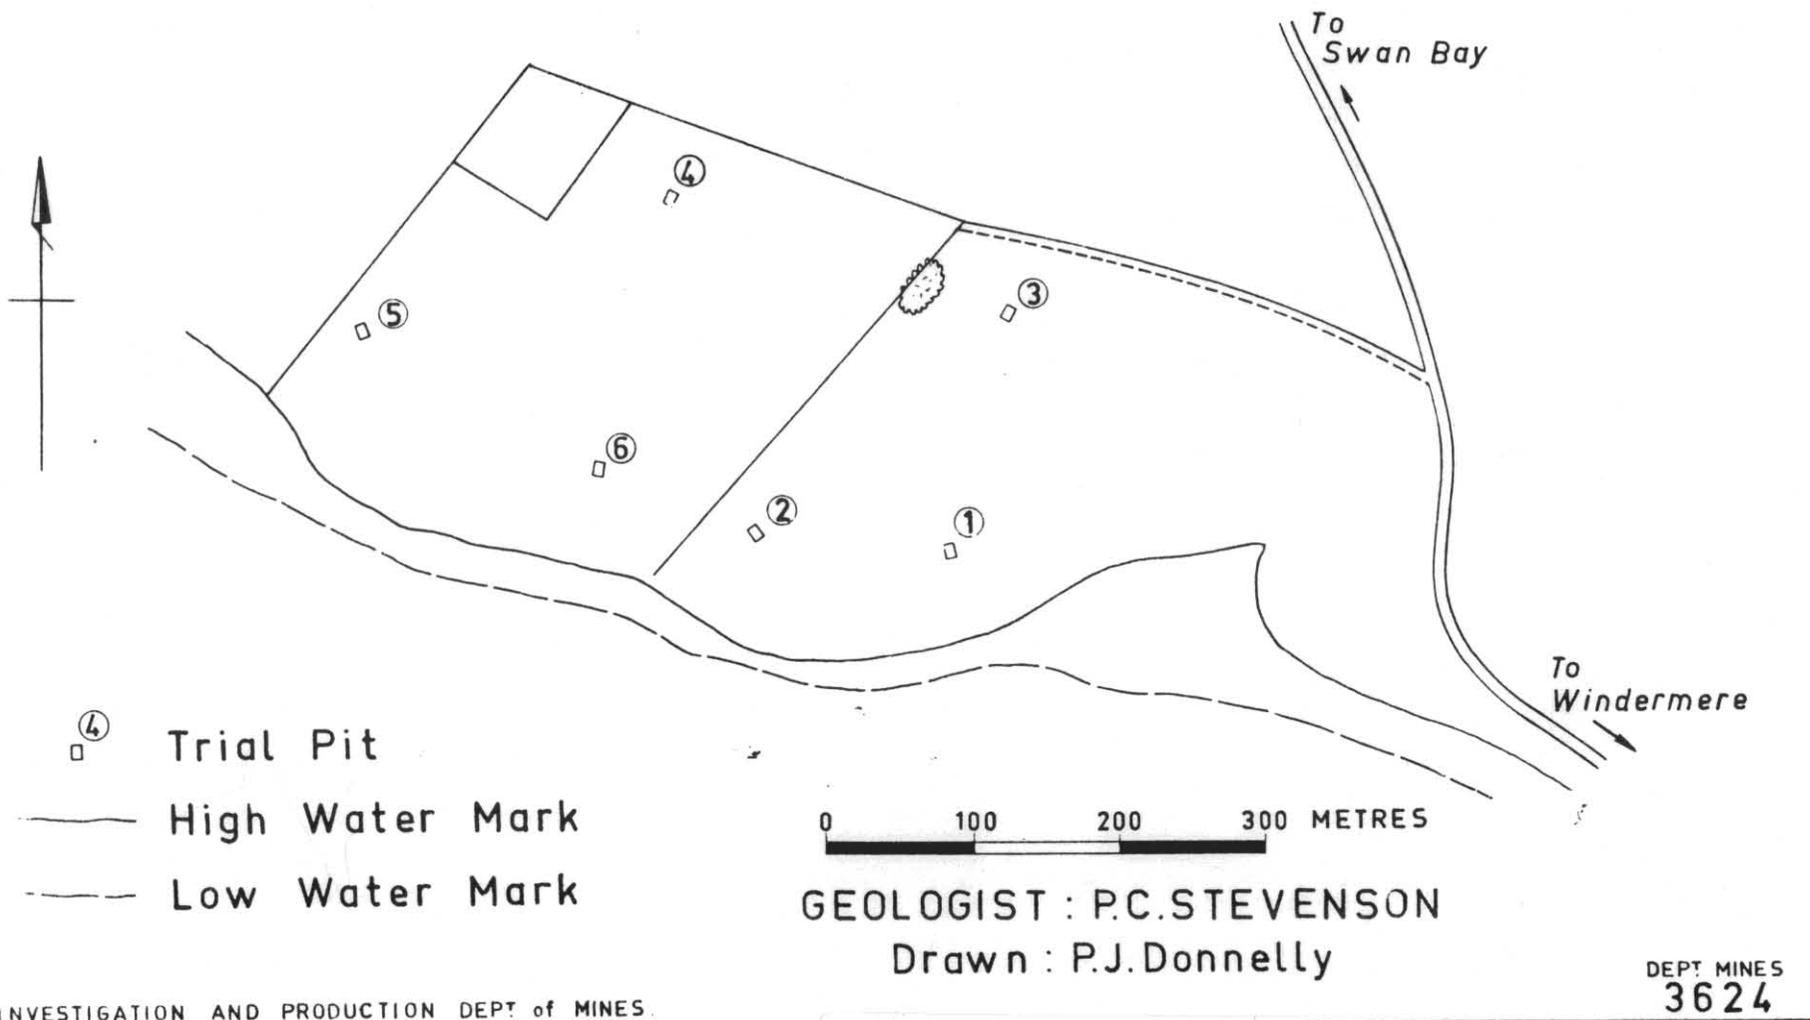
Figure 1. SKETCH PLAN SHOWING LOCATION
OF TRIAL PITS
Mr. R.H.Harris's Proposed Subdivision
Windermere

Six trial pits were excavated and examined on 30 May 1972 in the positions shown in Figure 1. The sections seen in the pits are described below:

The steepest slopes in the area are at the positions of Pit 1, 12°, Pit 2, 10° and Pit 5, 14°, and it will be seen that these angles lie between the estimates for basalt talus and sediments given above.

- (a) that houses are not built on slopes greater than 10° or in any position less than 100 ft uphill of any slope of 10°;
- (b) that stormwater and septic tank drainage, if any, is carried away to river level in pipes so constructed as to be flexible and not subject to leakage when in tension;

- (c) that roads are constructed as far as possible to avoid the steeper slopes or areas immediately uphill or downhill of them;
- (d) that the planting of trees is encouraged especially in the steeper areas.
