## An examination of the landslip potential at the Panorama Heights Subdivision, Devonport

by P.C. Stevenson

In response to a request from the Devonport Council dated 19 October 1971, the area of the Panorama Heights subdivision was examined on 25 and 26 January 1972. A surface examination was followed by the excavation of four trial pits.

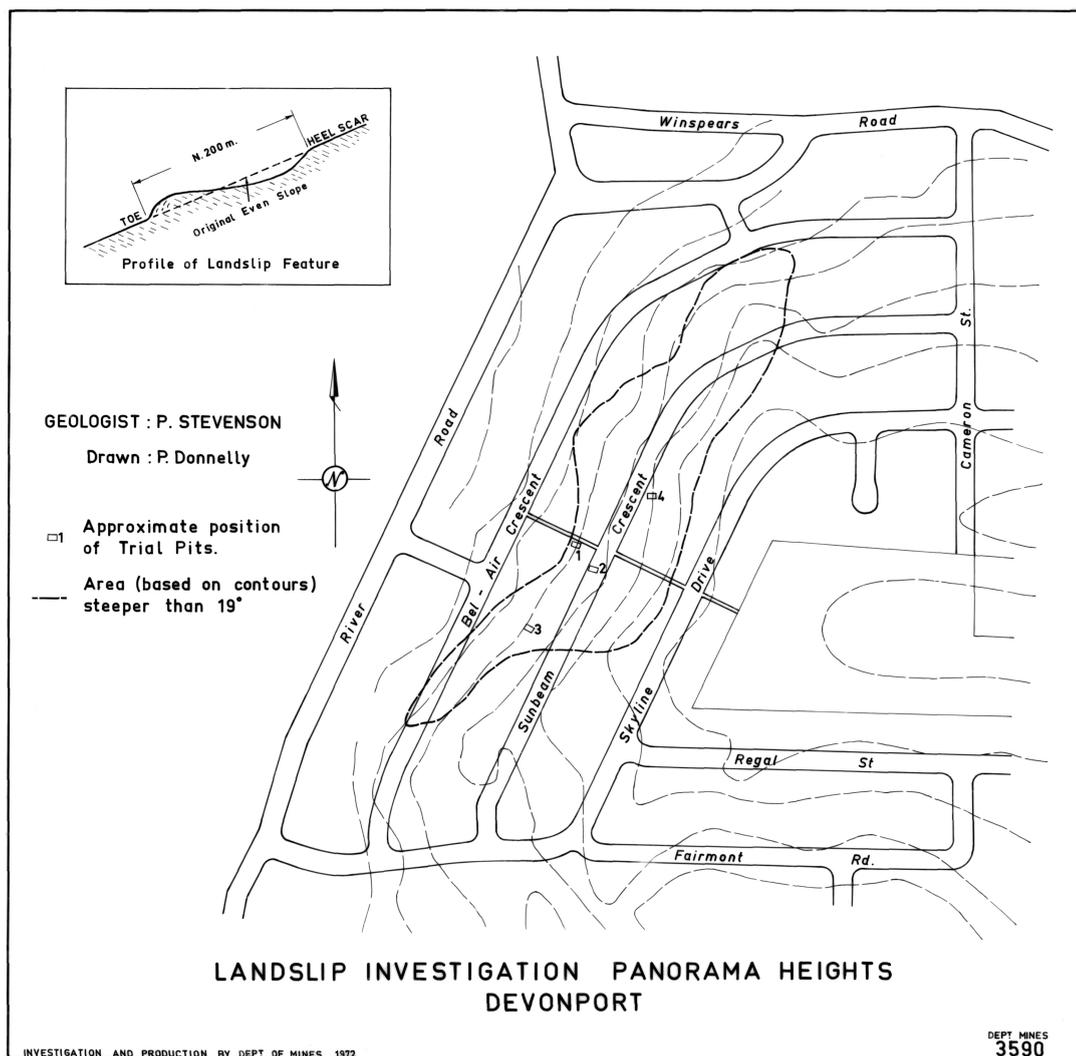
Figure 1

Because of the development in the northern third, and the dolerite in the southern third, and for reasons of access, the trial pits were dug in the central third of the site. In addition, there are changes of slope in the vicinity of these blocks which have the appearance of old slips. In detail one of these consists of an elliptical area of long axis about 200 m downslope and 80 m across slope. In vertical profile the old slips are concave and steeper than normal in the heel scar region, almost horizontal or even back-tilted in the centre and steeper and convex at the toe (fig. 1). One larger and perhaps two smaller features of this kind can be distinguished.

It appears that slope failure has occurred in the past in the region of pits 1 and 2 and at pit 3 and that the failure has occurred in 'red soil' clays. Those clays occur throughout the middle third, and can be assumed to extend over most of the northern third. A slip potential therefore exists in these areas. A slope of 19° has been assumed as an unsafe angle and areas steeper than this have been marked on Figure 1.

It is recommended that an analysis of the stability of the red soil slopes be carried out before building is allowed to continue in the subdivision. A drilling programme should be undertaken to enable representative samples to be obtained, and soil mechanics measurements be done to determine the physical properties of the material. An estimate of the possible subsurface moisture conditions would be required as preliminaries to the analysis.
