Report on the land stability of a proposed subdivision at Windermere

by P. C. Stevenson

The Department was asked to give an opinion on the stability of an area of land at Windermere, by the owner Mr R. H. Harris of Windermere Farm.

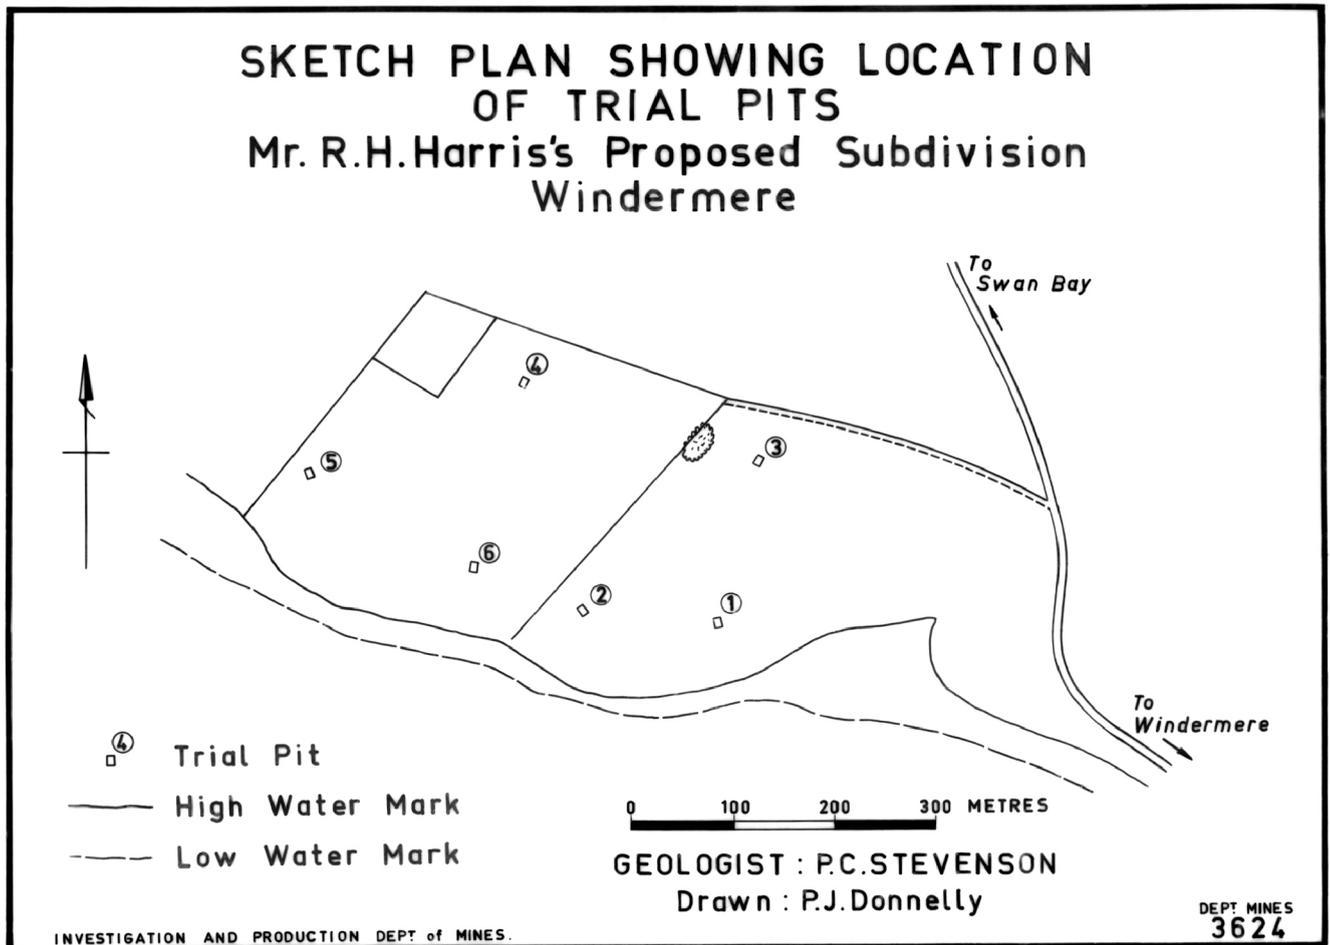
Figure 1

The land was that indicated in Figure 1. The area was first examined by a seismic survey to reveal the subsurface geology (Leaman, 1972). This survey showed that no basalt rock exists in the area, and that it consists of 3 to 5 m of basalt talus overlying Tertiary sedimentary clay.

Six trial pits were excavated and examined on 30 May in the positions shown on Figure 1. The sections seen in the pits are described below.

The steepest slopes in the area are at the positions of Pit 1 (12°), Pit 2 (10°) and Pit 5 (14°) and it will be seen that these angles lie between the stability estimates for basalt talus and sediments given above.

- (a) that houses are not built on slopes greater than 10° or in any position less than 100 ft uphill of any slope of 10°;
- (b) that stormwater and septic tank drainage, if any, is carried away to river level in pipes so constructed as to be flexible and not subject to leakage when in tension;
- (c) that roads are constructed as far as possible to avoid the steeper slopes or areas immediately uphill or downhill of them; and

(d) that the planting of trees is encouraged especially in the steeper areas.
