The stability of a proposed subdivision at Clara St, West Ulverstone.

P.C. Stevenson

An area of landslip to the west of Clara Street, Ulverstone was examined on 26 June 1973 at the request of the Ulverstone Council.

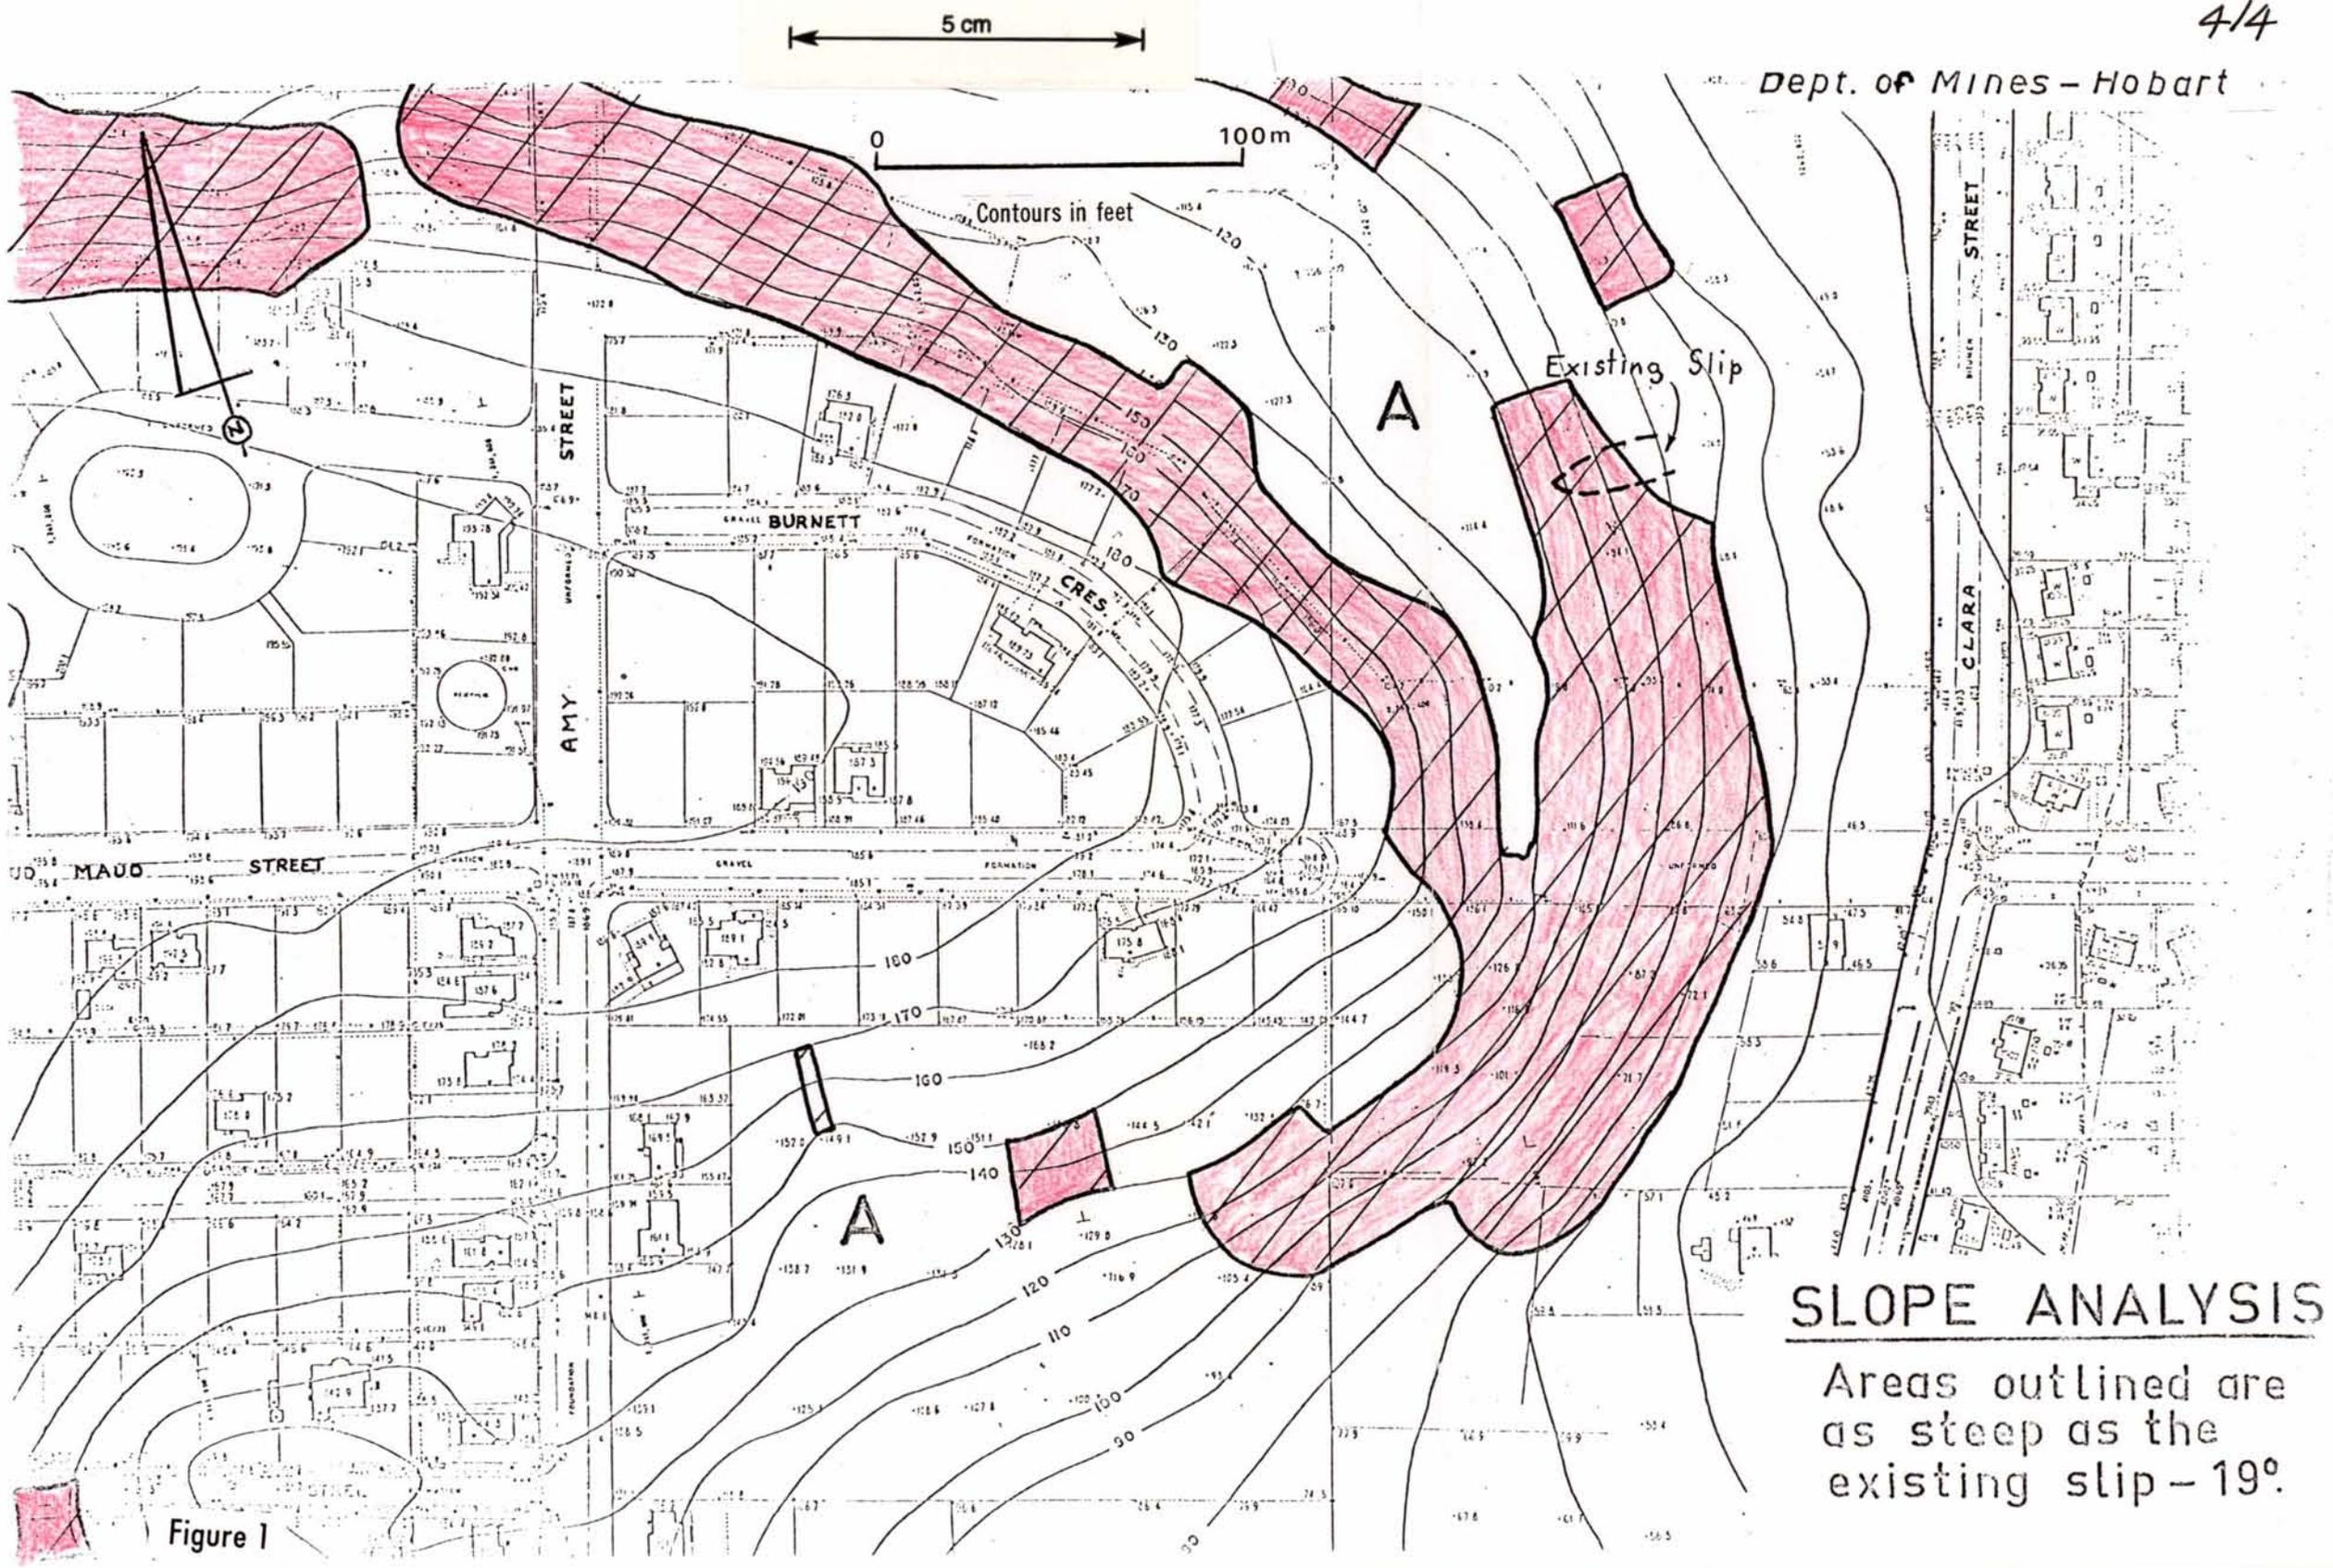
Figure 1

Although this is the only active slip in the area, old slips of much larger size are recognisable in several places around the hill (fig. 1) but the age of these is unknown.

An analysis of slopes as represented by the contours has been made for the Clara-Amy Street area. The average slope over these contours (20 ft) has been estimated for the immediate area of the existing active slip. All areas steeper than this have been determined and are outlined on the plan. The limitations of this technique, based as it is on coarse contours, are such that it tends to be conservative and the areas of steep slope are probably greater than represented by the outlined areas.

An examination of the contours also reveals anomalous areas (marked A, Figure 1) where divergent contours represent strong changes of slope. A horizontally and vertically concave head lies above a doubly convex toe. This particular appearance is recognised as diagnostic of old 'fossil' landslips. The age of these is unknown, but the risk of a recurrence must be appreciated and is in fact borne out by the existing slip.

SLOPE ANALYSIS

Areas outlined are as steep as the existing slip - 19°.
