UR1974-34

Stability of land at Fairlands Estate, Somerset.

W.L. Matthews

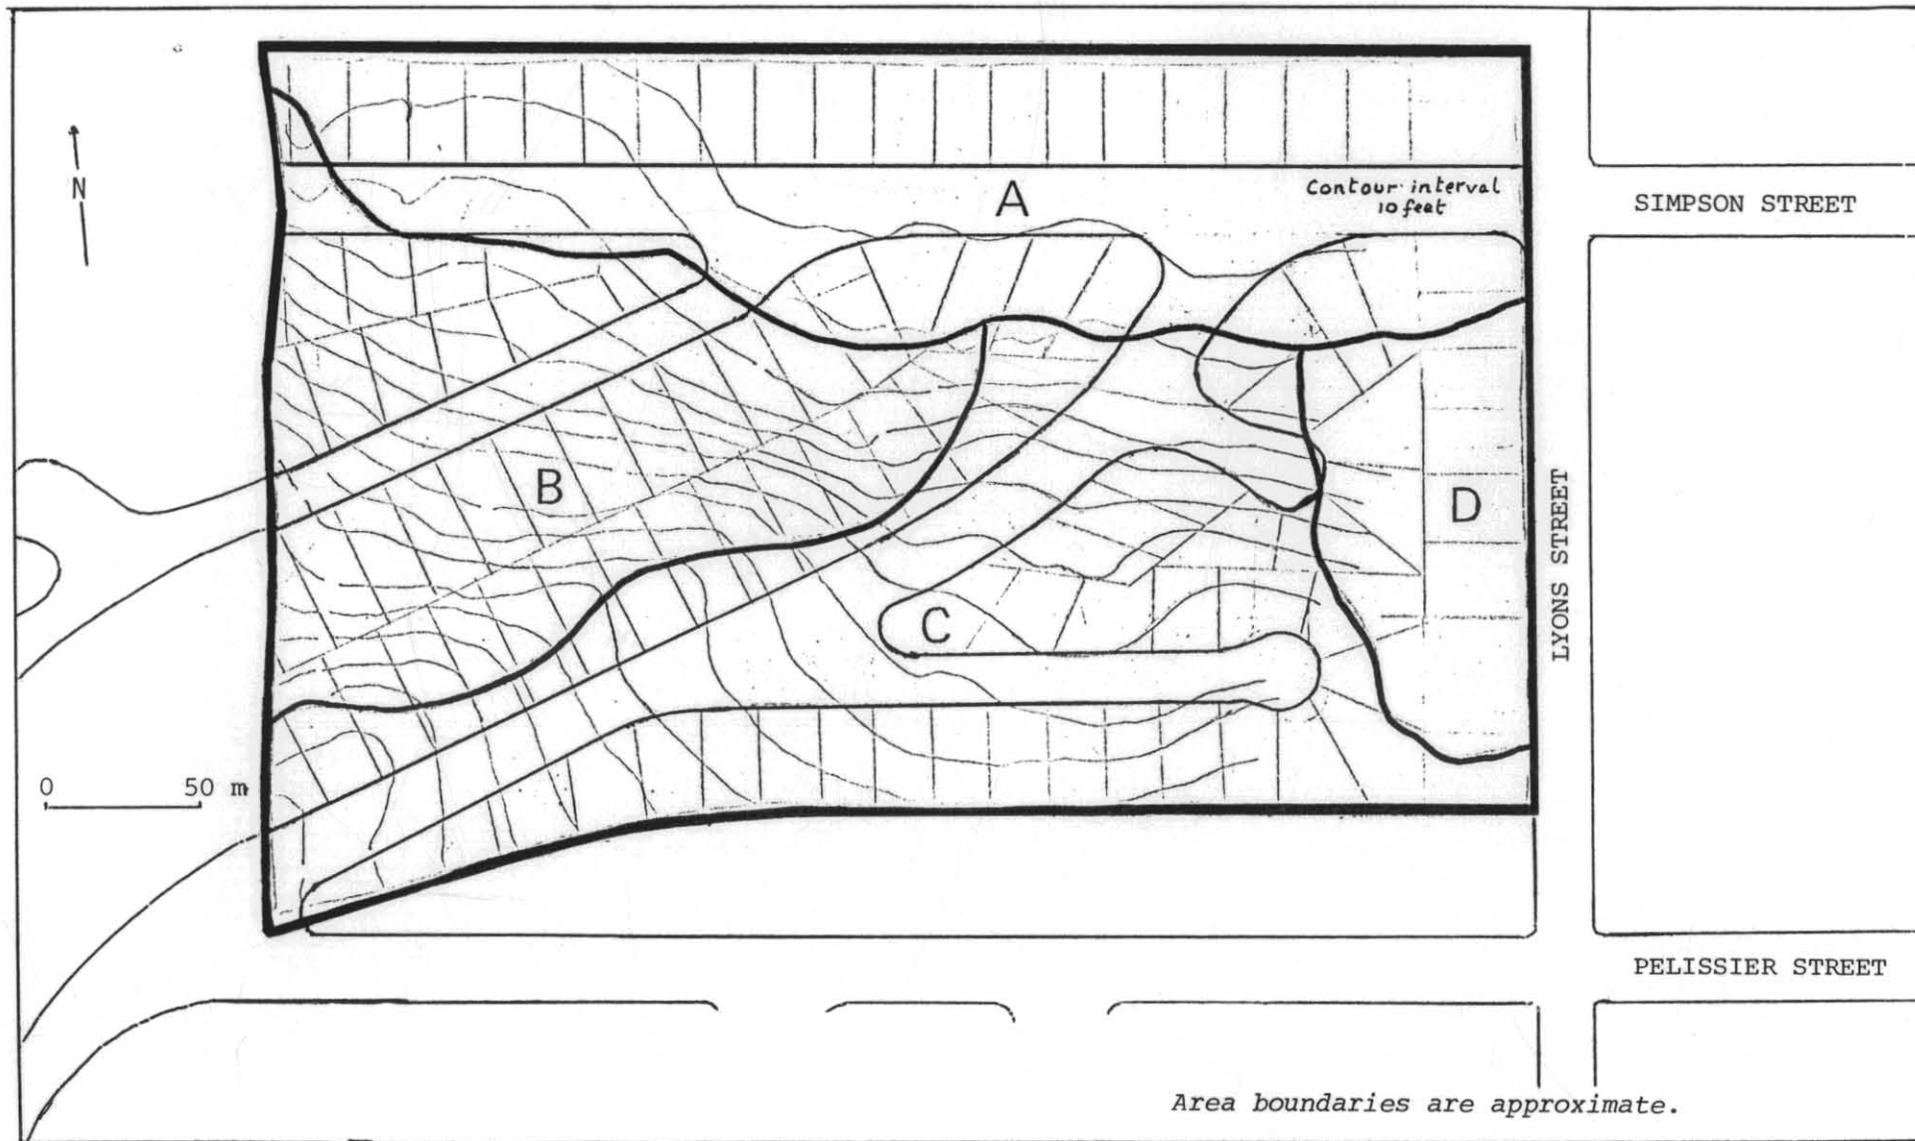
Figure 1. Part of Fairlands Estate, Somerset.

The portion of the subdivision that occurs on the marine terrace (Area A, fig. 1) could be safely developed except perhaps for areas close to steep slopes. Landslips that might develop on these slopes could extend down and affect part of the flatter land.

The north-west portion (Area B) of the subdivision should not be developed because of the presence of definite old slips and one fairly recent slip.

Much of the middle portion of the subdivision (Area C) should only be developed after detailed subsurface investigations have indicated there is no risk of landslips occurring in this zone. These investigations should include drilling and tests of the strength of the materials obtained.

Parts of the eastern portion (Area D) of this subdivision could be safe to build on subject to the results of some test pitting. It is possible that the older rocks occur further up the slope in this area and they are not

If any of these areas are developed, the seepages that occur within or near them should be drained so that water is not allowed to accumulate in the soil.
