UR1974-41

Test pits at Danbury Heights, West Tamar.

W.L. Matthews

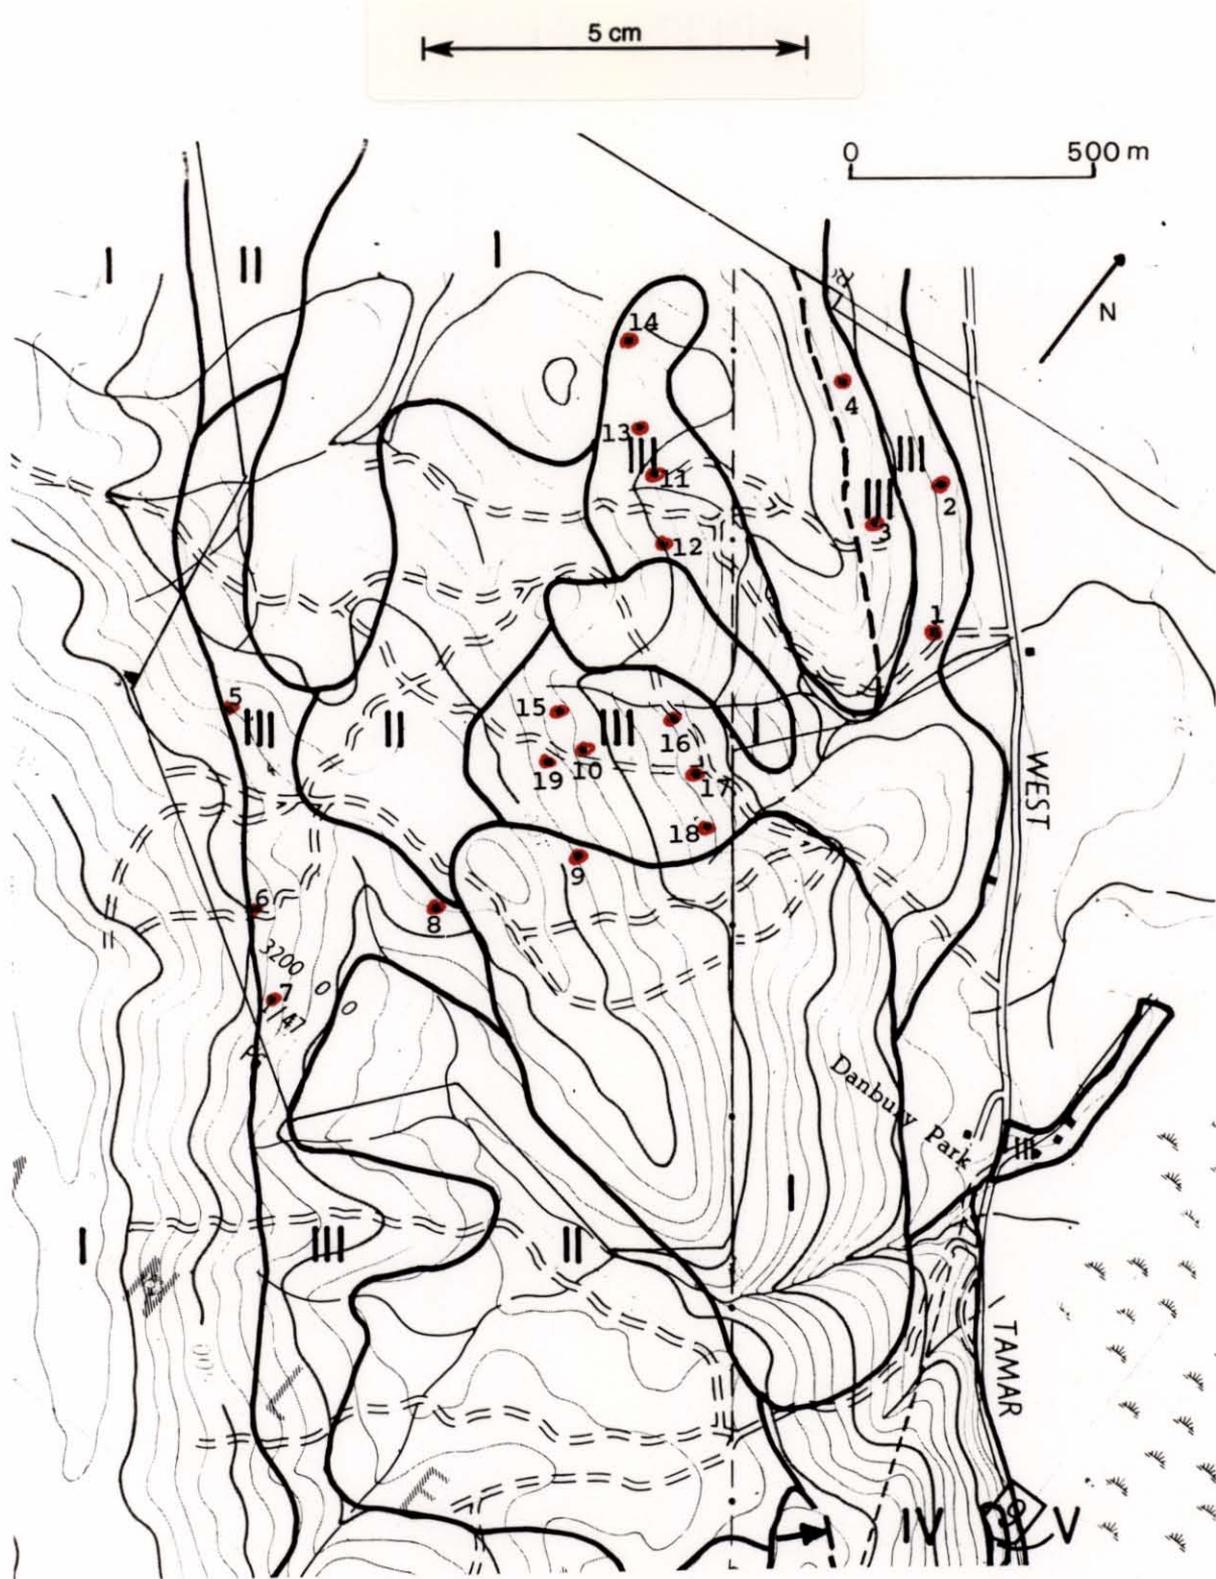
Figure 1. Proposed subdivision at Danbury Heights showing approximate positions of test pits.

The map accompanying the previous report indicated areas where test pits should be dug to examine subsurface conditions. It was thought that some areas shown on the Landslip Zone Map as Class III (fig. 1) could be reclassified. The positions of the test pits shown on Figure 1 are only approximate, except for pits 3 and 4 which have been fairly accurately located.

The logs of Holes 1, 2, 3 and 4 suggest that this area should remain in Class III. The upper boundary should be moved up hill as shown in Figure 1.

The Class III area which lies parallel to, and to the west of, the West Tamar Highway has been extended up hill as shown on Figure 1.
