UR1974-65

Further investigation of Block 3, Adams' subdivision, Windermere.

C.J. Knights

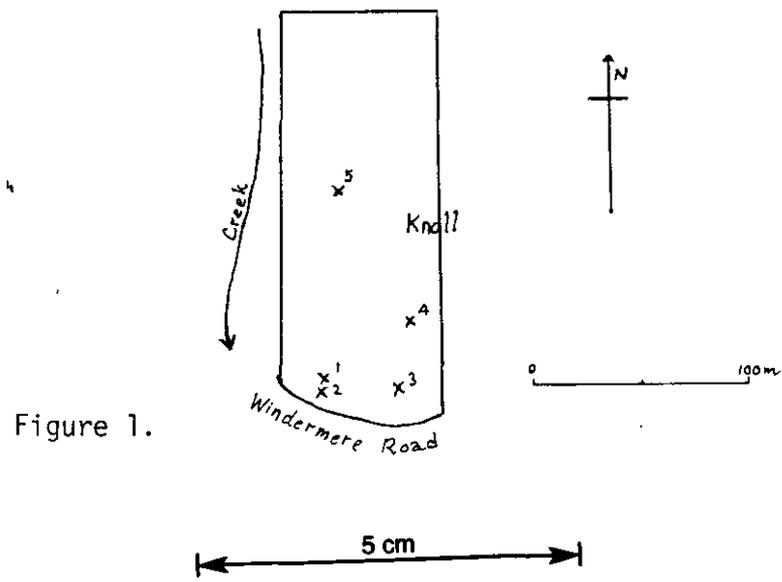
Figure 1.

The hill slopes are slightly hummocky, but do not show any topographic evidence of significant slipping. Five holes were dug by back-hoe to enable further investigation (fig. 1).

Trial pit results and topographic features suggest that on the slopes the top 1-1.3 m of soil is subject to movement, either as superficial slipping, or slower creep movement. However, there is no evidence of deeper seated instability and the block is suitable for a residential building.

- (1) The house should be situated on land which slopes at less than 7° (1 in 8).
- (2) Sullage should be piped and directed more than 40 m away from the house.
- (3) Stormwater should be piped to the creek.
- (4) No unsupported cut should be more than one metre in depth.
- (5) No fill should be deeper than one metre above the natural ground slope of the site.

A swimming pool must not be built on the top of the knoll, but may be constructed on land which slopes at less than 7° (1 in 8), in the north-west of the block, adjacent to the creek.
