UR1975-14

Test pits on a property at Don.

W.L. Matthews

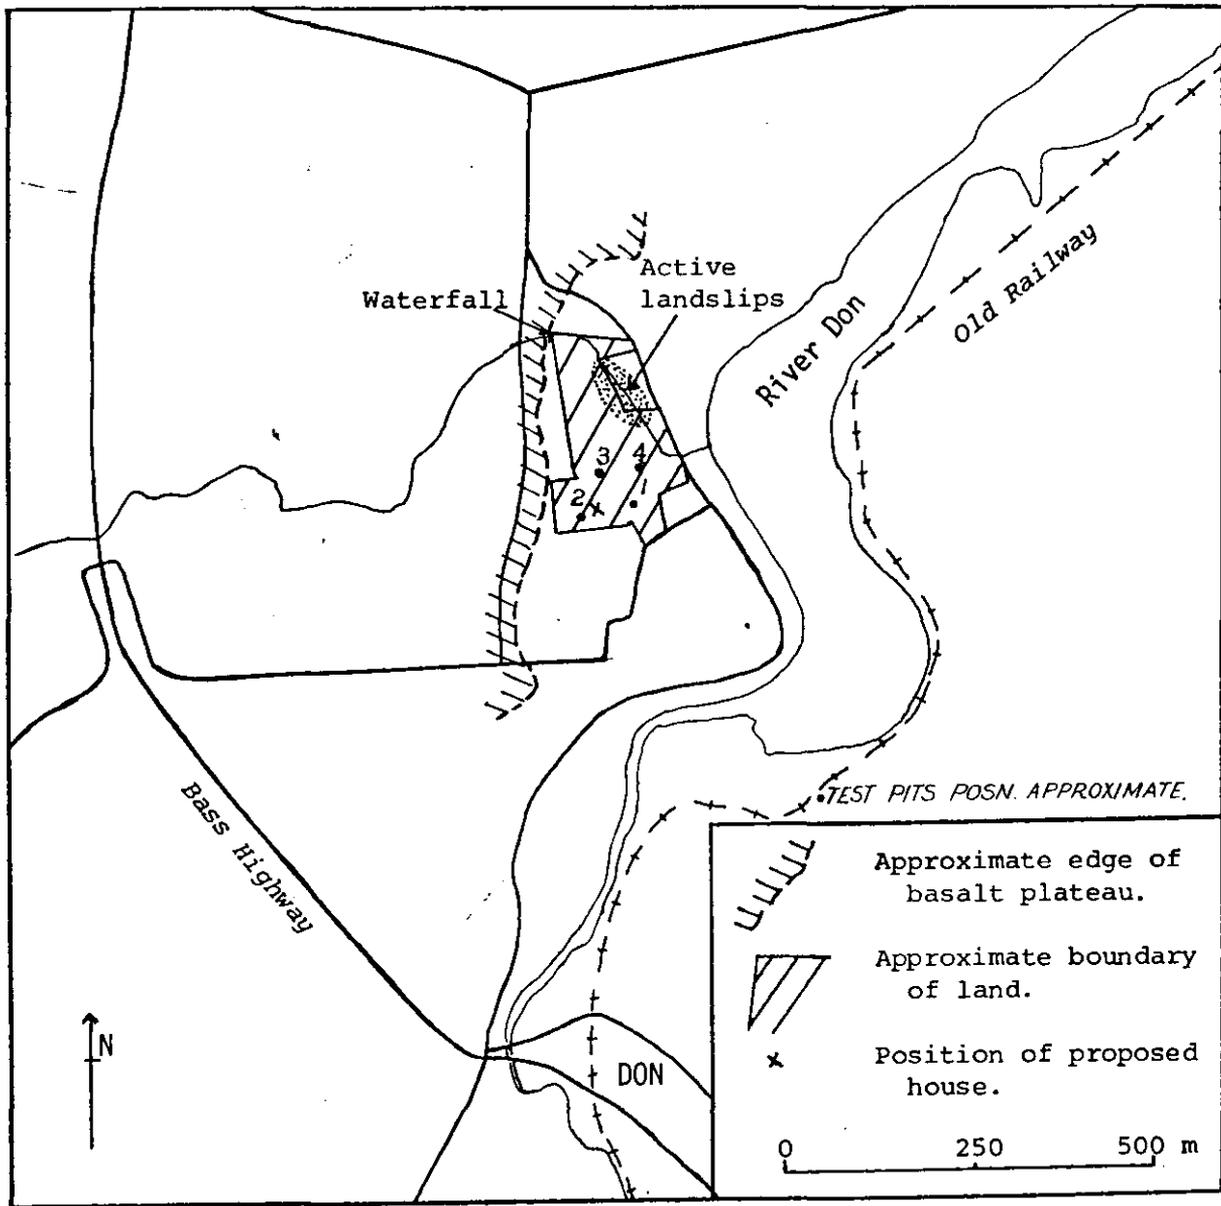
Figure 1.

Mr D.G. Jones is planning to purchase approximately 4 ha of land at Don [DQ425415] for a residential site. Following the recommendations from an earlier investigation of the stability of the land (Matthews, 1974), four test pits (fig. 1) were dug to examine the nature of the subsurface material and the groundwater conditions.
