UR 1975-54

Assessment of slope stability along Rosevears Drive, West Tamar.

P.C. Stevenson

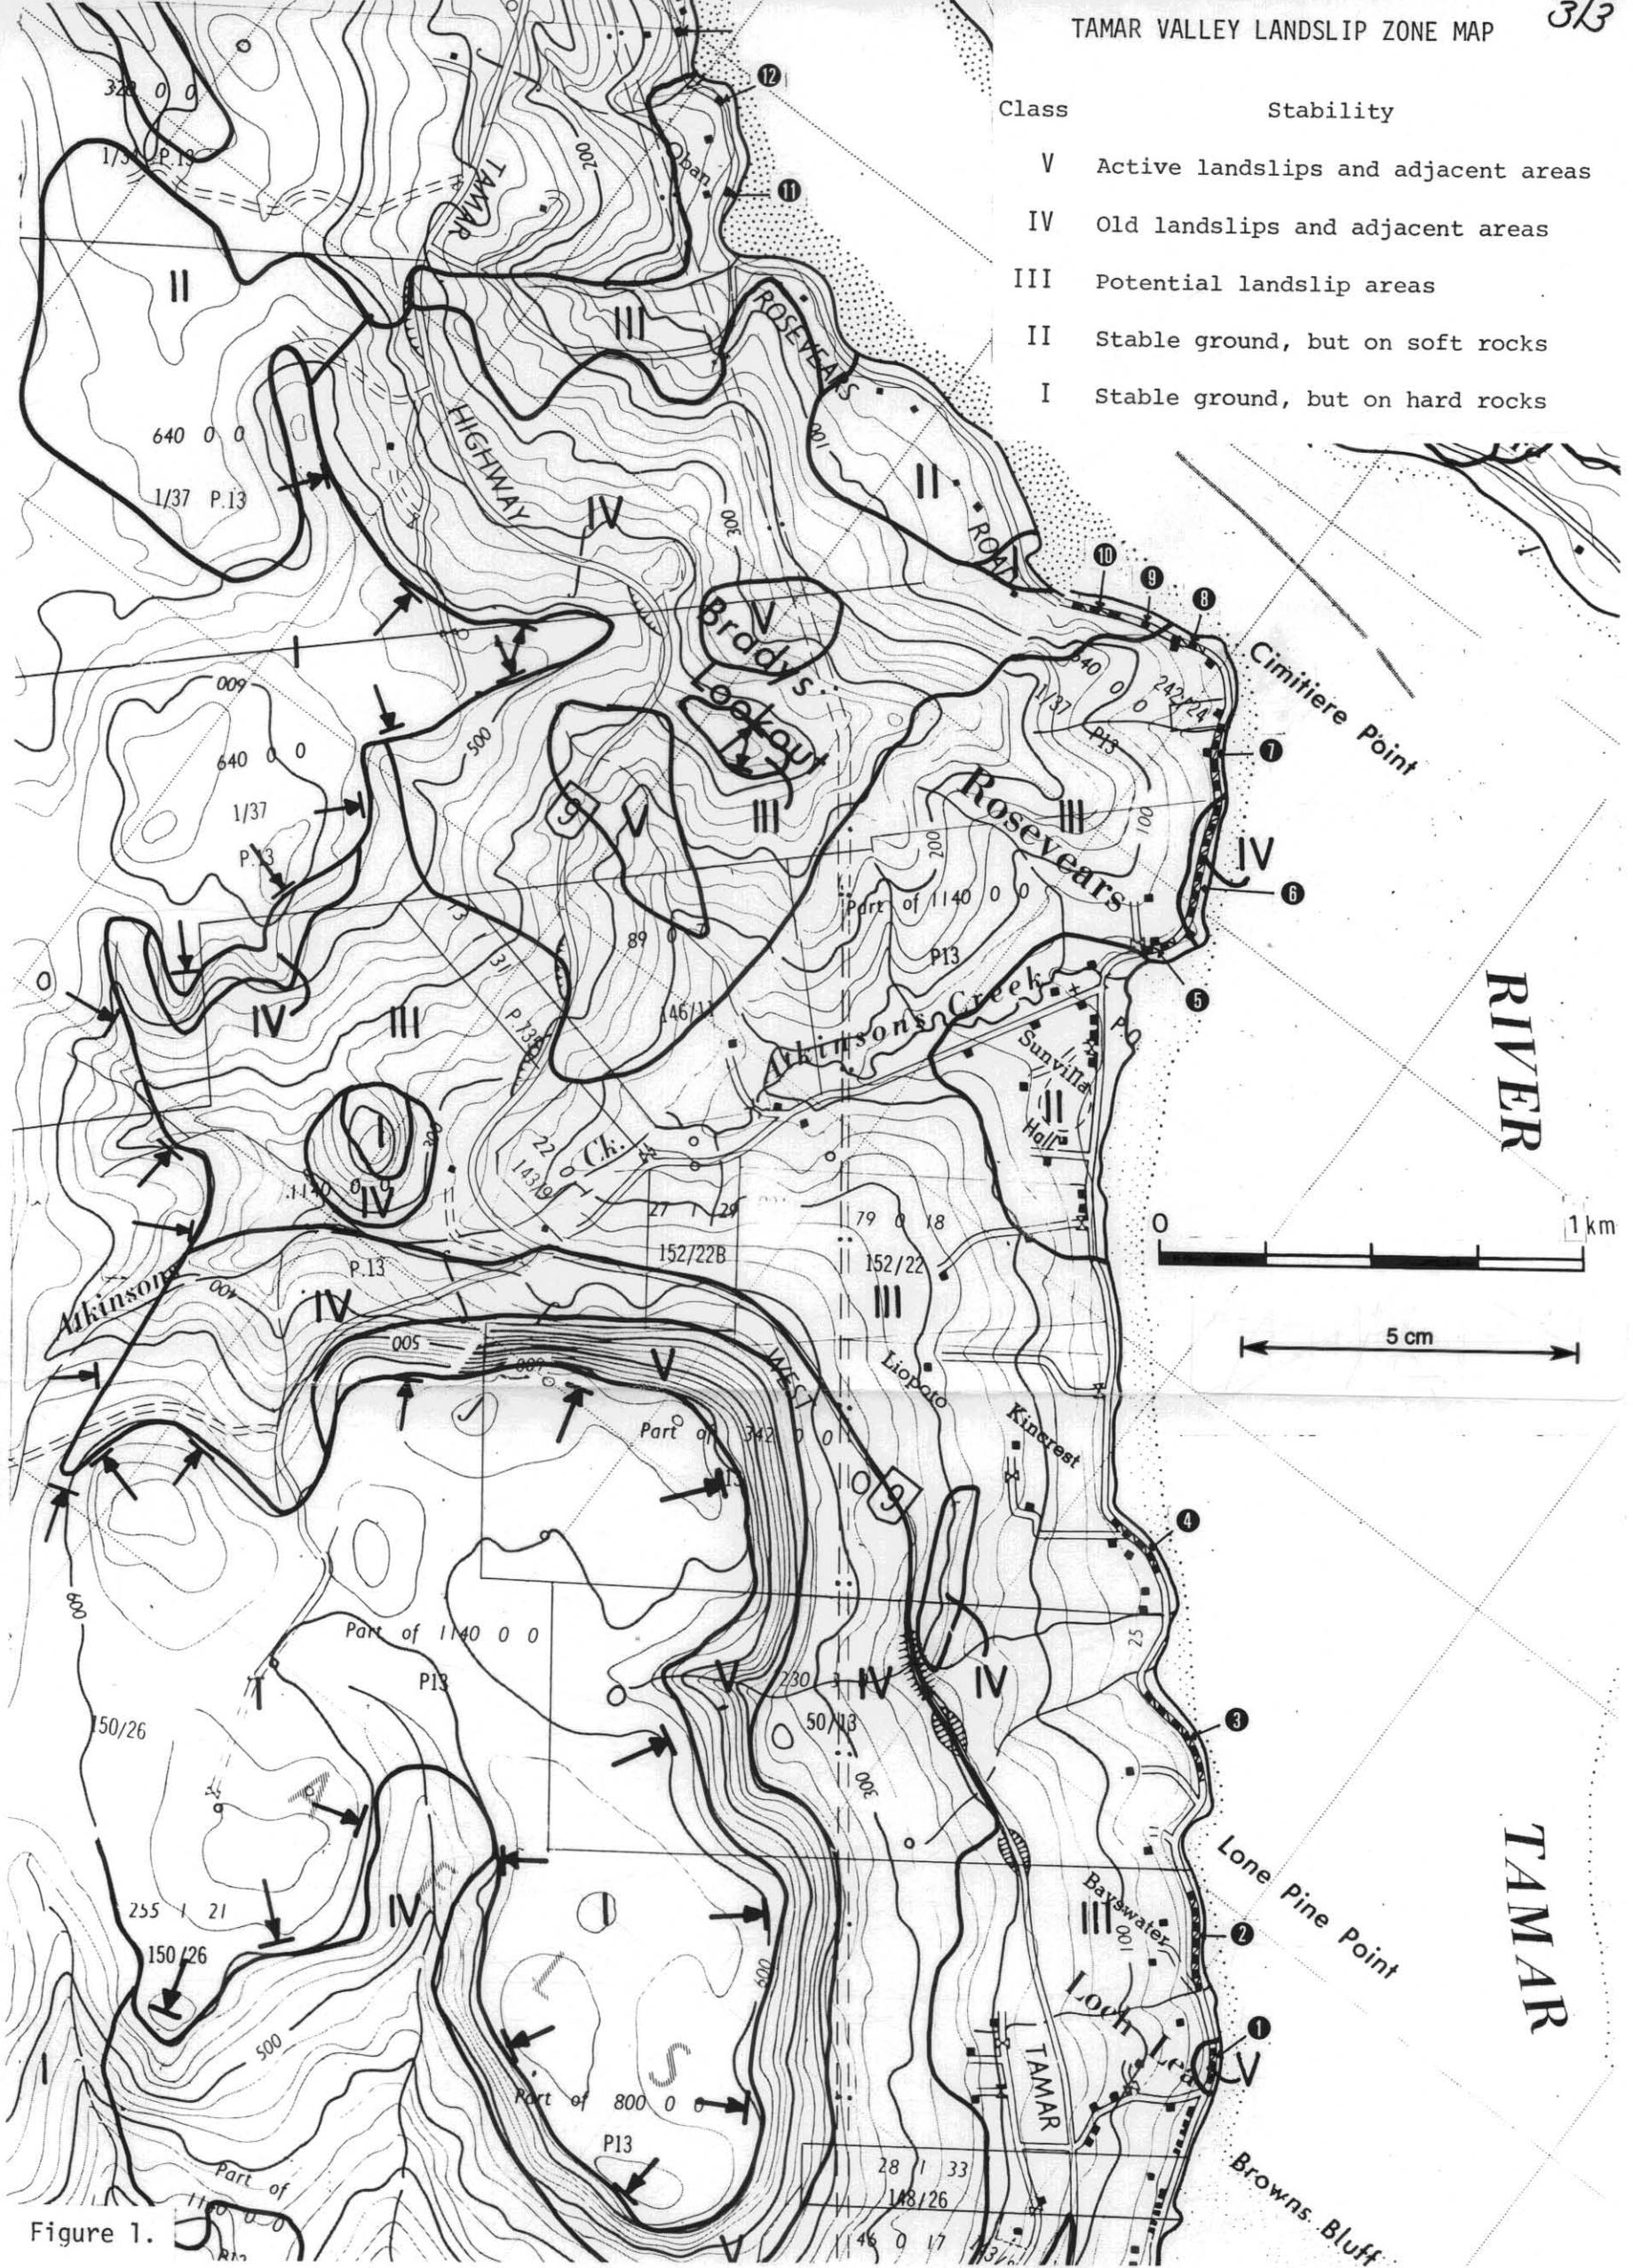
The road passes over an area of plastic clay and minor sand and gravel of the Tertiary Launceston Beds where there are some slopes of up to 20°. Zones of landslip risk have been drawn on the Tamar Valley Landslip Zone Map, a portion of which is reproduced as Figure 1.

The road itself is mainly on Class III land where failure is possible, but the very presence of the road has in places disturbed the natural ground slope and caused instability. Class III land has in places become active landslip and is now locally Class IV or V.

Locations indicated in Figure 1.

(1) Failure of the road base over a distance of some 30 m results in depression of the road surface and continuing cracking. Bore holes at the foot of and up McEwans Road show that a thick clay succession underlies the whole of this area and that pore pressures are very high. The area in general is Class III (fig. 1) but the small area where the road is in failure is Class V.

(2) The rubble wall on the upper side of the road is under considerable soil pressure and the closure of the table drain has aggravated the clay movement. Small buttresses below the road are damaged and the road in this area must be considered at risk. The steep slopes do not appear active at the moment but convex slopes near 'Bayswater' are thought to have a potential for failure.

(3) Over this section a bank 4 m high is showing small failures on the upper side of the road and rubble walls are under pressure. A wall below the road has collapsed.

(4) A 5 m high bank is here in active failure and has closed the table drain aggravating the condition by disturbing drainage and threatening the stability of the road.

(5) At this point a 2 m high bank is failing.

(6) This section is in Class IV and has been close timber-piled. The piles are not in good condition and may have already moved. Survey marks have been established on them but it is not known by whom.

(7) Rubble walls are here under pressure.

(8) Cuts here in gritty clay to form a space for a garage appear to be stable.

(9) A low rubble wall (one metre high) is under pressure.

(10) Timber piled section. The bitumen seal of the road is cracking at the north end and soil is leaving the piles on the down-slope side. Movement is probably occurring here.

(11) The road surface has failed at this point.

(12) The 5 m high rubble wall is in a dangerous condition over a length of about 20 m and its condition should be rectified urgently. The writer has followed the state of this wall for some years and although movement is slow, a critical condition will soon be reached. The exact origin of the failure is obscured and remedial measures can hardly be suggested without some investigation.

(13) At this point the dolerite bedrock emerges at the surface and is to be seen as very weathered but quite stable material. From here northwards the solid rock is close to surface and virtually no stability problems exist (Class 1).

In each instance of failure, a flexible approach but using these obvious principles is likely to be the cheapest and most practicable solution. The failure of small banks as at Location 9 could be rectified by rebattering and the reconstruction of the rubble wall.

At Location 4 reduction of the slope angle again appears to be the best solution, possibly combined with stone counterfort drains running down the slope. The acceptable angle of slope in cases of this kind can best be judged from that of the stable slopes in similar material nearby.
