UR 1975-60

Water supply for a golf course at Penguin

W.L. Matthews

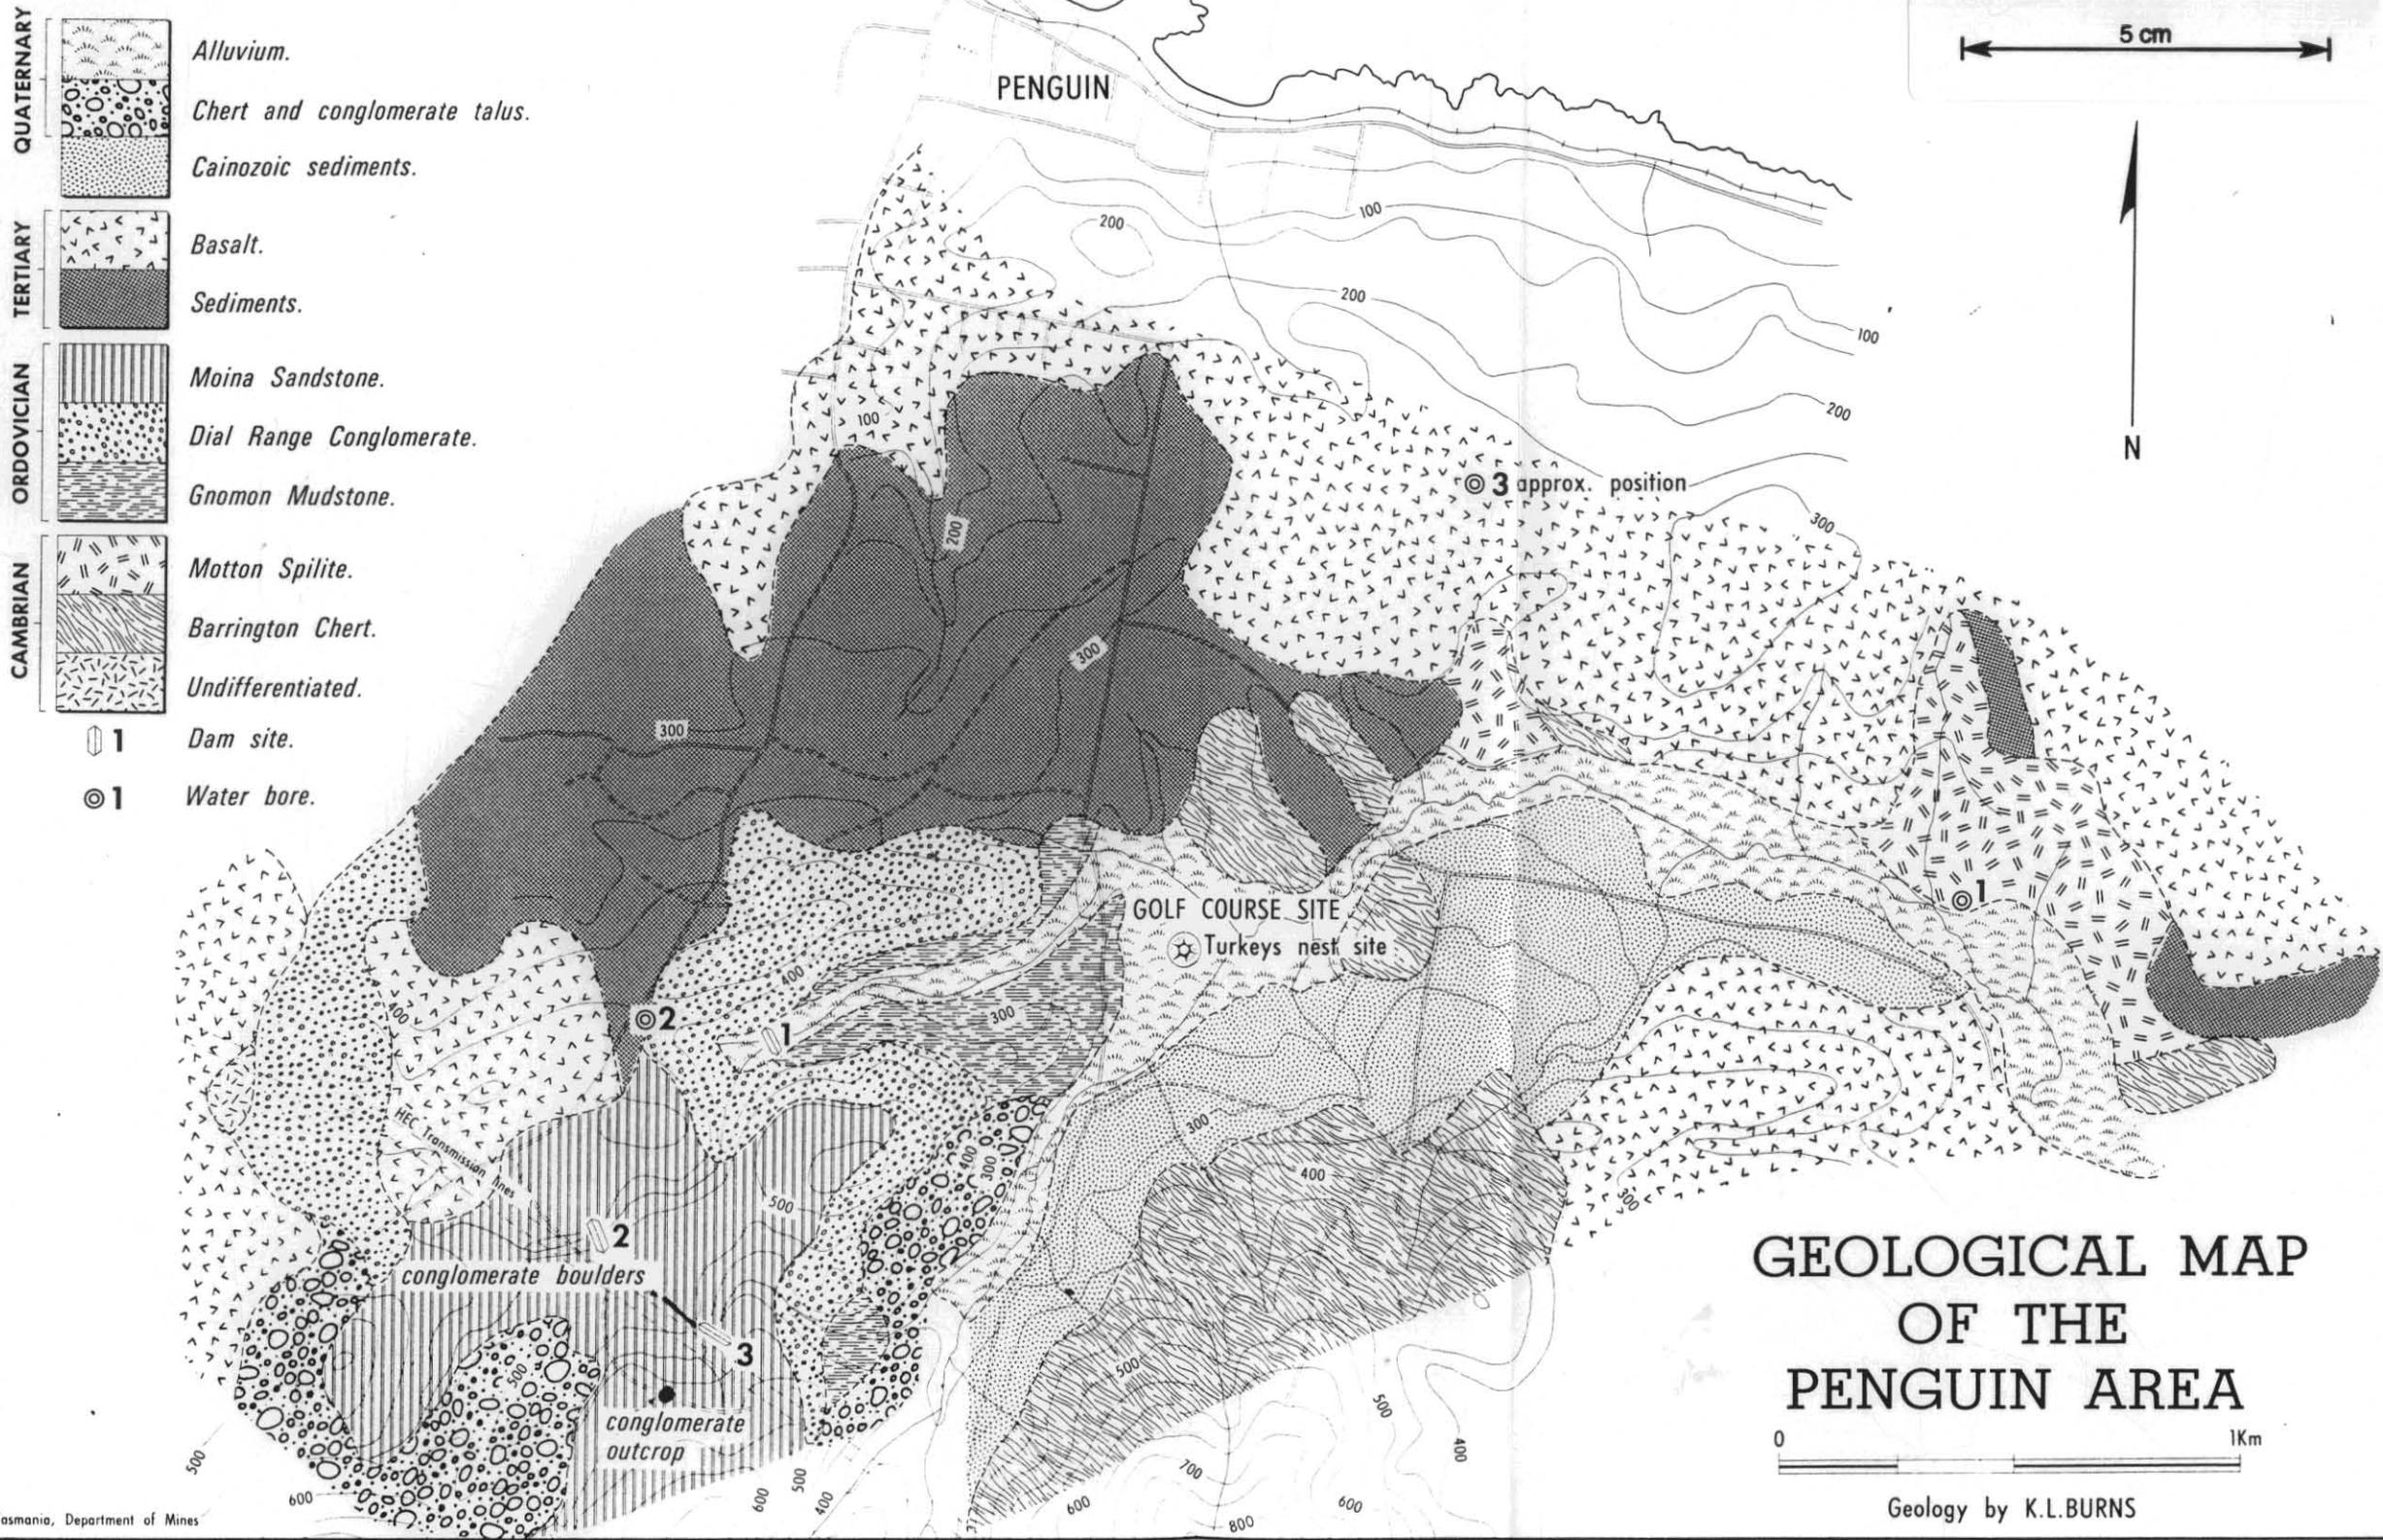
Figure 1

The geology of the area has been mapped by Burns (1963) and reported on by him in 1965 (fig. 1). Cambrian chert and spilite crop out in isolated areas along the sides of the valley of Myrtle Creek between the golf course site and the River Leven. Ordovician mudstone, conglomerate and sandstone occur on the northern end of Dial Range. Talus from these rocks cover the steeper slopes. Tertiary sand and gravel underlie the basalt and extensive areas occur south of Penguin. A strip of Cainozoic sand and gravel south of Myrtle Creek may be of the same age. Alluvium occurs along the beds and flood plains of the streams.

Three bores have been drilled near the dam sites but the positions of only two of these are known with a fair degree of accuracy (fig. 1). Hole 1 was pumped at 750 l/min when drilled and in the summer of 1974/1975 was pumped continuously at a set rate of 600 l/min when drilled for 10 weeks. About 5.5 m of unconsolidated material was struck in the hole (0.2 m of gravel at the bottom of this material) before slate and some clay were encountered. The hole was drilled to about 37 m in a low lying area. Hole 2 was drilled on a narrow ridge and struck about 5 m of soil and clay followed

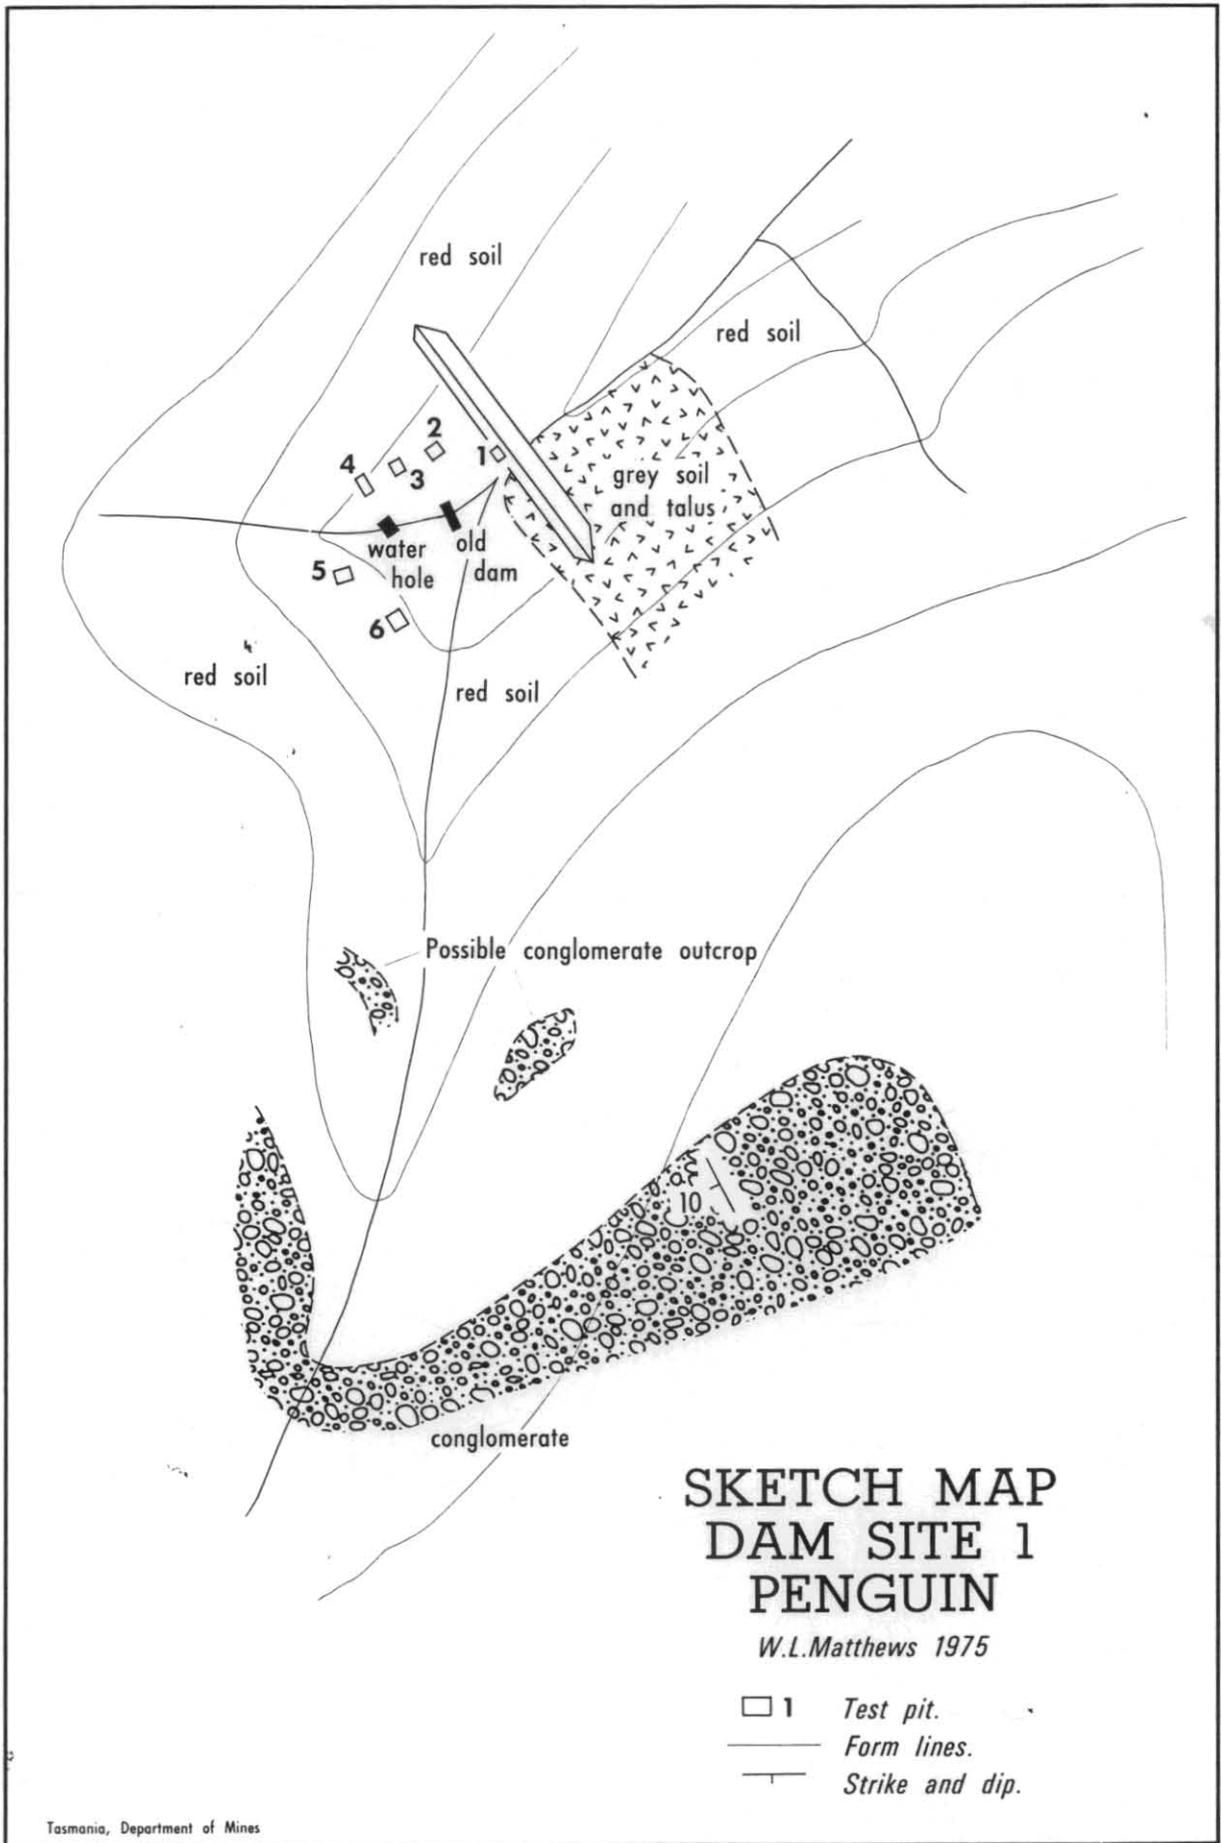
Figure 2

Dam site 1, on which work has commenced, is situated on a headwater tributary of Myrtle Creek below a small valley entering from the west (fig. 1). A more detailed sketch plan of the area is shown in Figure 2.

There are few exposures of bedrock in the area apart from conglomerate outcrops in the stream bed and on the flanks of the slopes about 400 m upstream from the dam site. Possible exposures of conglomerate also occur about 200 m upstream from the dam site, but low on the sides of the valley: these might be large boulders although they appear to display similar dips. The upper conglomerate exposures pass gradationally into sandstone with pebble bands and finally into beds consisting mainly of sandstone. Lower in the valley around the dam site, only soil and unconsolidated material is exposed. This is dominantly a red clay soil derived from the weathering of the Gnomon Mudstone containing quartz, and quartz and chert pebbles derived from the conglomerate uphill and concentrations of hematite boulders, particularly around Pits 2 and 3. On the eastern side of the stream a zone of grey soil and gravel is exposed on the surface and this is the material that has halted work on the dam. As the red clay occurs on the slopes upstream and downstream and also on the opposite bank it seems likely that this material is talus that has extended further downslope than in other areas due to a steeper slope or it could be the result of an ancient landslide. The material is likely to be relatively permeable and its thickness (at least in the area of the dam) should be determined as a cut-off would need to be dug to less permeable material. Alternatively the dam centre line could be relocated

a few metres upstream to avoid this material.

The other consideration is the depth of gravel in the alluvium around the creek. This should be determined so that a cut-off can be extended to weathered rock (probably Gnomon Mudstone).
