UR1975-61

Stability of M.E. Steward's land, Don.

W.L. Matthews

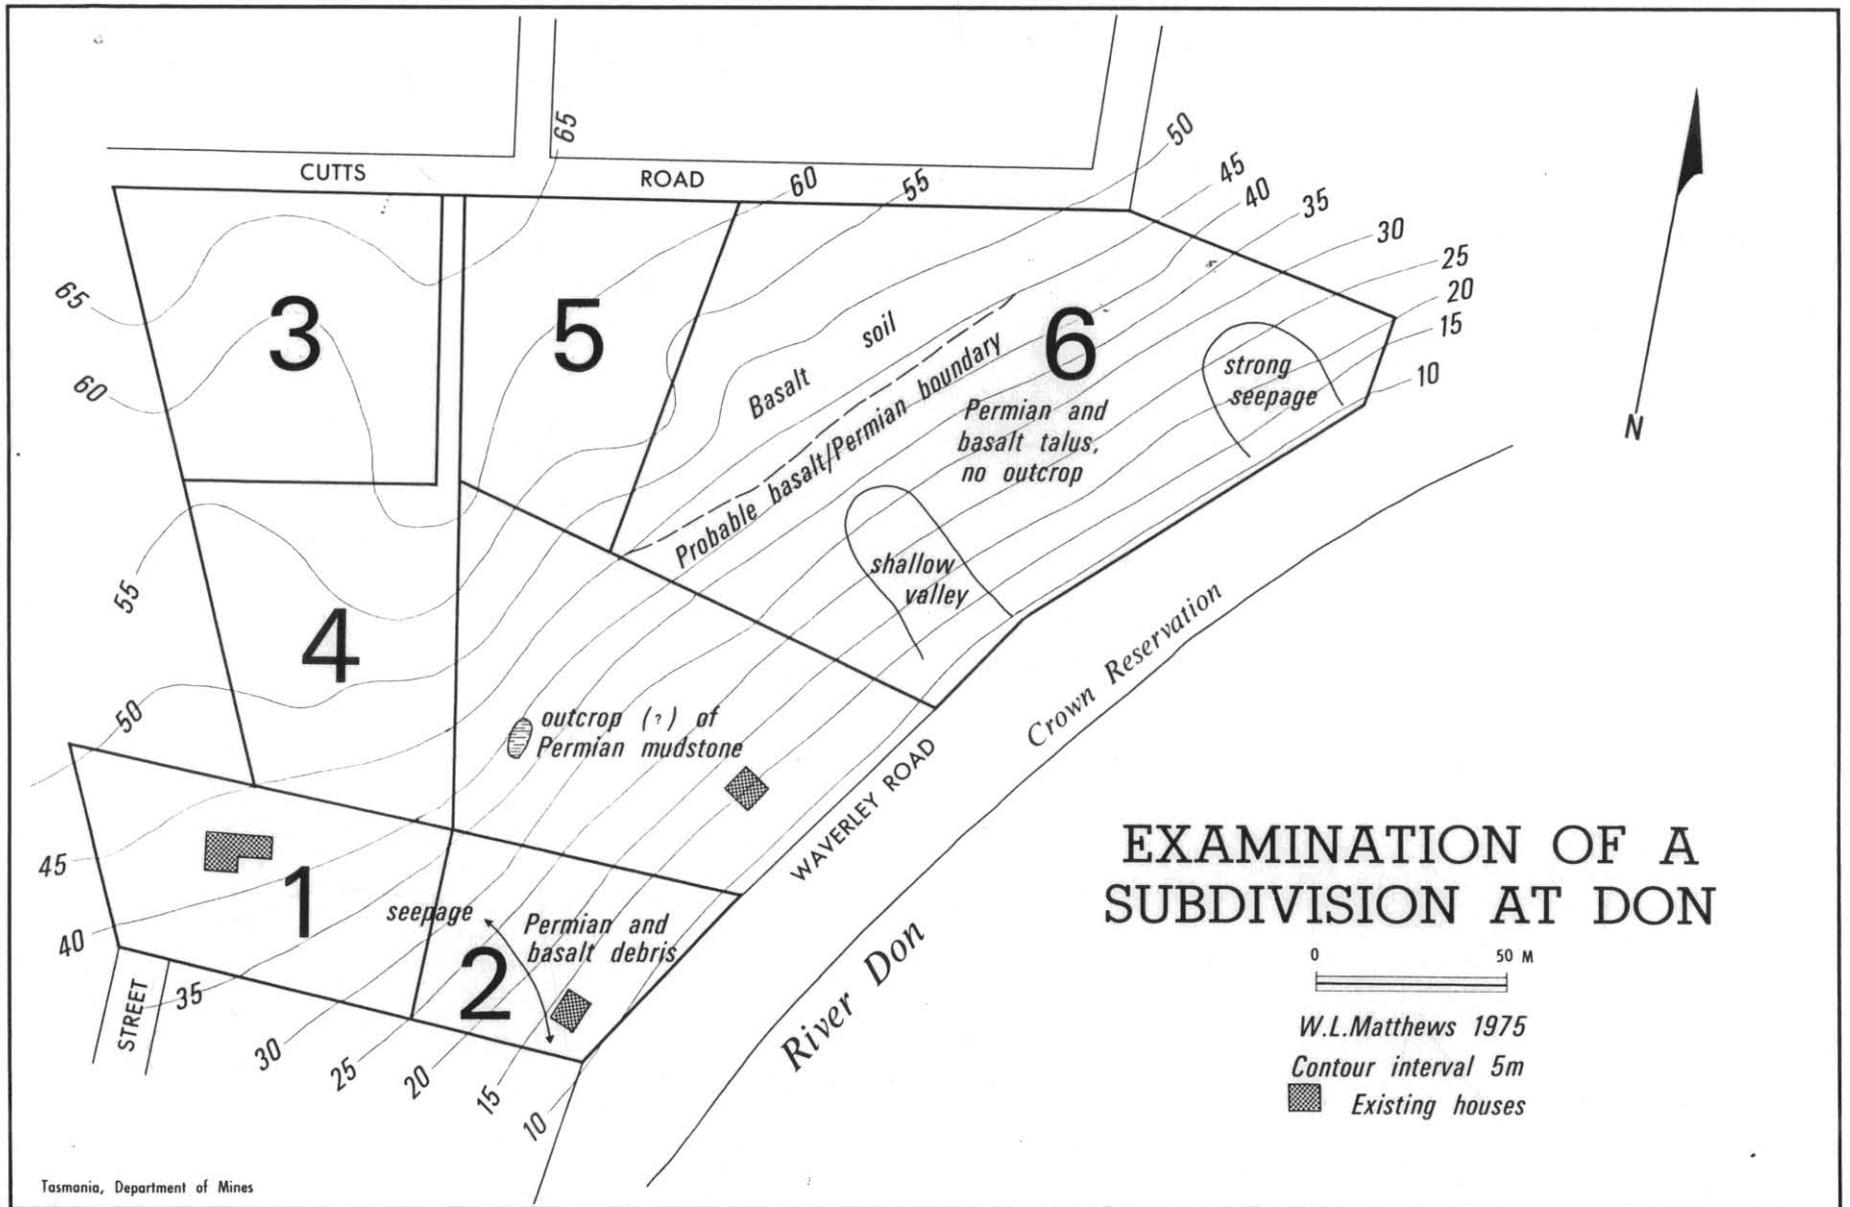
Figure 1.

Mr Steward owns land adjoining Waverley Road about 500 m north of the Bass Highway bridge over the Don River. The area of land is about 4 ha and has been subdivided into six blocks, two of which are very steep. The Devonport Council asked the Department of Mines for a report on the stability of the two steep blocks (fig. 1, blocks 2, 6).

Near the north-eastern corner of Block 6 near the road there is a strong seepage with soft ground around it that might have been subject to some movement in the past. Near the south-eastern corner of the block, there is a shallow valley which may represent a very old landslide. There is some flatter land in the north-western part of the block which is underlain by weathered basalt. It slopes at an average angle of 18°. Even this slope is relatively steep and there is some risk of instability.

Block 2 is a much smaller area of land which has an overall slope of about 27° except for a narrow flatter area near the road and where the present house is situated. There is a fairly strong seepage coming from near the top of the block and flowing diagonally down the slope behind the house.

Slips in the Permian rocks are not unknown and Burns (1963) mapped areas of these rocks to the south of the Bass Highway as being affected by slips. Although a house has been on one of the blocks for some time, and has been unaffected by landslips, the presence of seepages and steep slopes underlain by talus indicates that unstable conditions are possible. It is likely that any slips that may form would probably be of a shallow nature (i.e. soil and debris slipping on bedrock). There is thus some risk of landslips affecting Blocks 2 and 6. If the subdivision was modified to include part of the flatter land of Block 5 in Block 6, replacing the land taken with some of the steeper land of Block 6, this would allow homes to be built on flatter land on both blocks. A similar modification could not be undertaken with Block 2 as Block 4 is already sold and has a house built on it. The risk of instability on Blocks 2 and 6 could be lessened by the planting of trees.
