20. Examination of Groom's and Lonah slips, near Penguin.

W.L. Matthews

GROOM'S SLIP

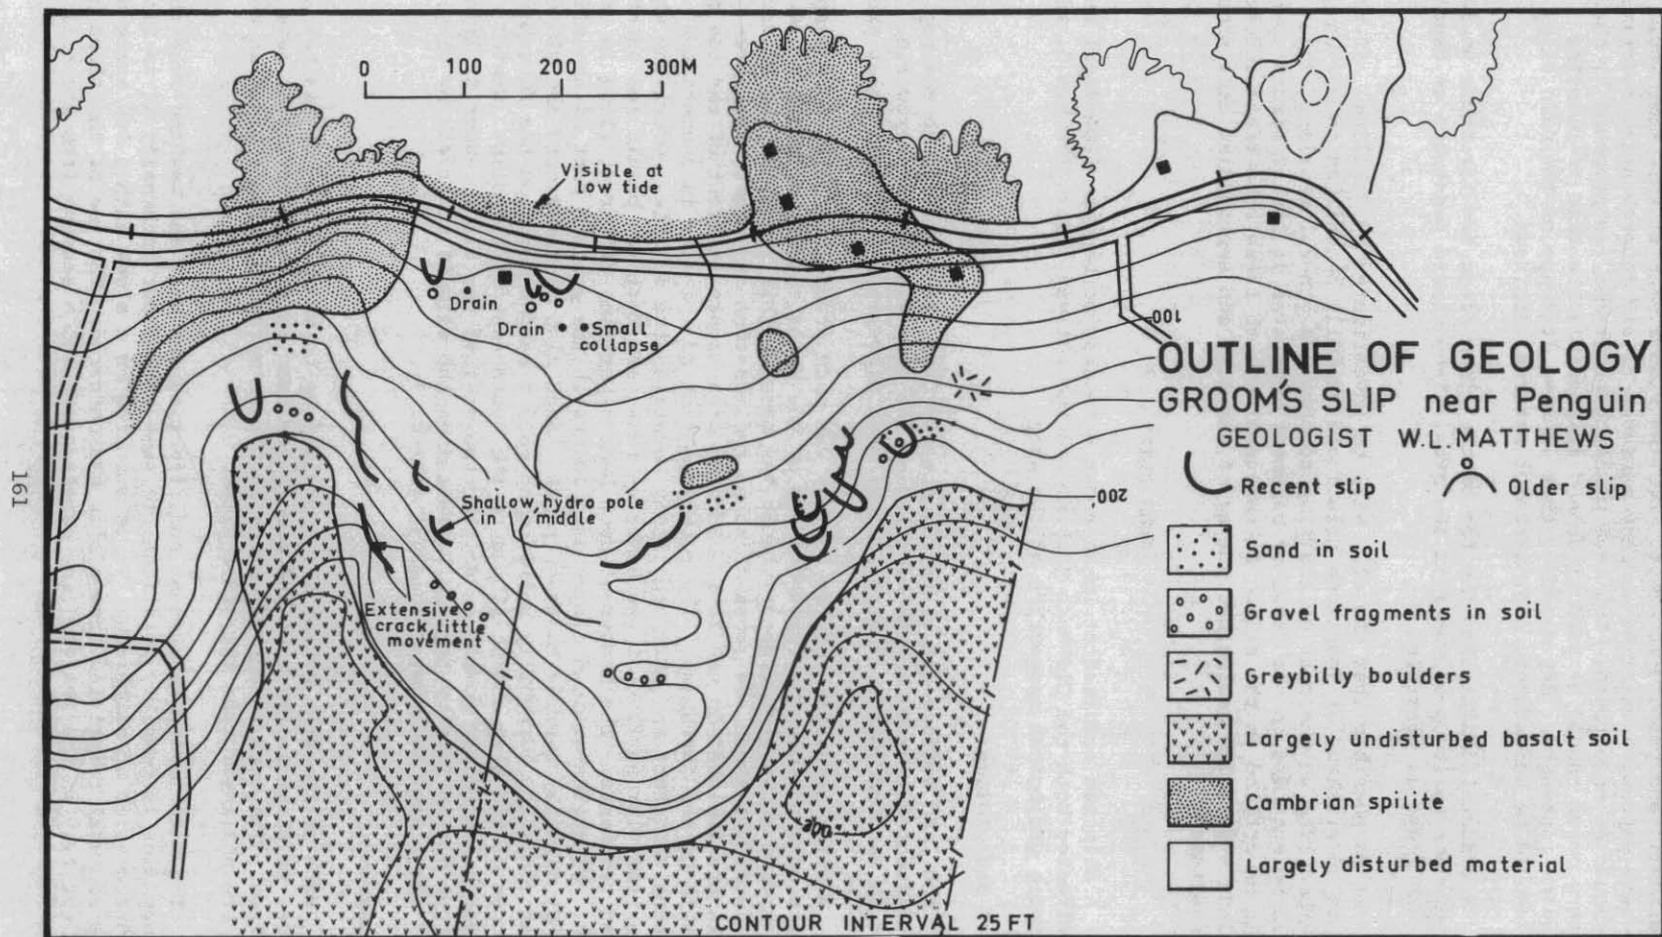
An outline of the geology is given on Figure 46. A Cambrian basaltic rock (spilite) occurs on the two points, up the ridge on both sides of the disturbed area, along the foreshore in front of the slip (where it is very weathered and is best exposed at low tide) and at isolated places between the ridges. Overlying the spilite are a series of basalt flows and interbedded sediments. It is not known how many of these units there are, but it has been suggested by Matthews (1965) that there could be up to 4 or 5 sedimentary horizons in the Penguin area. Greybilly, a silicified sand, occurs on the eastern ridge, east of the highest mapped spilite. Rounded siliceous gravel boulders occur at various places, mainly on the slopes to the plateau (fig.46). There are areas within the slipped material where such gravel fragments occur but where they are clearly not *in situ* whereas the locations marked in Figure 46 may be near the beds from which they are derived. Areas of sand in similar locations are also marked. Nye's sections drawn after the drilling show sequences of basalt, gravelly clay and sand. Towards the base of the slip in the tunnels, rounded gravel including basalt boulders are recorded by Balsille and on the shoreline above the spilite, sand beds are shown in Nye's section. It appears possible that the slip has ridden over shingle of ancient beaches and sand deposits (old dunes?, as most sand occurrences are fine even-grained deposits).

The slip affecting the road and railway line is probably a deep rotational slip. The steepness and height of slope, the high rainfall and disrupted drainage have influenced the movement.

The recent slip is almost certainly not a sign that the whole of Groom's slip is moving, but is a local movement in the toe. The tunnels appear to have been successful in stopping the movement of the main slip.

the old slip and promote movement. Dealing with a slip of this size would be a very expensive exercise and any measures to aid in preventing reactivation should be encouraged. The tree planting programme, as proposed by the property owner should be supported, and if possible the rate of planting should be increased. Any measures that improve drainage of the main slip mass should be undertaken, e.g. areas of internal drainage.

Horizontal drains into the toe of the slope along the foreshore would help prevent built up of water in the area. They should penetrate as deeply into the slope as possible.

It is possible that the slip will be investigated by drilling. If this work is undertaken, at least one hole could usefully be drilled in the undisturbed land at the rear of the slip to obtain a general section. This should be extended to sea level or basement whichever is struck first. Others should be drilled in the slip. In conjunction with these subsurface investigations a detailed geological survey of the slip and surrounding area should be undertaken.

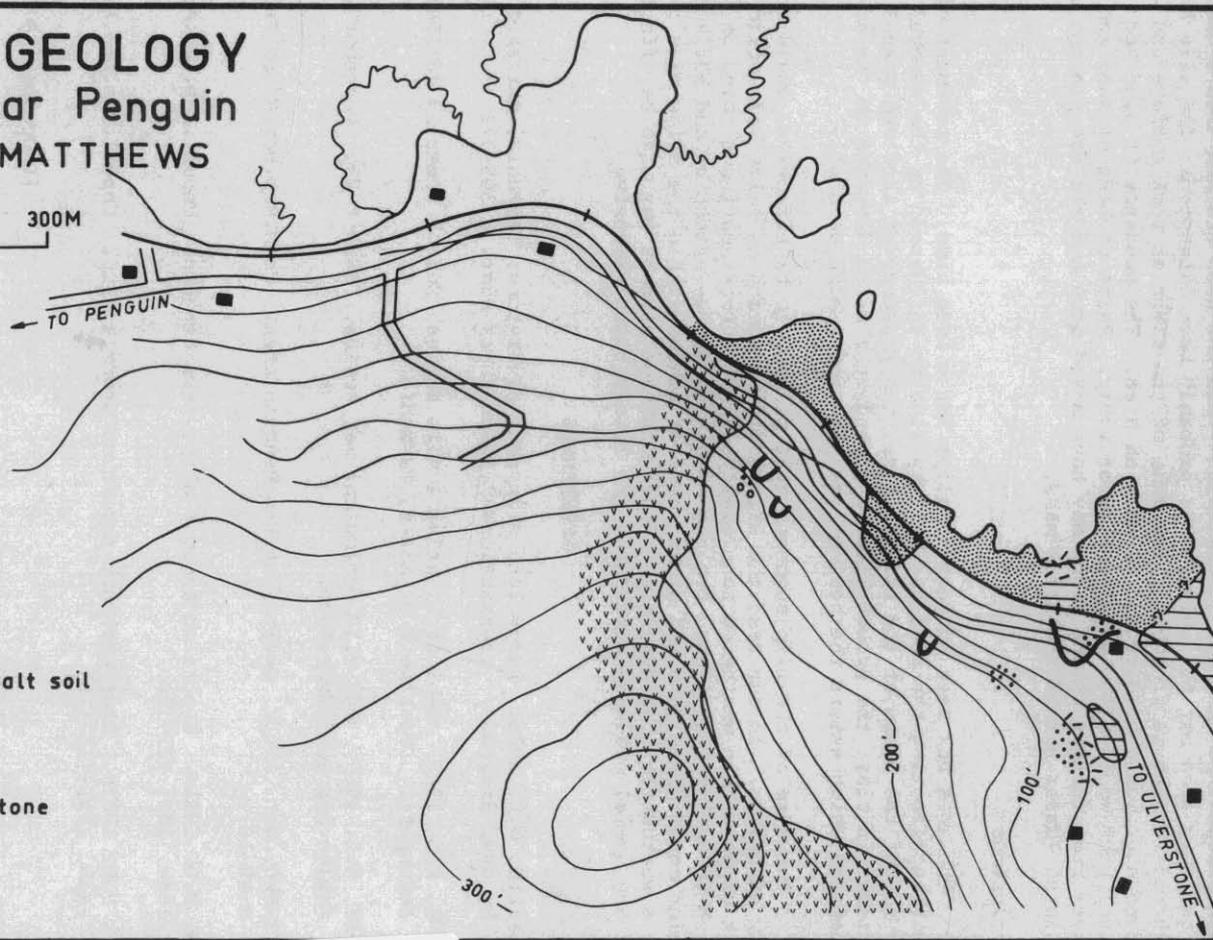
Figure 47.

Much of the area behind the shoreline up to the plateau top has been subject to slips in the past and some large deep rotational movements have occurred. The more recent movements have been marked on Figure 47 and in general are shallower than the older slips.

The slip moving at present and affecting the road and pushing over the railway line is possibly rotational to some extent but internally it is fairly disturbed as in an earthflow. It is situated on a slope with a low angle and it is somewhat surprising that a slip has occurred. The toe of the slope has been cut away in the railway line construction and a seepage from the hill

behind seeps into the heel of the slip. This has been drained into a culvert in the slip area but the culvert has probably been disrupted. The slip has occurred in what is probably a low zone of the Cambrian rock surface and groundwater would be directed to such an area. The presence of sand and gravel beds would allow ease of flow of water. Parts of beds of sand and gravel from further up the slope may have moved down and are now present in isolated lenses within the slide mass.

The area has been subject to slips for a long time. The movement of the slip affecting the road and railway line is influenced by the removal of the toe of the slope at the railway line, the presence of sand and gravel horizons in clay, the probability of groundwater being directed to the area, a seepage which enters the heel of the slip and a high rainfall.

The size of the slip suggests that piling, to be effective, would be very expensive. In any case the slip could be moving on relatively solid rock or on a thin weathered zone overlying solid rock leaving nothing in which to anchor the piles. Drainage measures may be effective and horizontal drains could drain sand and gravel beds or lenses within the slide mass and are a worthwhile consideration. Other drainage methods may also be effective but any useful drainage procedures are likely to be expensive.
