UR1975-69

Ground movement at Tarooma.

P.C. Stevenson

The Public Works Department requested an investigation of ground movement affecting the surface of the Channel Highway between Meath and Belhaven Avenues, Tarooma [EN285451], because of the possibility of the severance of mains, cables and the road itself.

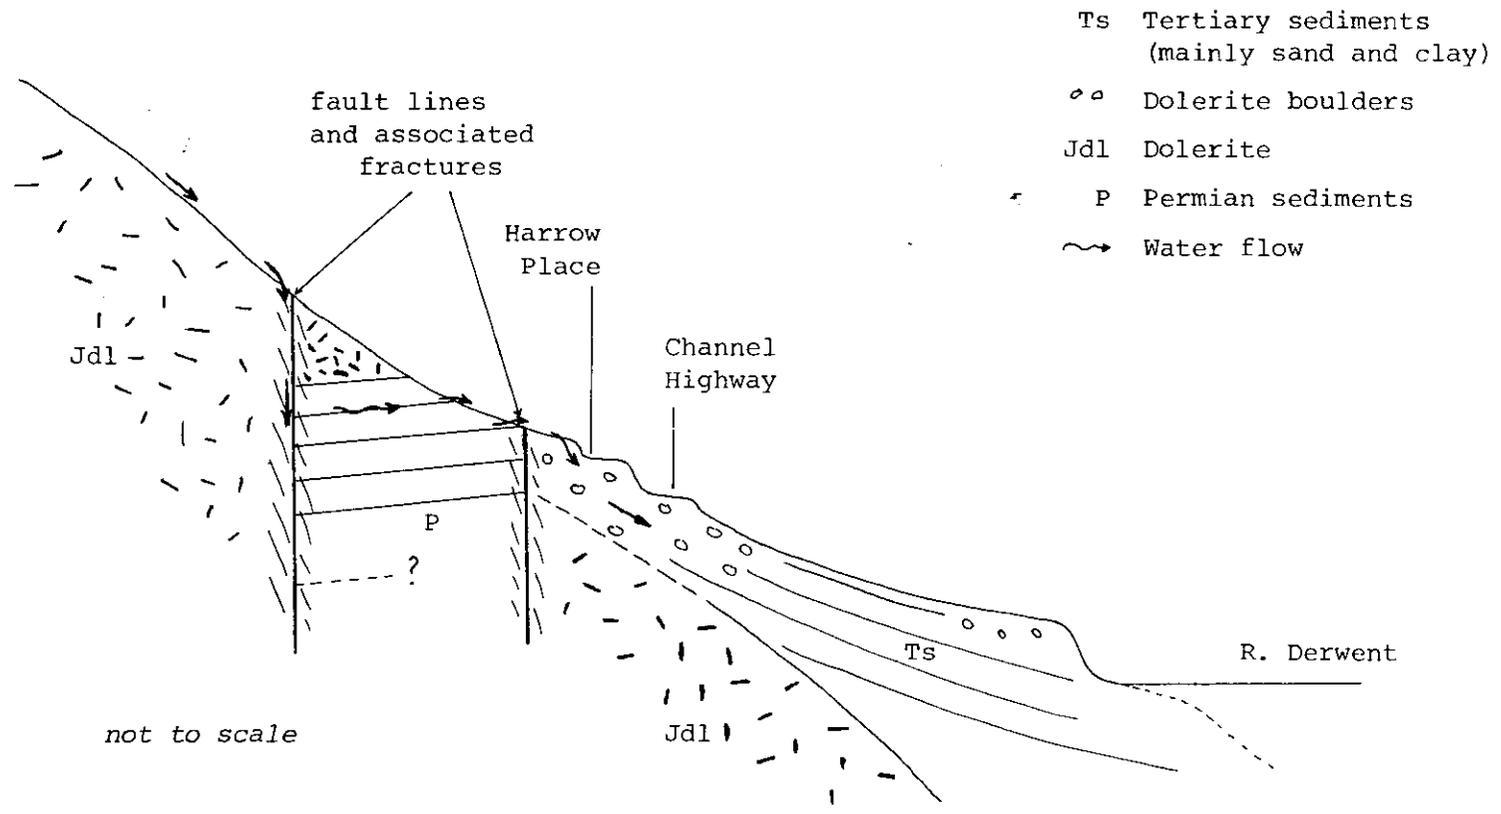
The whole complex is mantled by clayey and stony soils, while the development of housing and the uncleared bush further obscure detail. The nature of the geology is shown in Figure 1.

Figure 1. Diagrammatic section in the Harrow Place-Belhaven Avenue area, Tarooma.
