UR1975.70

Inspection of Block 2, W. Meddings-Blaskett's proposed subdivision, Legana, West Tamar.

W.L. Matthews

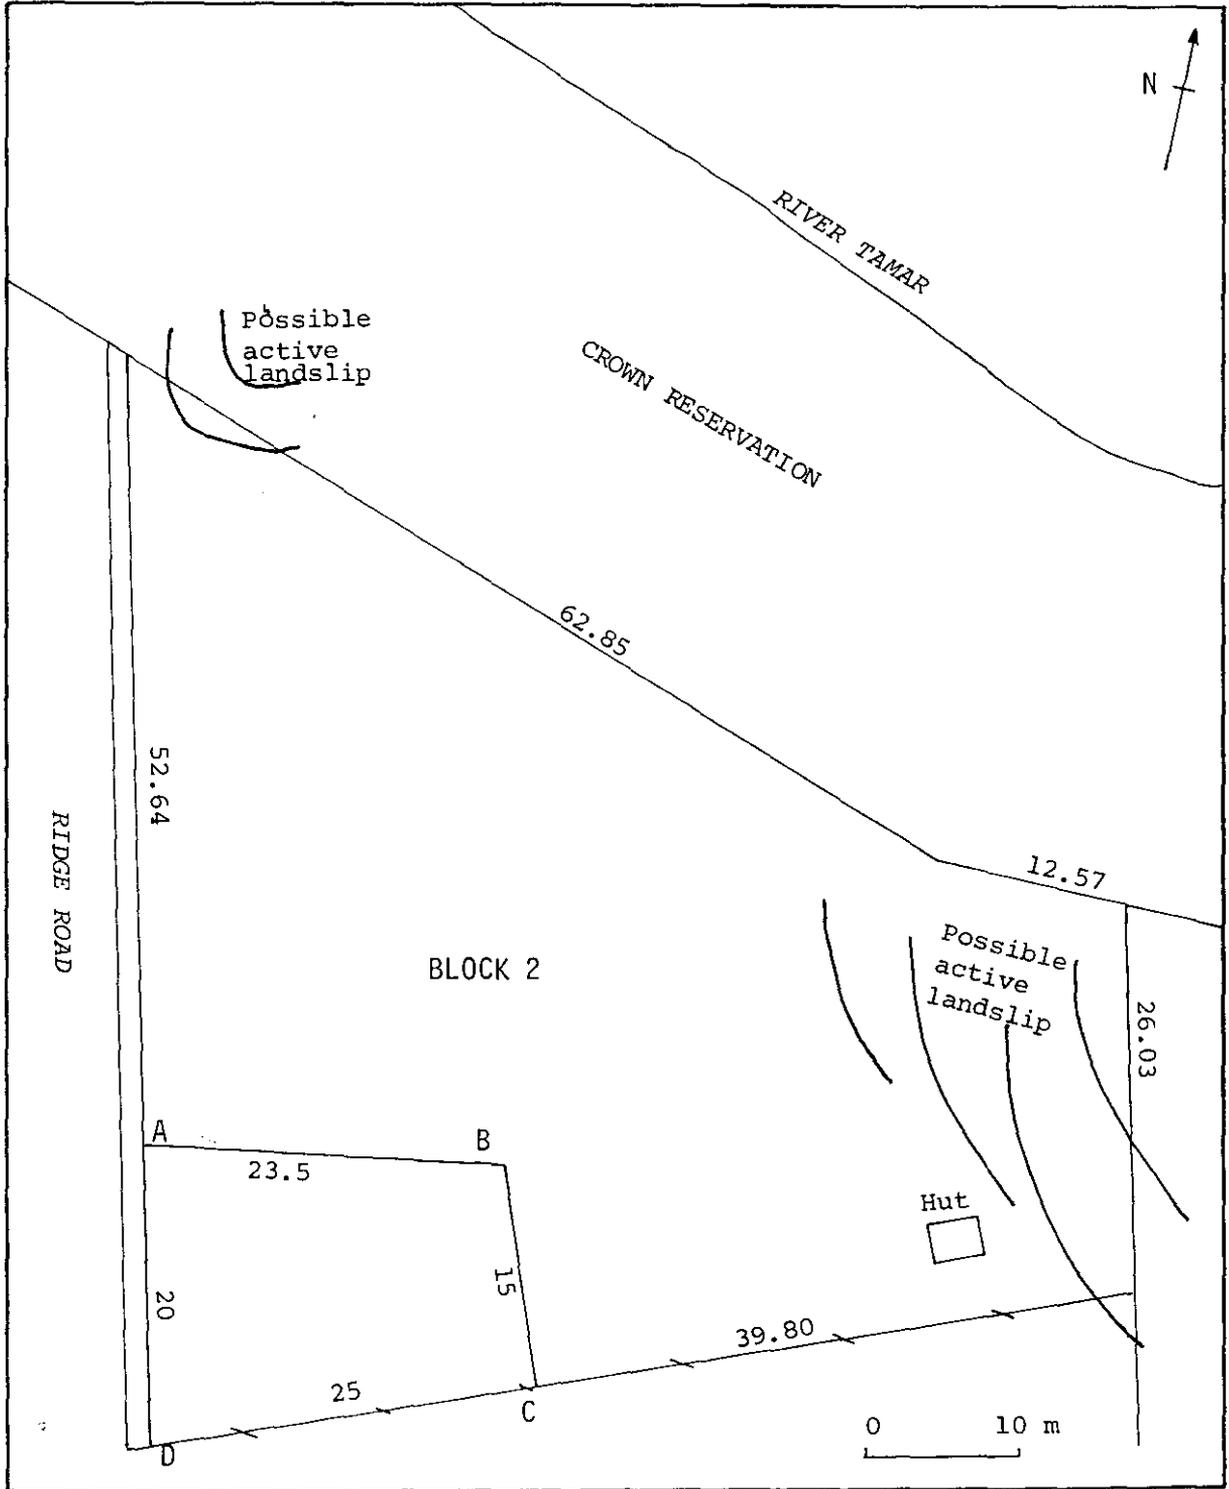
Figure 1

Examination of the foreshore indicates that the land is underlain by interbedded Tertiary plastic clay, sandy clay and compacted sand with some zones where seams of iron oxide are abundant. The landsurface below the block and including the northern part of it, slopes towards the River Tamar at an angle of about 20°. The remainder of the block slopes at an angle of 2-3° in the same direction. This flatter land is 25-30 m above river level. The width of flattish land on the block ranges from about 37 m on the west side of the block to about 25 m near the middle to almost nothing on the east side.

Landslips are known to have occurred in the area from previous examinations. Signs of movement can be seen all along the shoreline to the north, east and west of the block. Movement has taken place near Legana jetty (west of the block) during the last few years, and during the winter of 1975 a new movement has taken place on the east side of this i.e. a little closer to the block and about 120 m from it. Signs of old movements can be seen below the block and extend onto the northern part of it. It is unlikely that there have been active movements for at least 2-3 years. Near the eastern edge of the block and extending onto it (near the hut), a large old rotational slip has taken place, the heel of which extends for about 75 m. The age of this movement is unknown but the slip can be seen on 1947 aerial photographs but it could have still been active after this date. It has areas of internal drainage along the heel zone which hold ponds of water. To the east of and coalescing with this large old slip are slips that have occurred in the winter of 1975, the heels of which extend a little into the flatter ground. These slips have occurred on steeper ground than that below the block. These recently active slips extend to and coalesce with a large slump that is said by local residents to be underlain by a coal mine adit. From examination of aerial photographs, the slip took place between 1956 and 1968.

In view of the abundance of slips in the area, both old and recently active, it is apparent that considerable care should be exercised if the block is to be developed. The occurrence of slips during the winter of 1975 has further strengthened this view. Observations in other parts of the River Tamar area have indicated that the movement of the heels of slips backwards into the flatter lying land is taking place at a faster rate than was expected. As the river currents and tides remove material from the toe zones of slips, this backward movement can be expected to continue.

If the block is developed, then any development should take place within the quadrilateral A B C D (fig. 1). Any house or building should be single storey and preferably of light weight construction.

The trees along the north side of the block and along the foreshore should be left standing as an aid to stability. Sullage from the house should not be allowed to permeate down the bank in front of the block and water from the roof should not be allowed to concentrate in any one area and flow down the steep slope.

Drainage from the road spilling over the steep bank would have an effect on the stability and if this were piped to the river, the risk of further instability would be reduced.
