UR1975-73

Seismic survey at a golf course at Penguin.

W.L. Matthews

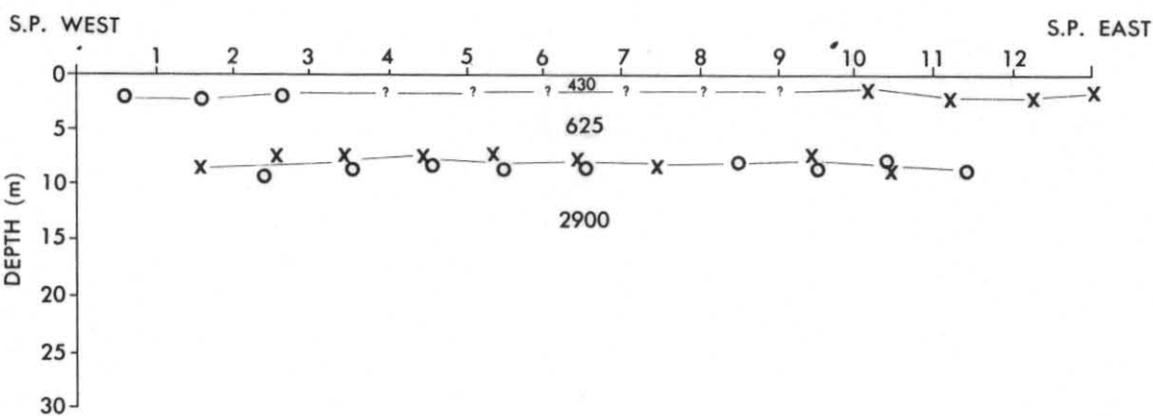
SPREAD 1

Spread 1 was fired beside a bore which the driller (private contractor) logged as follows:

Depth (m)	Description
0- 0.6	Topsoil
0.6- 5.2	Clay
5.2- 5.3	Gravel
5.3- 8.8	Slate
8.8- 9.1	Clay
9.1-11.3	Slate
11.3-13.1	Clay
13.1-17.4	Slate
17.4-38.1	Slate with occasional basalt and feldspar

Burns (1963) mapped Motton Spilite and Barrington Chert in the vicinity of the bore, with alluvium around the stream. Mudstone horizons are included in the chert formation and much of the log suggests that this may be the formation penetrated, with the exception of the last section which penetrated "feldspar and basalt". As the chert unit is older than the spilite, it would be unlikely that the spilite would be encountered beneath the chert. All the bedrock encountered in the bore probably belongs either to the chert unit or to the spilite, the former being the more likely. The spilite does not tend to weather very deeply in most areas and would be expected to give higher

seismic velocities than were obtained.

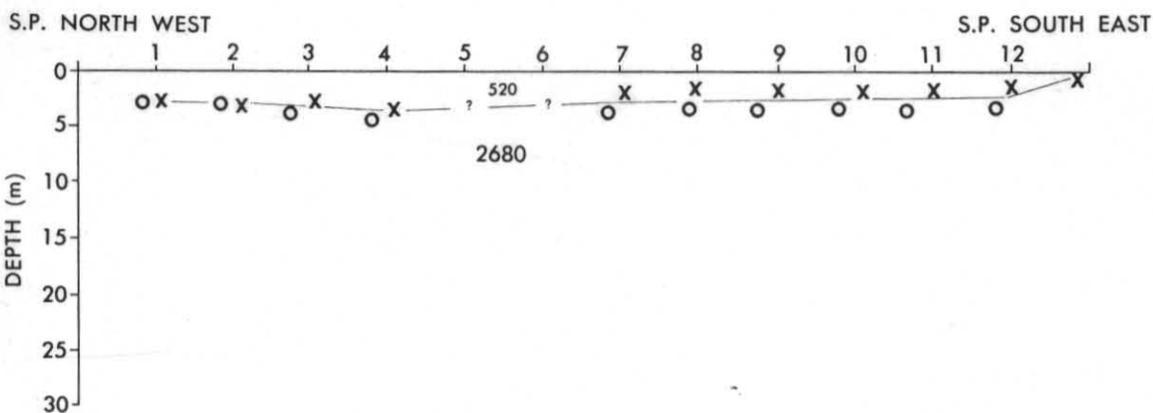
SPREAD 2

The chert unit probably underlies Spread 2, as chert crops out on the ridges opposite both ends of the Spread. If chert underlies Spread 1, the rock underlying Spread 2 is probably more fractured, giving a lower seismic velocity. This would indicate that the prospects of groundwater are better than near Spread 1. An alternative explanation for the lower velocity on Spread 2 is that mudstone is the underlying rock. Similarly if chert underlies Spread 3 at depth then it would be less fractured (having a higher seismic velocity) than Spreads 1 and 2 and would have less potential as an aquifer.

Bedrock is overlain by unconsolidated material below Spreads 1, 2 and 3 and it is unlikely that much of the water supplying the bore comes from this material. There could be a thin water bearing horizon on top of the bedrock under Spread 2 and it is possible that the material ($V_1 = 1570$ m/s) underlying Spread 3 is saturated sand or gravel.

The most suitable site for drilling the first bore appears to be near or south of Spread 2.

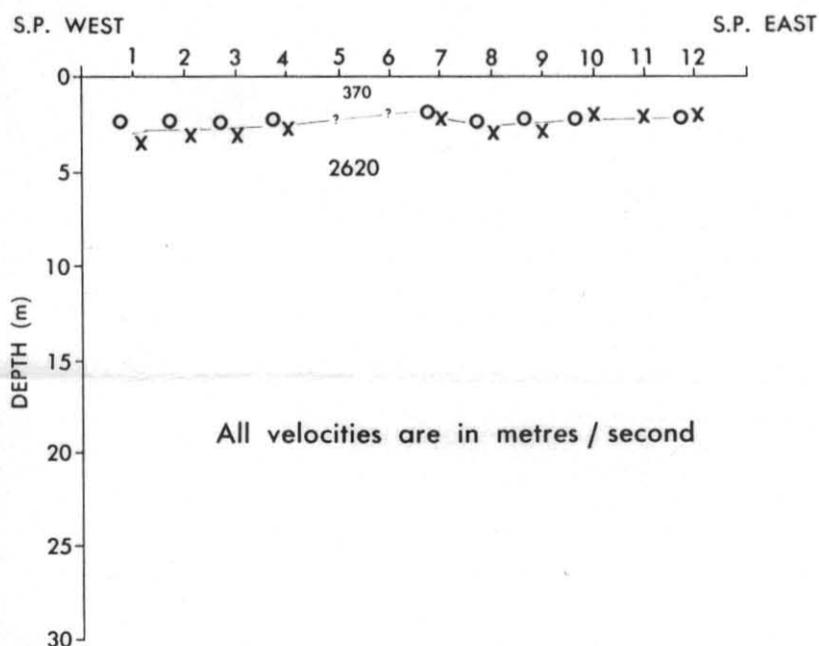
SPREAD 4

One spread was fired diagonally across the centre line of dam site 1 and indicated a depth to bedrock of 1-2.5 m. If work at the dam site is to continue, it would be necessary for this to be confirmed by digging a trench across the creek bed, and also to determine the nature of the bedrock material. The geology of the surrounding area suggests that mudstone should underlie the dam site, but if fractured chert occurs there, large scale seepage could be expected.

Bedrock lies at shallow depth under the creek bed at dam site 1. If work is to continue at this site a trench should be dug across the creek. This would confirm the depth to the bedrock and would also allow the nature of the bedrock to be determined. Test pits should be dug up the eastern embankment to determine the thickness of the gravel and the nature of the bedrock. Alternately the centre line of the dam could be sited a few metres upstream where there is clayey soil.
