UR1975-76

Notes on auger holes at a proposed subdivision at Freshwater Point

W.L. Matthews

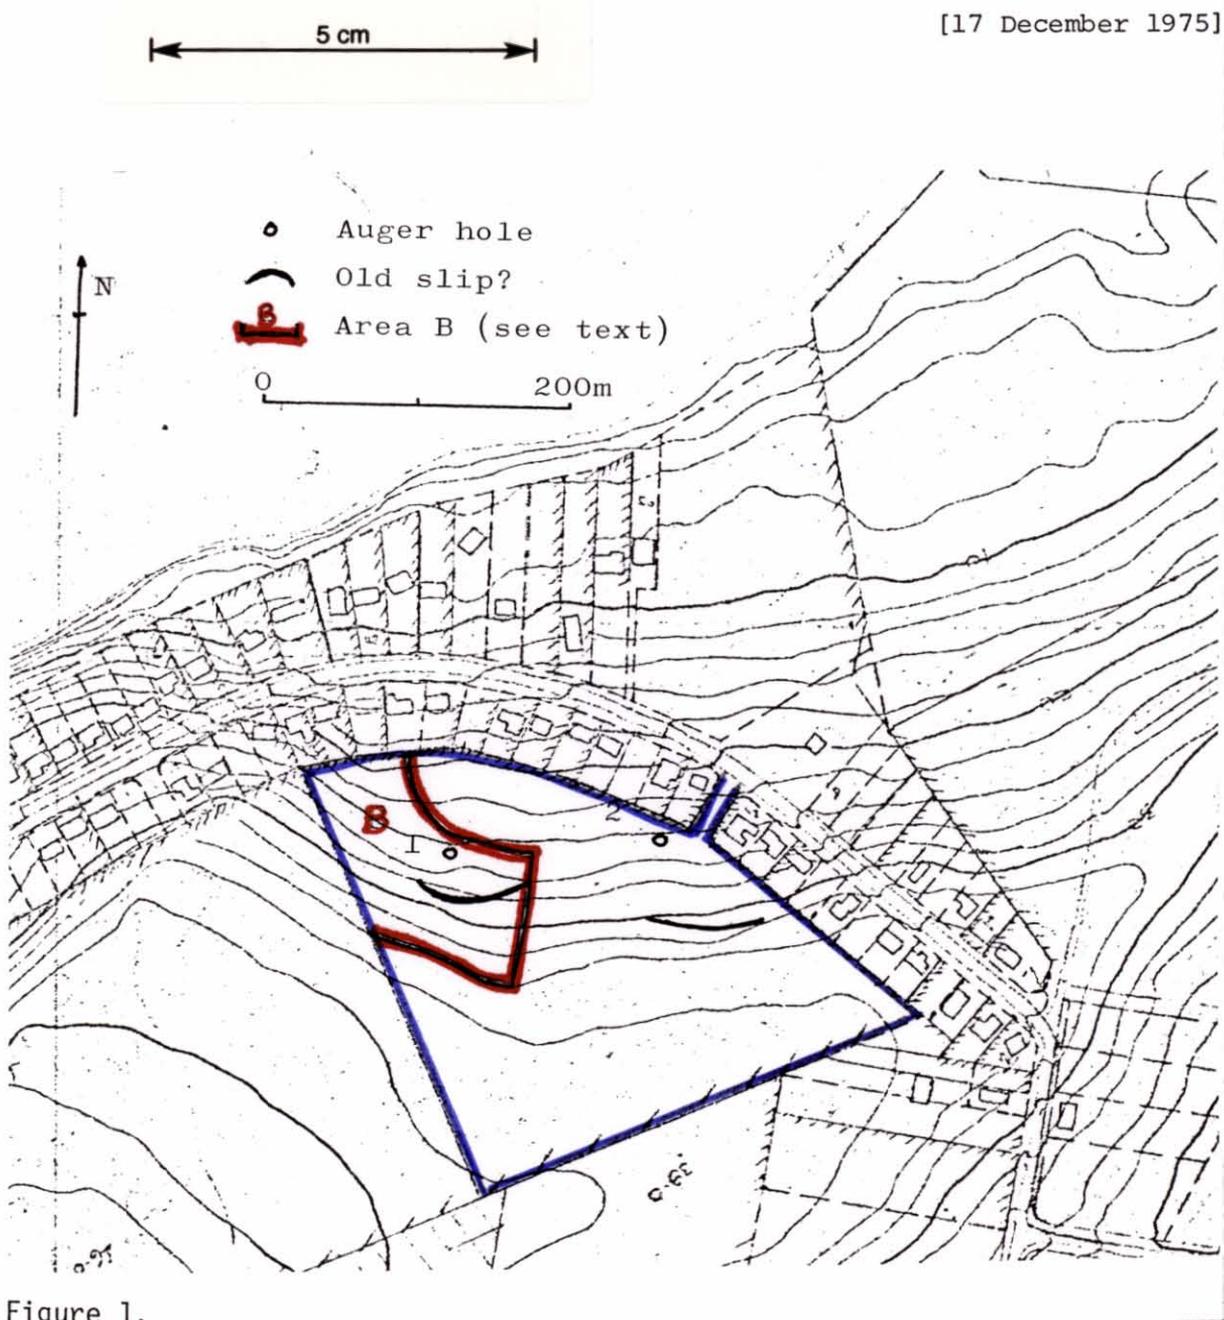
The steeper land in the northern part of the subdivision would probably be recommended for proclamation as Landslip Area B. However it might be possible to exclude the eastern part of this land if it were to be developed strictly in accordance with the recommendations of a consulting engineers report. The area then remaining as Landslip Area B is shown in Figure 1.
