TASMANIA DEPARTMENT OF MINES
UNPUBLISHED REPORT 1975/86

A landslip affecting a pipeline near Bradys Lookout, West Tamar

by C. J. Knights

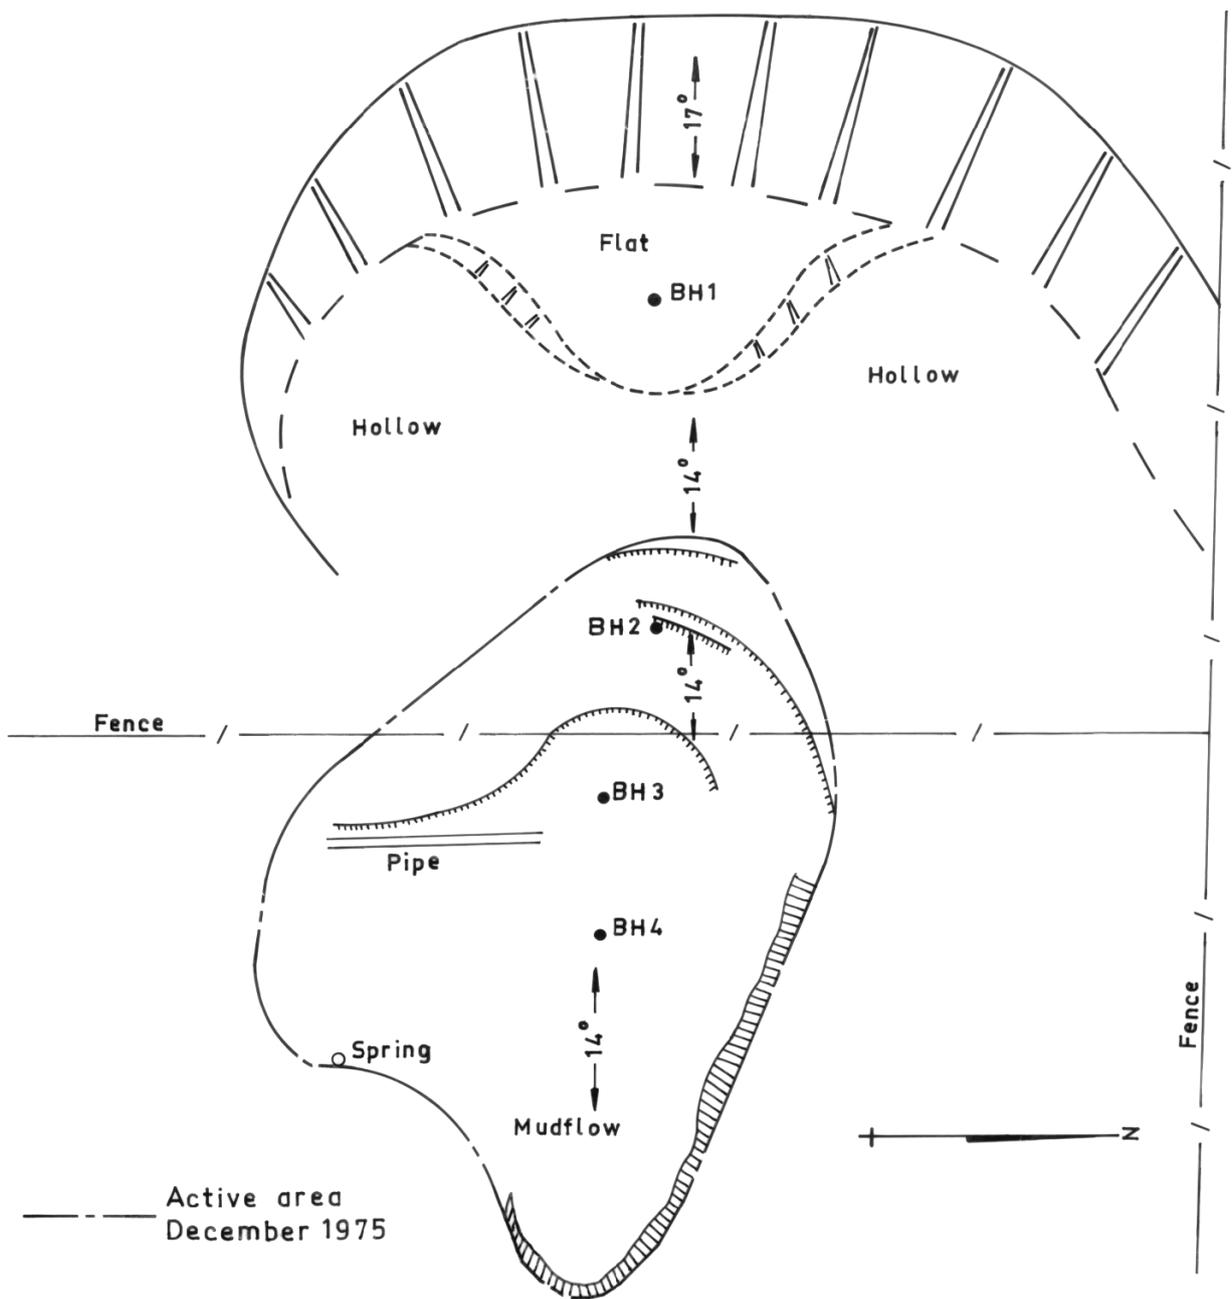
Figure 1

The active slip under concern is on a slope of 14°. It appears to be shallow seated and has a slow mudflow at the toe. This small active area is situated on an older, larger landslip structure which could be only marginally stable (fig. 1).

The positions of the holes are marked on Figure 1. The logs are as follows.

From the bore hole logs, the active slip is shallow, between 1.8 and 2.7 m deep near the pipe. Although the clays were often near saturation, there was no freely running water in any of the holes. It appears that this activity occurs when the clays approach saturation and hence zero cohesion. This type of slip reacts to a few days of heavy rain and will stop moving after a short period of dry weather.

Hole 1 was drilled through the heel of the old structure to a depth of 7.3 metres. Layers of stiff plastic clays with fissures were intersected, but there was no sign of water. This old slip appears to be stable.

Landslip affecting pipeline east of Bradys Lookout

1. Open surface drains should be installed to intersect surface runoff; one set to be close to the top of the bank of the old structure, another set to be installed around the active slip area. Water from both sets of drains may be taken by pipe to the natural watercourse below the slip.
2. In this type of shallow slip vegetation is an important stabiliser, both because of transpiration from depth in the soil and binding together by roots. Fast growing trees or bushes are suggested, preferably those with vegetative reproduction. It is suggested that vegetation is extended to include the heel area of the old structure.
3. If the previous measures are carried out, this will improve the stability of both the old and new slips. It should then be safe to tie back the pipe onto the old slip, well back from present activity.
