UR1976_03

1976/3. Test pits on T.E. Atkinson's property, Don.

W.L. Matthews

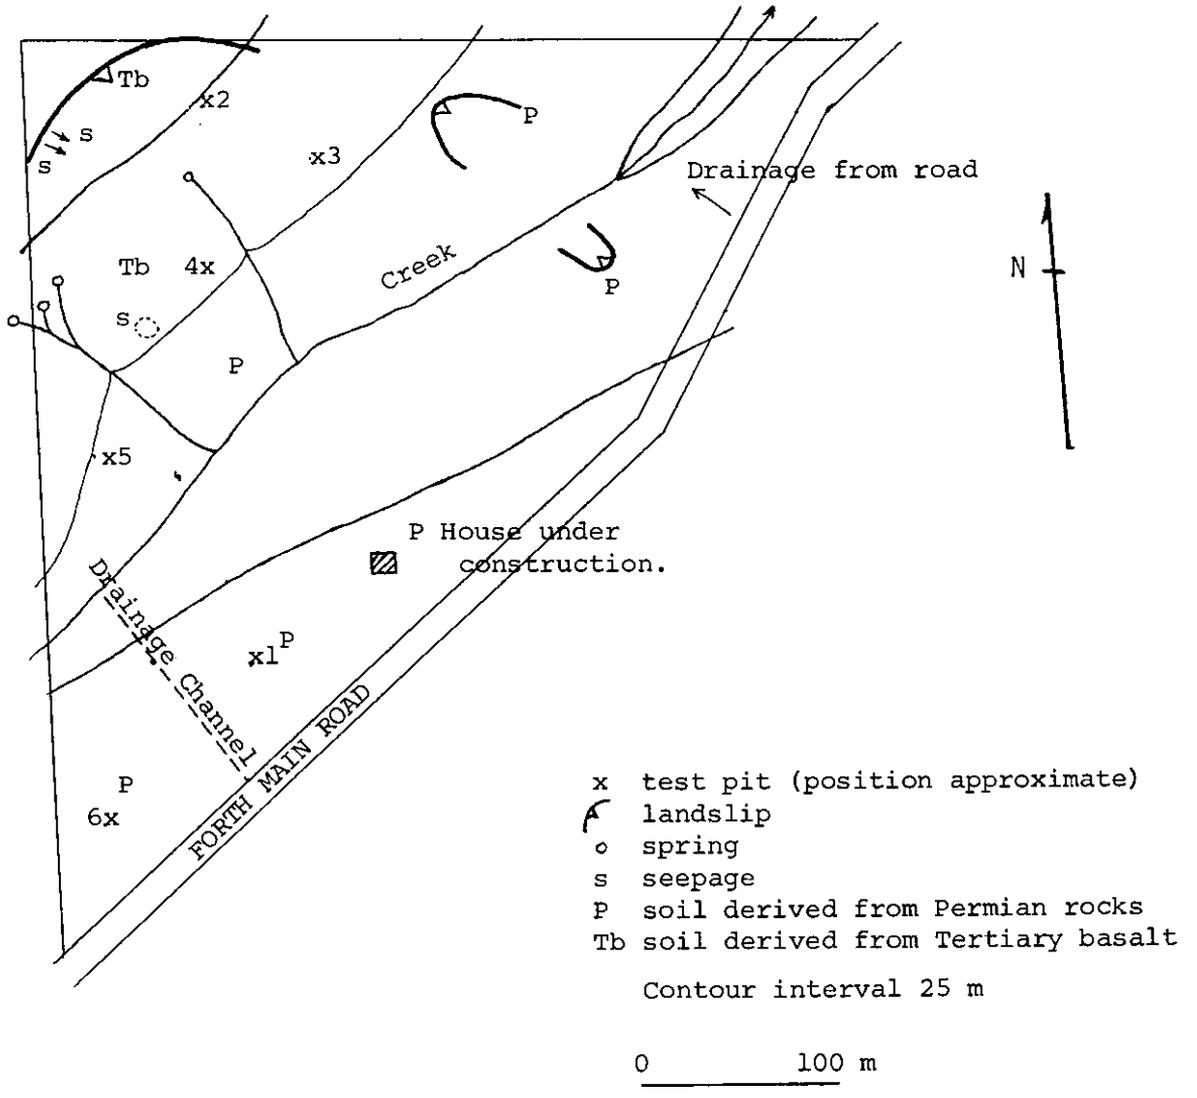
Figure 1. Sketch map of T.E. Atkinson's property, Don.

Test pits 1, 3, 4 and 5 encountered Permian rocks (probable Permian in test pit 5), whilst test pit 2 struck weathered basalt or basalt derived debris from a nearby old slip. Test pit 6 penetrated material which may be weathered basalt although it is surrounded by grey soil similar to that derived from Permian rocks. It is possible that Tertiary sediments occur beneath the Tertiary basalt and overlying Permian rocks, this being supported by the occurrence of two greybilly-like boulders near test pit 6.

Houses could be built with reasonable safety on each block providing some precautions are taken. Houses should be sited in the positions of the test pits in most cases, with the exception of test pit 2 which is an unsuitable site due to its proximity to an old landslip. A site should also be selected a little downslope from test pit 6 (but not near the water course which traverses it from the road).

Only one house should be built on each of the proposed blocks; any more intensive development requires more detailed investigations. In developing the blocks, excavations around the slopes for access roads and house sites should be kept to a minimum and where they are necessary, should be supported soon after digging. Surface drainage on the slopes should not be inhibited by development and areas where such drainage builds up, should be drained to prevent water build up in the soil. Seepages, particularly near any of the proposed house sites should be drained. Sullage and water from septic tanks should not be dispersed near the house sites.
