UR1976-06

1976/6. Inspection of a landslip on D.J. Squibbs' property, Spreyton.

W.L. Matthews

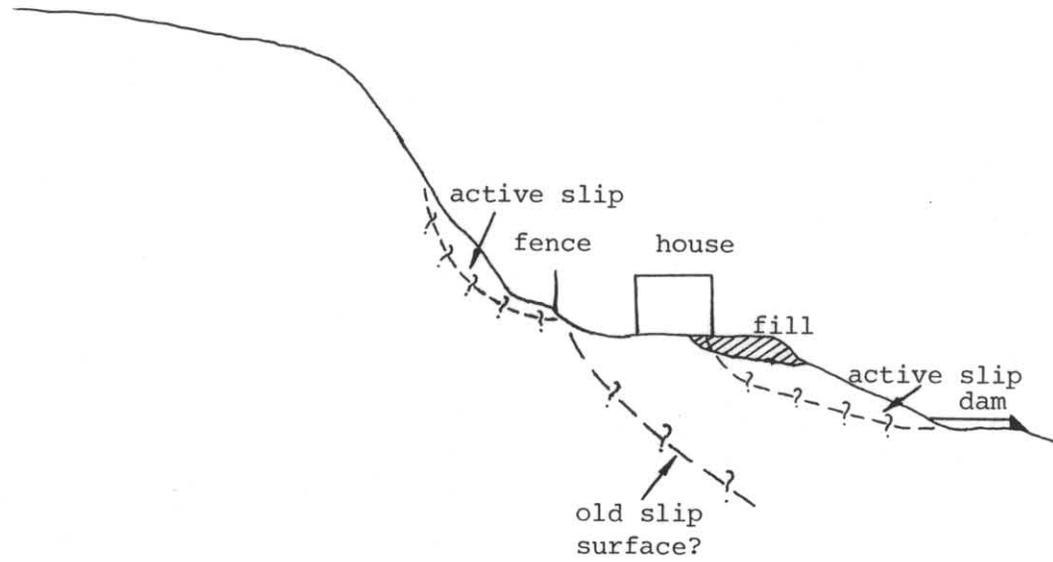
Most of the slips are old and show no signs of recent movement, but two slips have taken place since the house was built and are affecting the property (fig. 2). One slip has occurred on the steep slope directly behind the house and the other is on the shallower slope in front of the house. It is probable that the flat on which the house is built is an old rotational slip, but there does not appear to be any renewed movement on this slip. The slip to the rear of the house has not affected the building but has bowed the fence just behind it. The heel of the slip in front of the house passes under the building and has caused quite serious cracking to the brickwork in the north-eastern corner. Each of these slips has the appearance of being relatively shallow, the one in front of the house probably being the deeper.

Figure 2. Sketch section of slip area.

More extensive (and expensive) treatment could be undertaken for the lower slip. Any further backward movement of this slip would seriously affect the house. The slip is probably not too large to consider piling, the cutting of deep french drains through the slip or the placement of a permeable toe loading material against the lower part of the slip. Subsurface investigations with either an auger drill or back-hoe would aid in determining whether any of these possibilities were feasible. Any measures planned for the slip should be undertaken before the winter.
