1976/16. Ground movements at Casuarina Crescent, Glenorchy.

P.C. Stevenson

The Department of Mines was requested by the Glenorchy Council to report on apparent earth movements at Casuarina Crescent [EN209608].

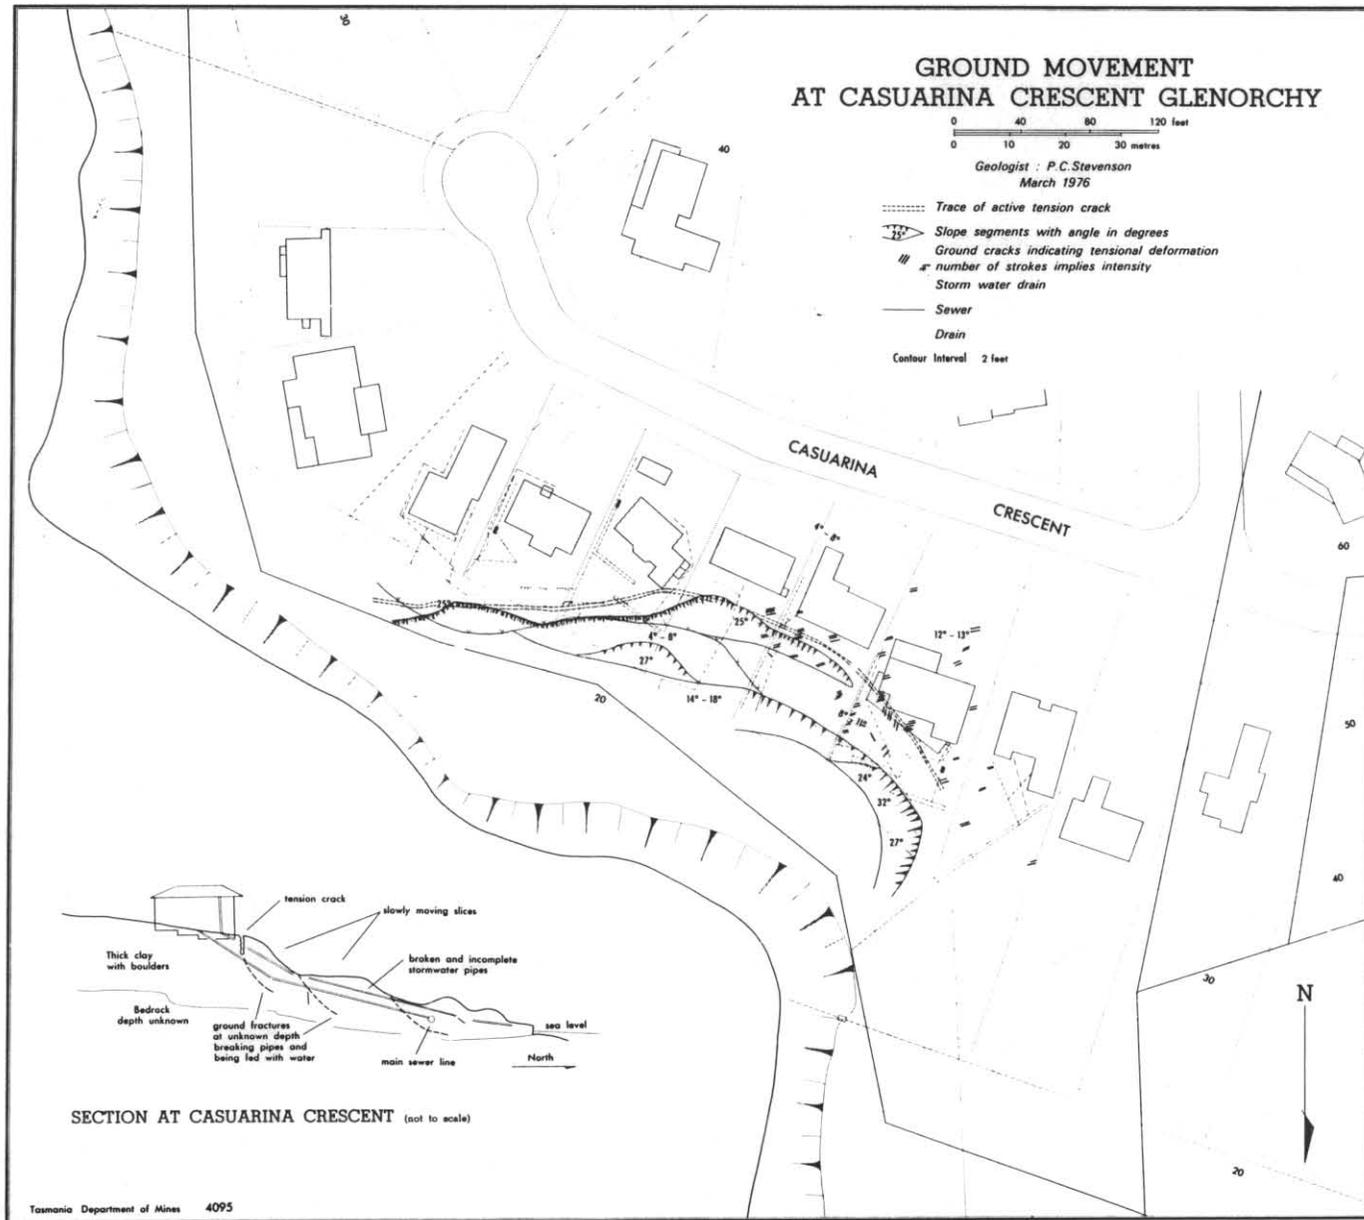
The ground surface has been disturbed by mass movement or landslip over nine house blocks. A general account of the ground surface features is given in Figure 1.

The most prominent feature when assessing the present and possible future damage to the houses is the large tension crack, evidence for which can be seen on blocks of Nos 14, 16, 18, 20, 22, 24 and 26. The crack was seen open at No. 14 and can be inferred from the movement of paving slabs,

Where seen at Nos 20, 22 and 24 the crack crosses the upper flat surface and so has not caused a steep bank to form but at Nos 14, 16 and 18 the crack has been accompanied by slumping on the lower side with the production of a steep bank.

The ground movement can be pictured (see inset, fig. 1) as a series of slices, curved in profile and in plan slowly sliding successively down on curved fracture surfaces. That this process has been continuing for some years is plain and it is to be feared that it will continue if nothing is done. The process seems to have been active before 1946 for the slopes appear quite disturbed in the photographs, but such a process is intermittent and may be active only at intervals of 20 or 30 years or longer.
