1976/17. Damage to a house at Dilston, East Tamar.

C.J. Knights

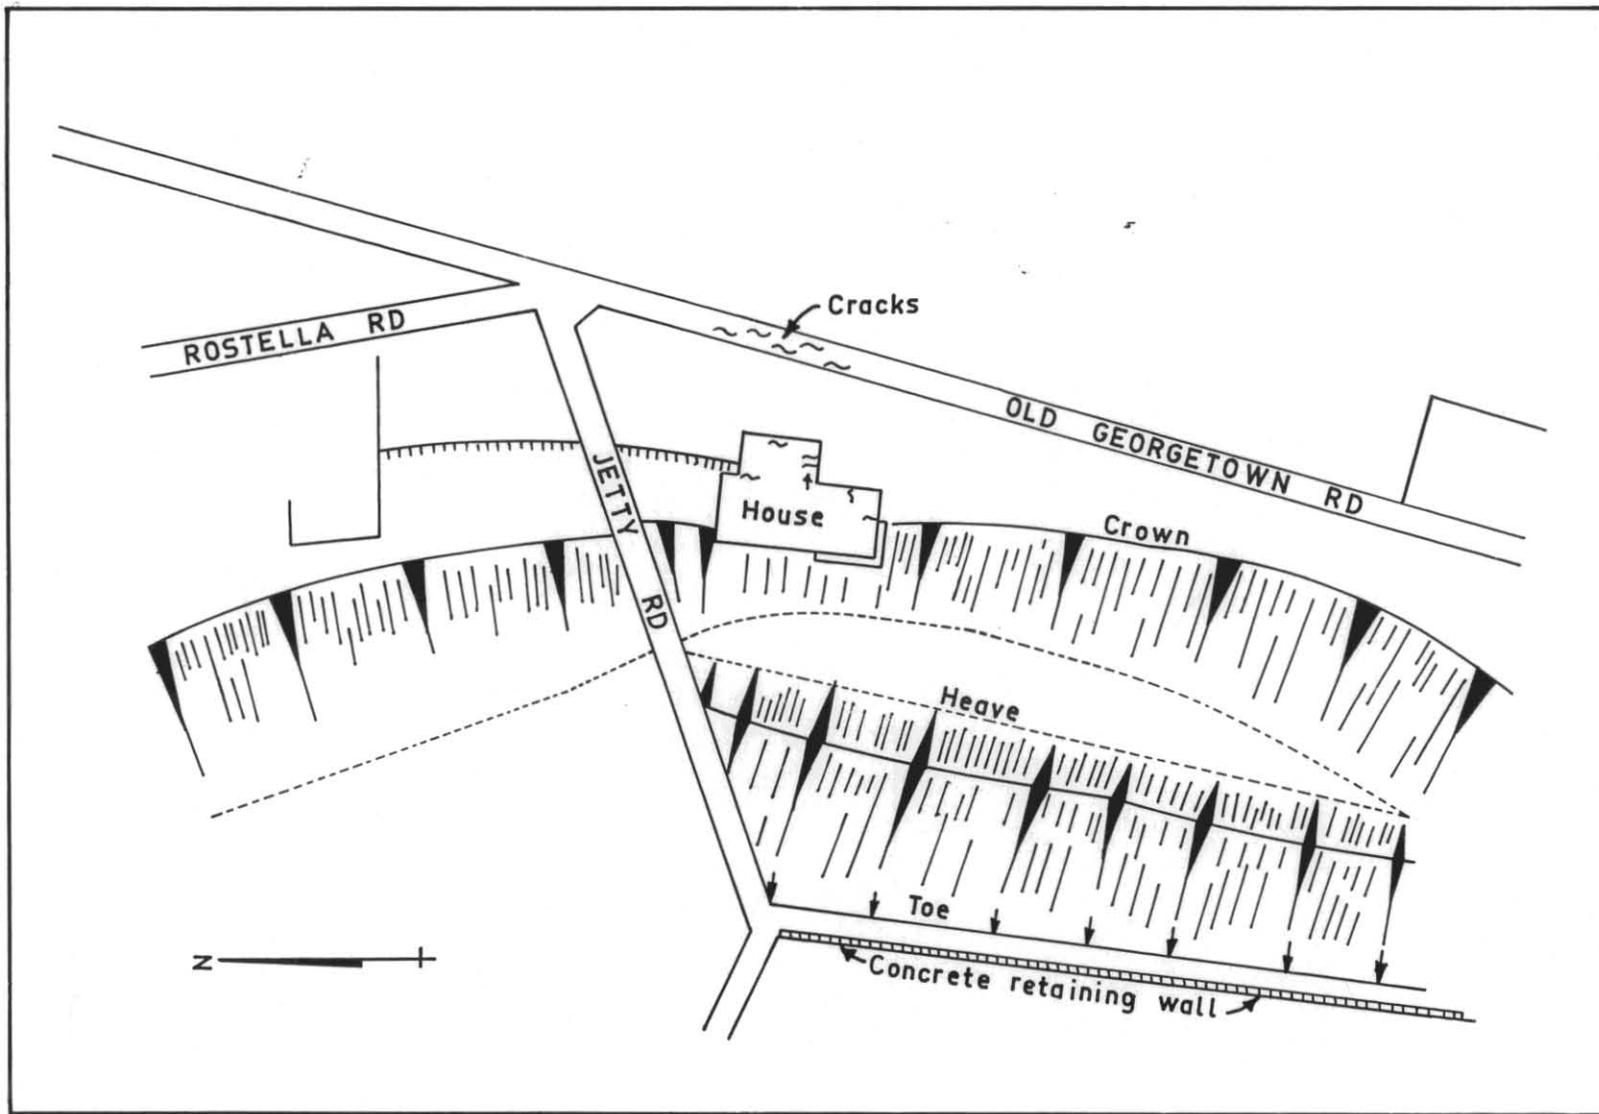
Figure 1. Location of house and landslip.
