1976/21. Investigation of proposed Forestry Commission roads near St Marys

D.J. Sloane

W.C. Cromer

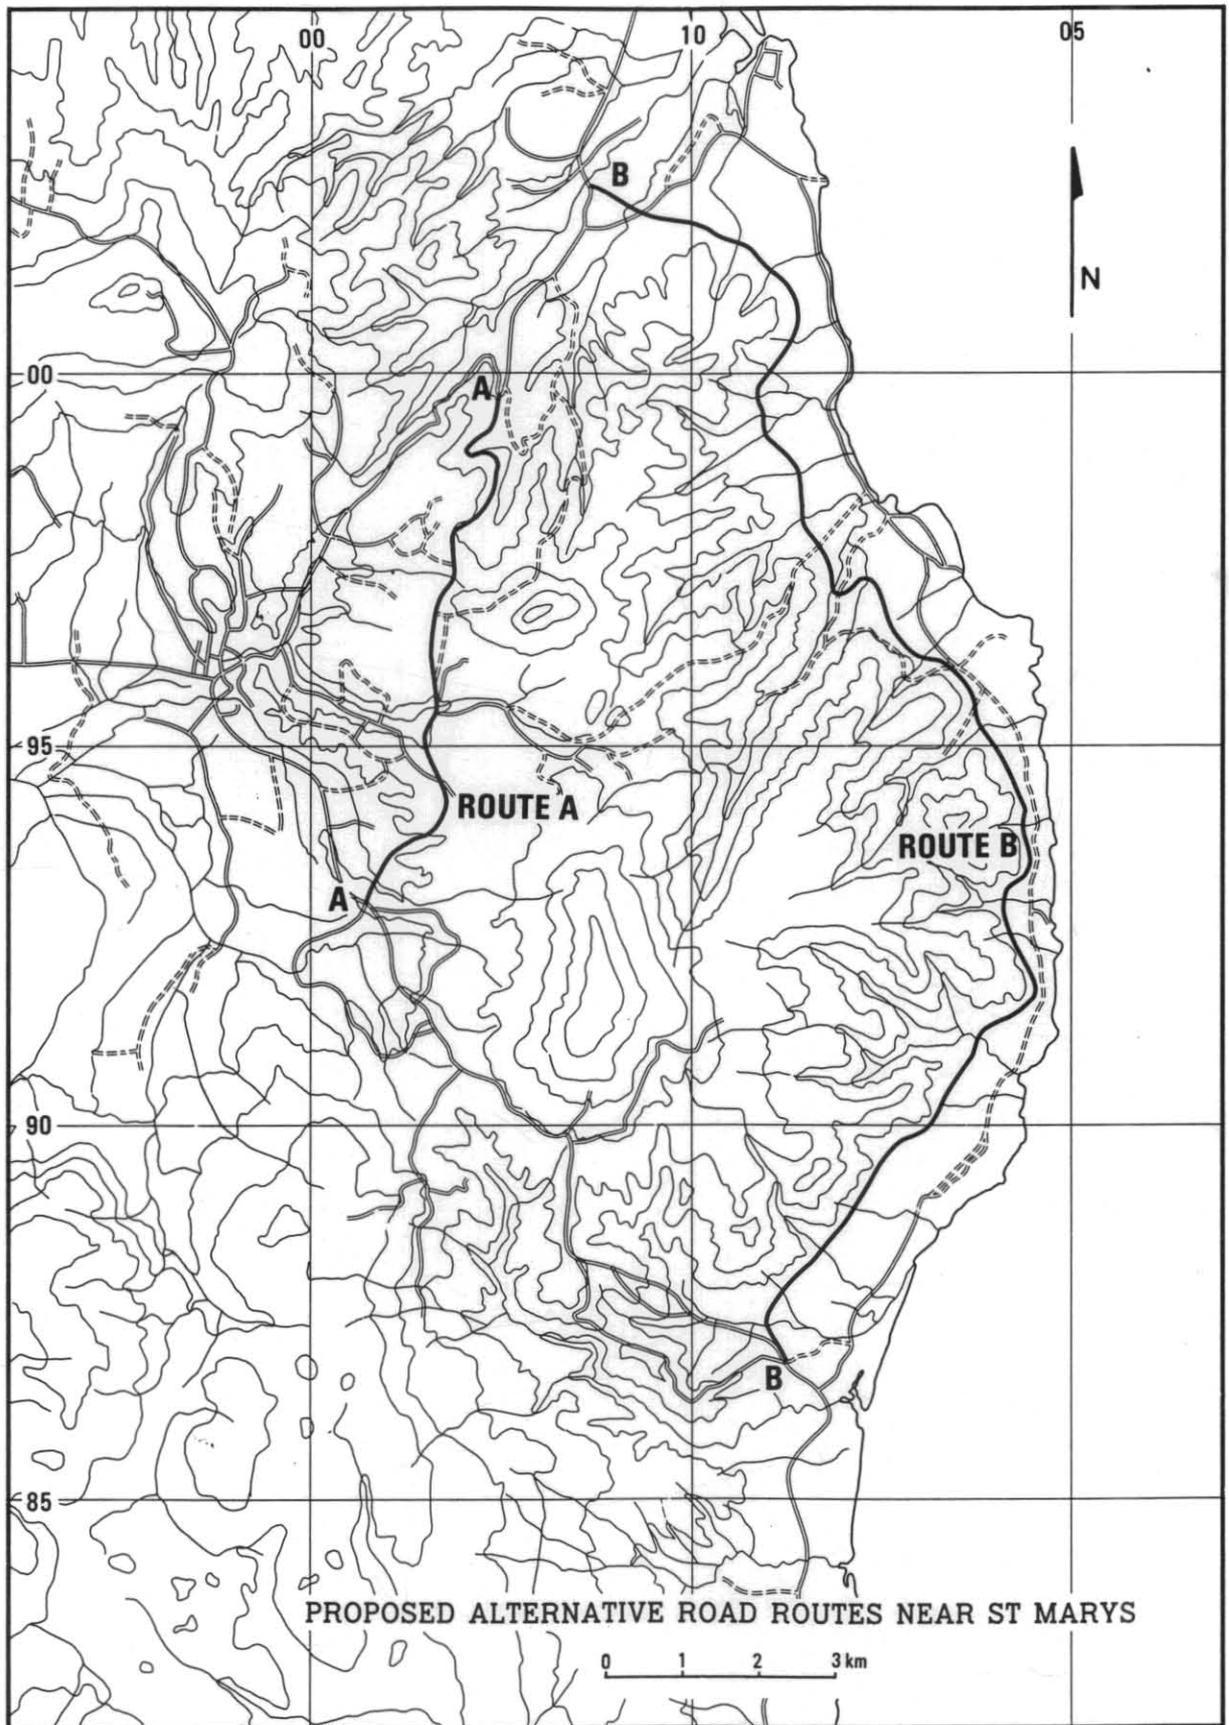
Figure 1.

At the request of the Forestry Commission, the Department of Mines has investigated two proposed alternative road routes near St Marys (fig. 1). A brief inspection was made of each route to determine whether geological and geomorphological factors would adversely affect road construction.

No problems are envisaged on the southern 4 km of this route through Irish Town to the Tasman Highway at Elephant Pass (fig. 1). The 3 km long northern section through Whites Gully to the gravel pits at St Marys Pass (fig. 2) was examined in detail as problems were expected in this area. The slopes in this area are very steep, with slope angles generally between 30° and 35° and locally up to 40°. This section of the route lies entirely in adamellite granite of Devonian age and passes along the western side of Whites Gully, apart from one area where it detours westwards around the head of a large tributary valley. The route crosses about 9 small ephemeral streams and one major creek. It should be stressed that whilst the small streams are ephemeral, large quantities of water are carried during the periods of high intensity short duration rainfall, to which the surrounding area is prone. The swath of flattened vegetation on either side of one stream is up to 15 m in width and is indicative of the rapidity of flow and volume of water carried during periods of peak stream discharge. Small bridges or large diameter pipes will be required to carry such large volumes of water in these areas. It is largely the underdesign of these features that has caused the failure of the roadway at St Marys Pass. Where the route crosses the large tributary flowing into Whites Gully a 10 m bridge will be required due to the large volume of water, granite boulders and pebbles carried by the stream during peak floods. The nature of the material carried by the stream can be seen by the many tonnes of boulders and pebbles which have been deposited where it is crossed by the existing track from the gravel pits.
