1976/31. Engineering geology and slope stability analyses of the Round Hill quarries, Burnie.

W.R. Moore

The Senior Mining Engineer, Department of Mines, Burnie requested that the Engineering Geology Section 'establish guide lines that were to be the basis of the final design for the working and rehabilitation of the Round Hill area'.

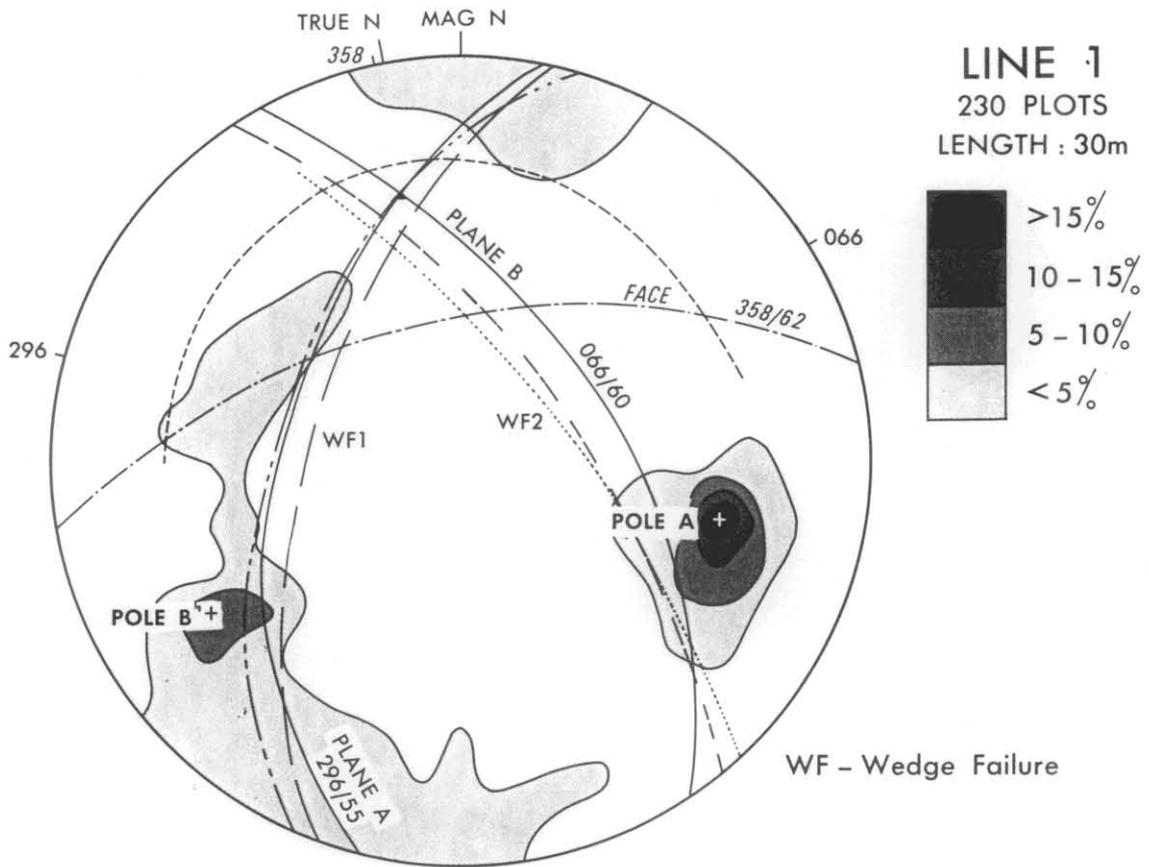
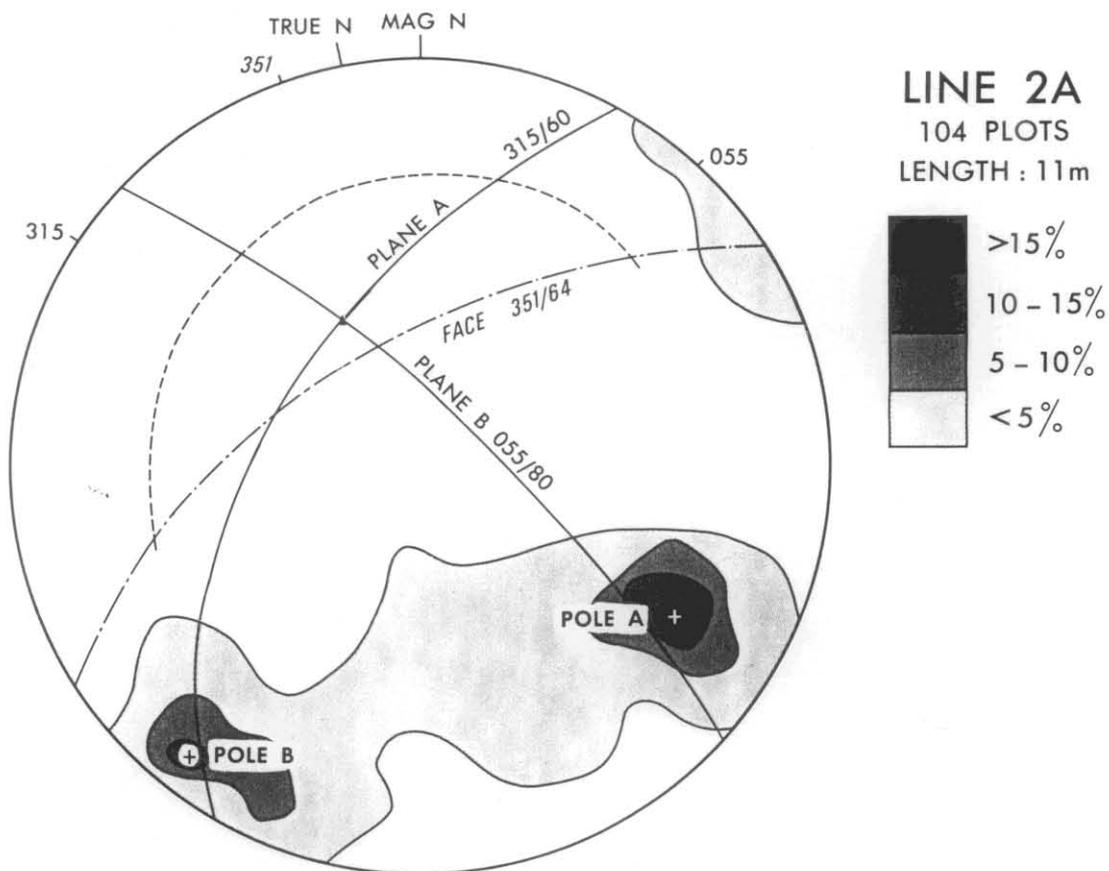
Figure 2. Structural analysis, Lines 1 and 2A

This line (plate 5) was measured along a bench 8 m above the roadway at the eastern end of Round Hill in the Burnie Council lease area. The bedding plane (A) is the dominant discontinuity. Plane B is a well developed sub-continuous joint. The stereo-plot indicates a strong potential for wedge failure with a plane of inclination of the intersection of the two discontinuities surfacing on the slope face of the bench. This bench face has a dip of  $62^\circ$  at  $358^\circ$ . The direction of sliding of these potential wedge failures is  $34^\circ$  at  $361^\circ$ .

Two wedge failures are present on this bench and when plotted fall into the zone of instability between the friction circle for the assumed friction angle and the slope of the bench face. Wedge 1 slid in a direction of  $356^\circ$  with an angle of inclination for the intersection of the two faces of the wedge at  $40^\circ$ . Wedge 2 slid in a direction of  $349^\circ$  and angle of inclination of  $43^\circ$ . To stop these wedge failures the angle of friction would have to be increased to  $40-43^\circ$  or the face angle would have to be lowered to  $30^\circ$ .

The intersection of the two sets of discontinuities falls within the zone of instability between the friction angle circle and the great circle for the quarry face. Wedge fractures can be anticipated which will slide in a NW direction on a bearing of 351° with an average angle of inclination for the intersection of the two sets of discontinuities of 55°, but which can be as low as 35°.

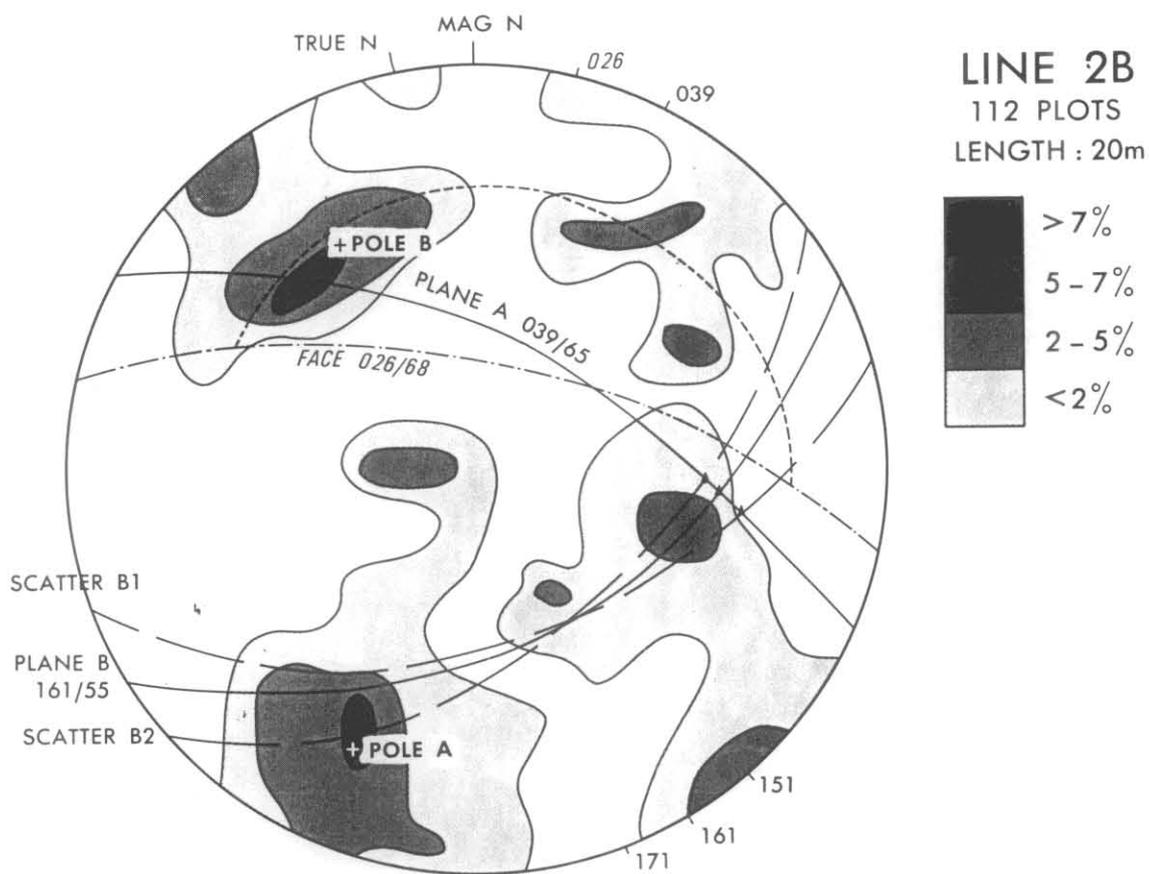
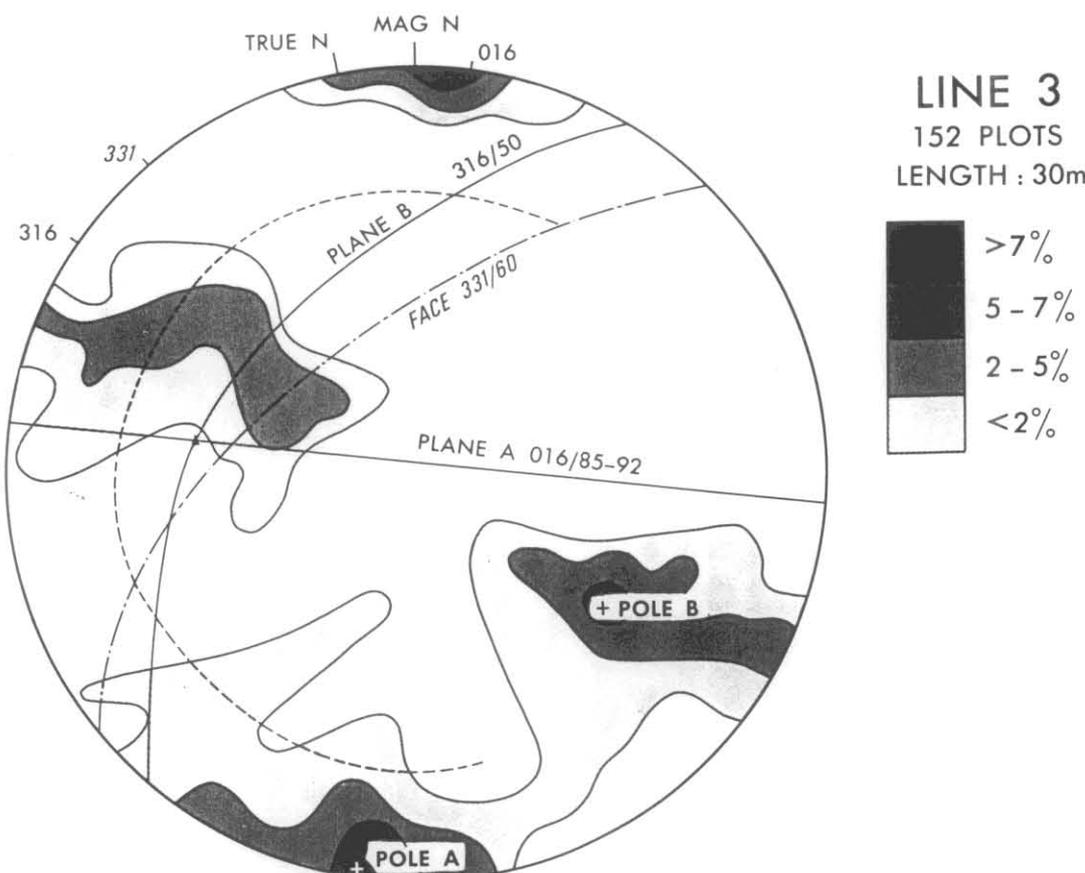
Figure 3. Structural analysis, Lines 2B and 3

Wedge failure is not likely to occur because the angle of inclination of the intersection of the two sets of discontinuities is steeper than the quarry face angle the wedge will not surface on this face, although the scatter of 20° in this plot indicates that this type of slope failure is possible.

Wide wedge failures are possible due to the intersection of the two sets of joints in the zone of instability between the friction angle circle and the great circle for the face. These wedge failures can be anticipated to slide on 289° bearing with steeply inclined plane of intersection of 48°. If the face slope was lowered to 35° the danger of wedge failure would be alleviated (assuming that the present direction of dip was maintained). Planar failure from the Set B joints is considered more likely. Some small scale planar failures do occur.

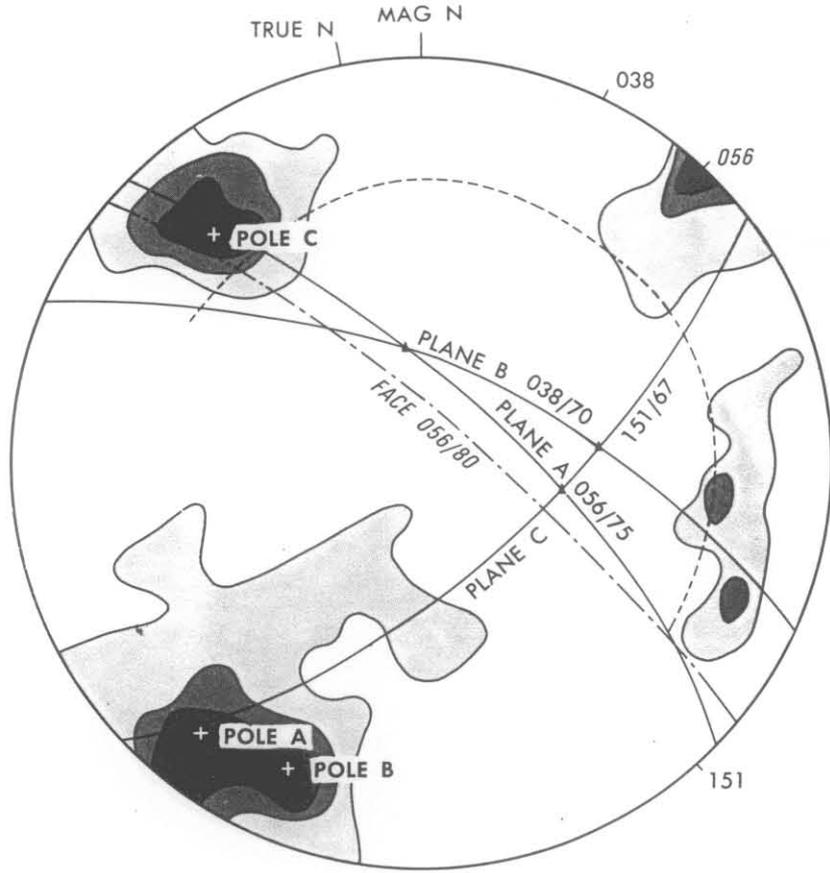
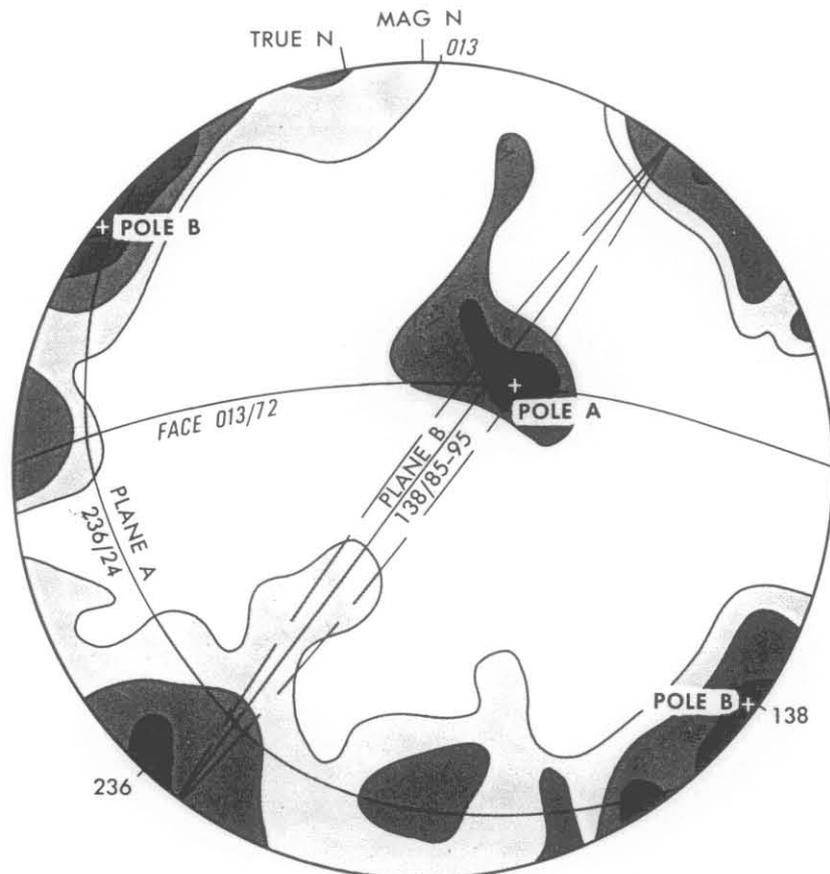
Figure 4. Structural analysis, Lines 4 and 5

Small wedge failures are possible due to the intersection of the two sets of discontinuities A and B, and A and C, but the angle of inclination of these intersecting planes is very steep, 66 and 63°. The intersection of joint Set B and bedding Set C is more likely to give wedge failure but even here the average angle of inclination of the intersection of the two planes is 54° at 095°, but may be as low as 40°. Minor planar failure is likely to develop with weathering and aligning of the joints of Set A and B but this is only because this quarry face is excessively steep (80°). The plot shows that the major discontinuity (the bedding) is at right angles to the face and it is because of this happy coincidence either intuitively designed by the quarry operators or as a result of the explosive shattering of the face, that this steep face has continued to stand and not failed.

The stereo-plot is opposite to that seen on Line 4 and indicates a condition of grave instability. The influence of bedding dipping into the face is well illustrated. If the beds were dipping NW the face would collapse.

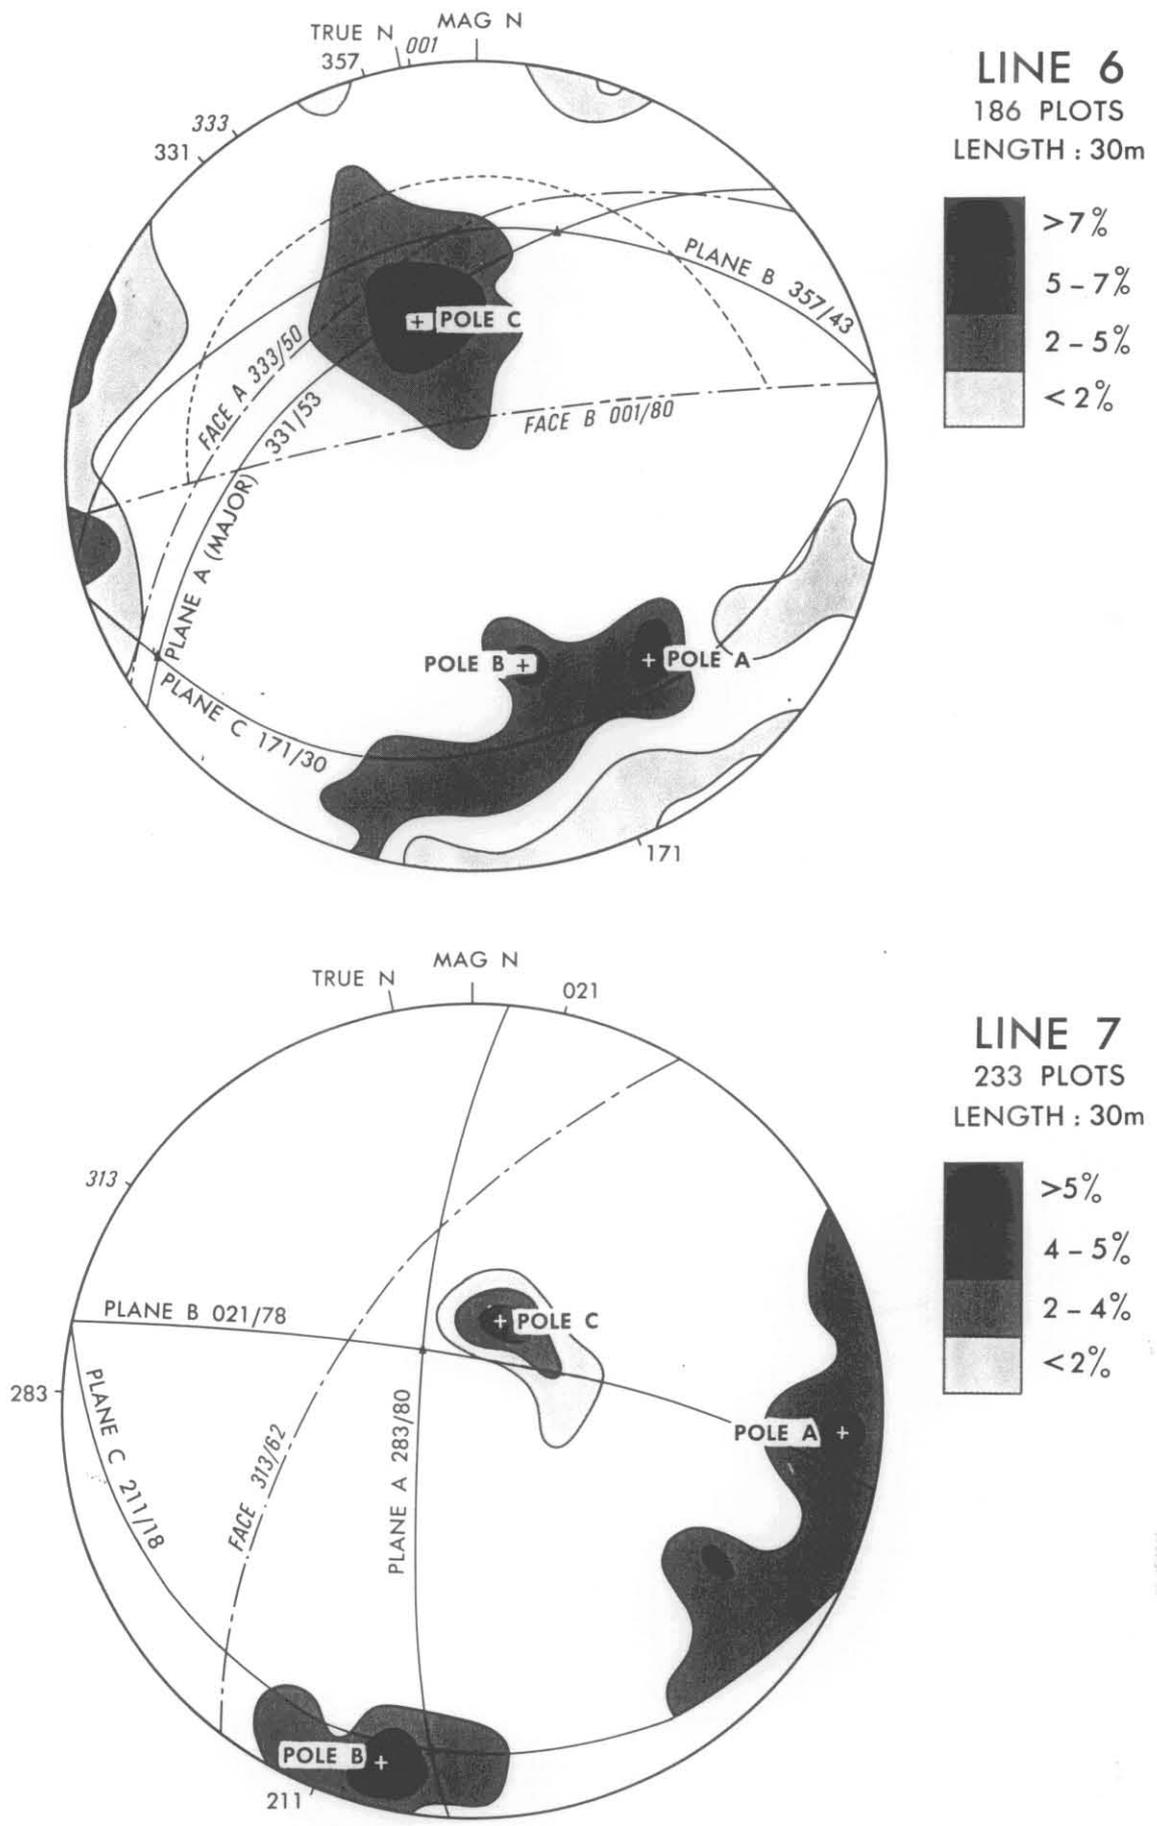
Figure 5. Structural analysis, Lines 6 and 7

Wedge failures are possible because of the three sets of intersecting joints on face B but the angle of inclination of the intersection of the set of discontinuities is too great for them to surface on face A. This plot

Because of the highly cleaved mudstone, fretting failure, where the slope disintegrates into small blocks and rubble, is occurring at outcrop. This fretting will probably be so rapid that wedge failures will not occur and the fretting process will lower the face angle so that slope stability will be achieved.

This line was measured at the east end of Round Hill. Three sets of discontinuities are visible on the plots. Set A and B are discontinuous sets of joints and Set C the bedding. The two joint sets are widely scattered around the periphery of the plot which allows fretting to occur similar to that occurring in the mudstone although the sediments in this section are quartzite. No wedge or planar failures are likely as the joints dip more steeply than the slope of the face and the bedding dips into the face.

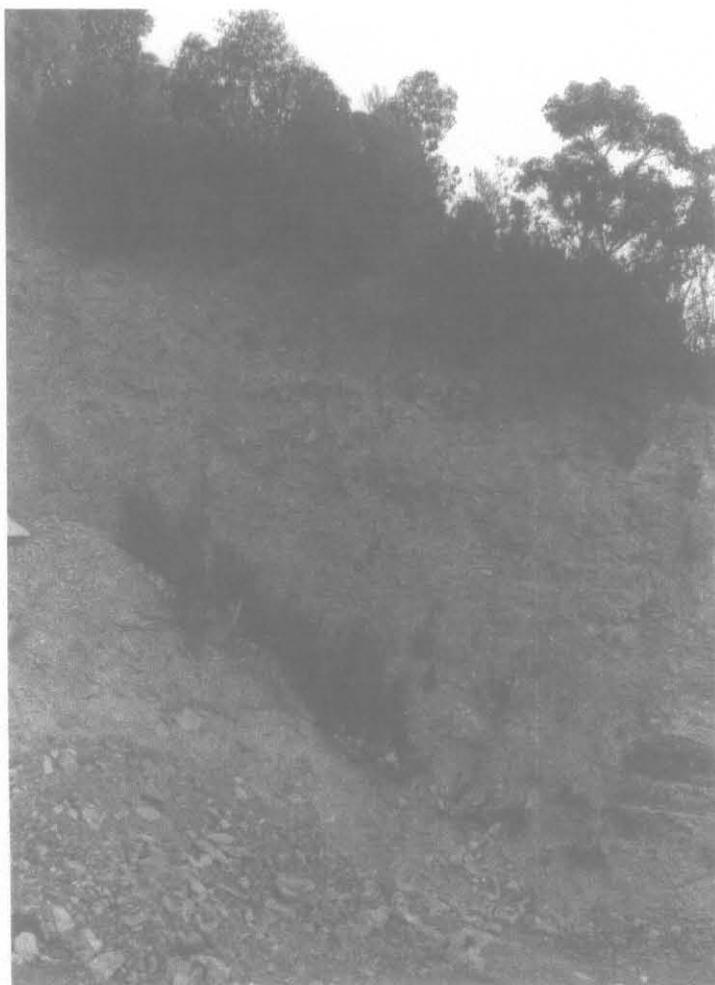
most of these deposits have now been worked out by past quarrying, outcrops showing the original thickness of this material at the base of Round Hill have been preserved between the boundaries of some of the quarry leases (plate 1). The talus is probably a solifluction deposit of Pleistocene age.

Plate 1. *Talus deposits, Holloway's western boundary track.*

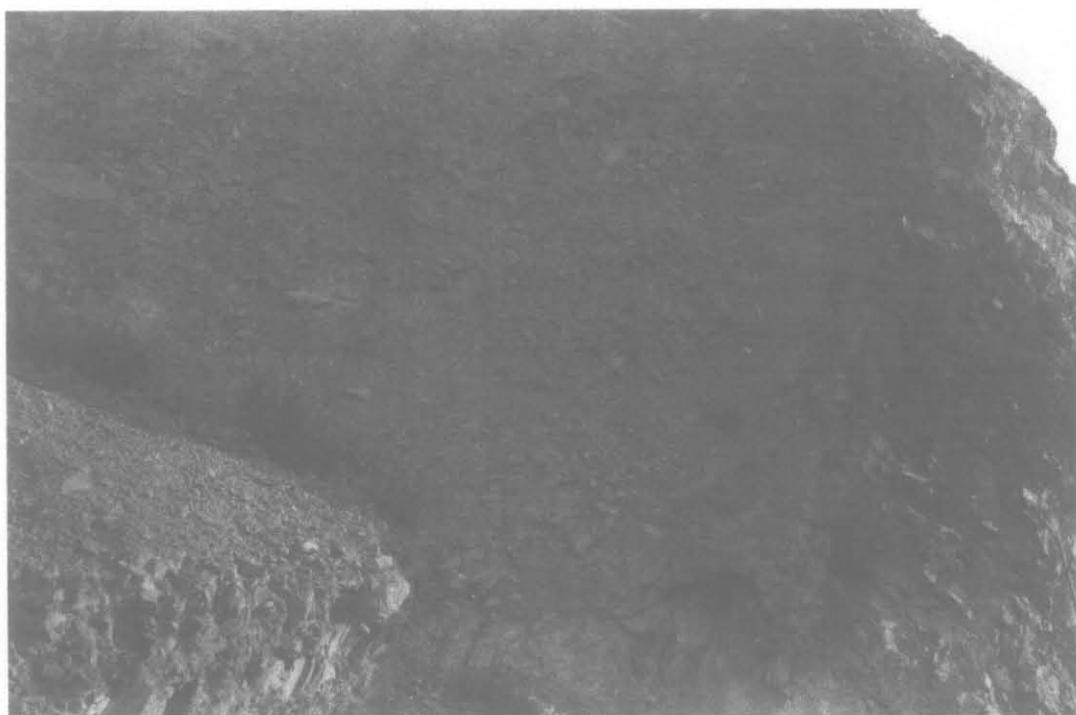
The material is a very poorly sorted gravel containing quartzite fragments, ranging in size from small pebbles to large blocks. The talus appears to have been deposited over an irregular rock surface. Although the matrix is probably rock flour it becomes cemented (plate 2).

Plate 2. *Ill-sorted talus and irregular rock surface.*

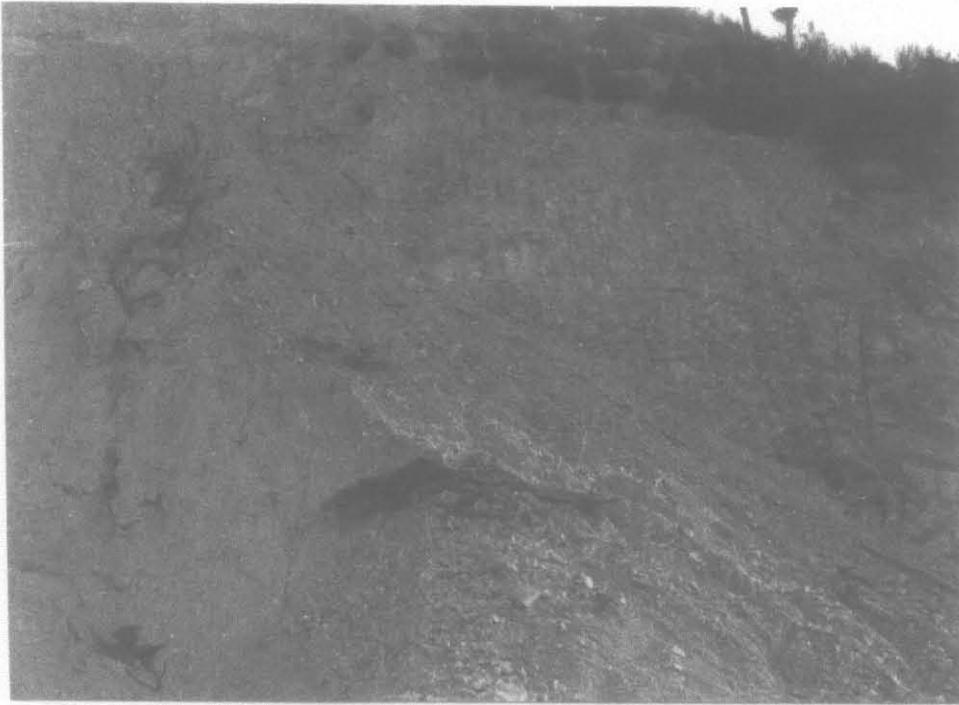
The deposits are surprisingly thick on Round Hill and extend high up the slope and thick deposits are visible at the top of the Public Works Department quarry about 60 m above sea level (plate 3). The talus deposits thin rapidly above this level as seen on the highest bench at Holloway's quarry and a change in slope visible 10-15 m above this bench may mark the limit of the deposit.

The angle of repose of these talus deposits is remarkably high and even though slumping does occur (plate 3), the angle of repose is still high (45°). The high angle of repose is due to the cementing properties of the matrix material that enables the talus deposit to adhere to the underlying rock as in the gunite technique used by civil engineering contractors in tunnels and road cuttings.

Plate 3. *Thick talus deposits, showing slumping.*

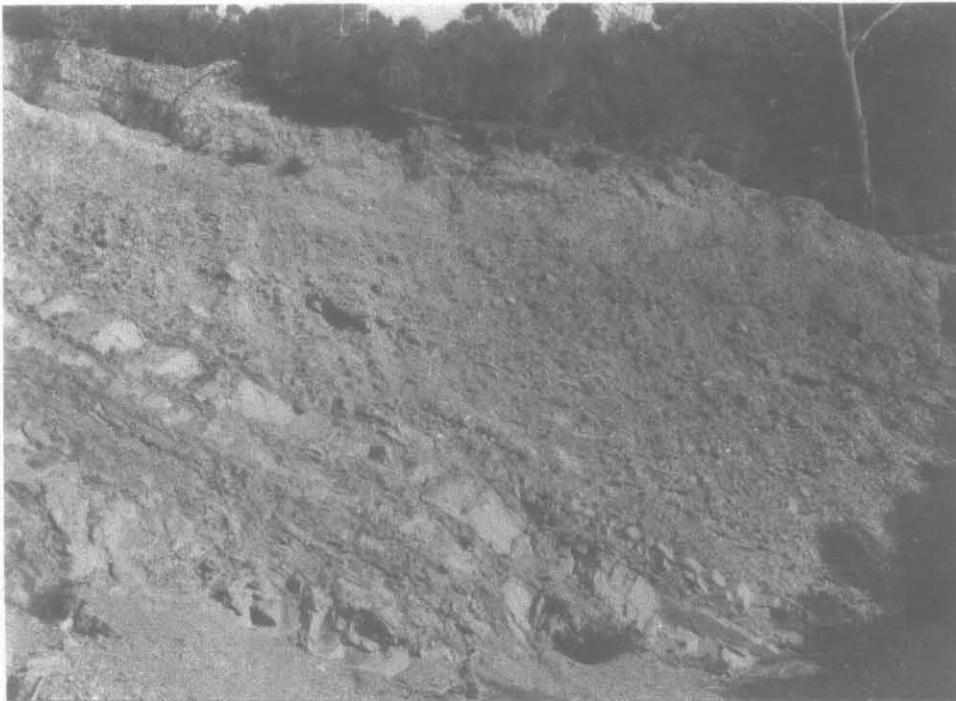
Beneath the talus deposit is a soft weathered zone of the quartzite and mudstone. The talus and upper part of the weathered zone comprise most of the superficial material that has so far been quarried (plate 4).

Plate 4. *Talus deposits overlying weathered quartzite and slate.*

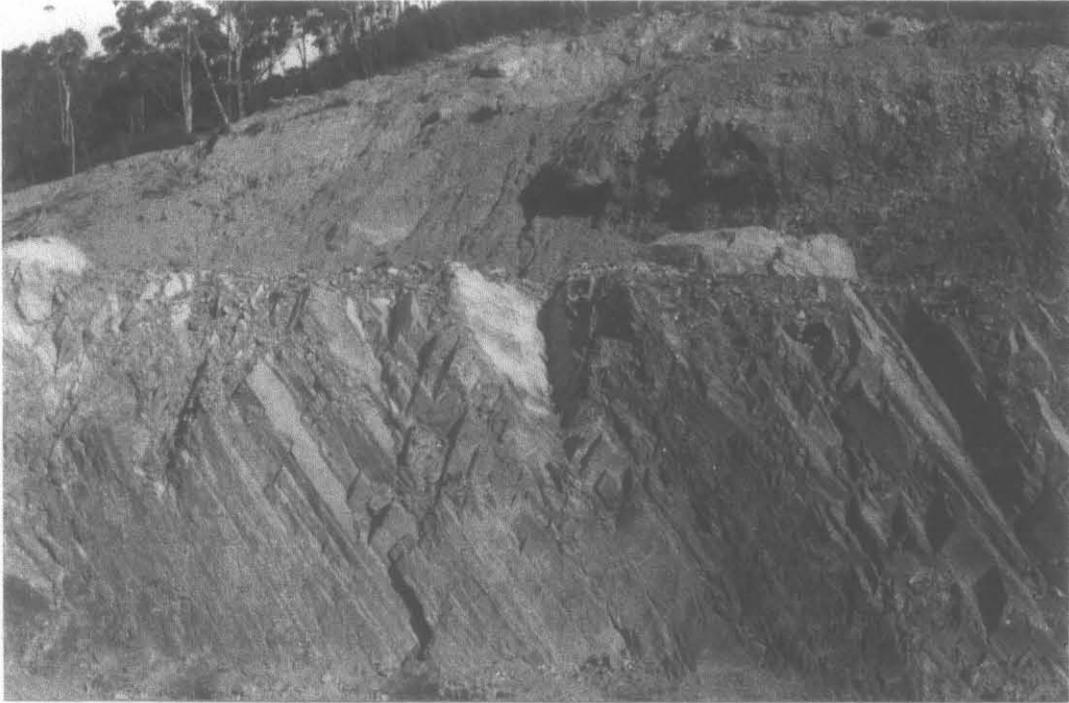
Plate 5. *Line 1, showing wedge failures.*

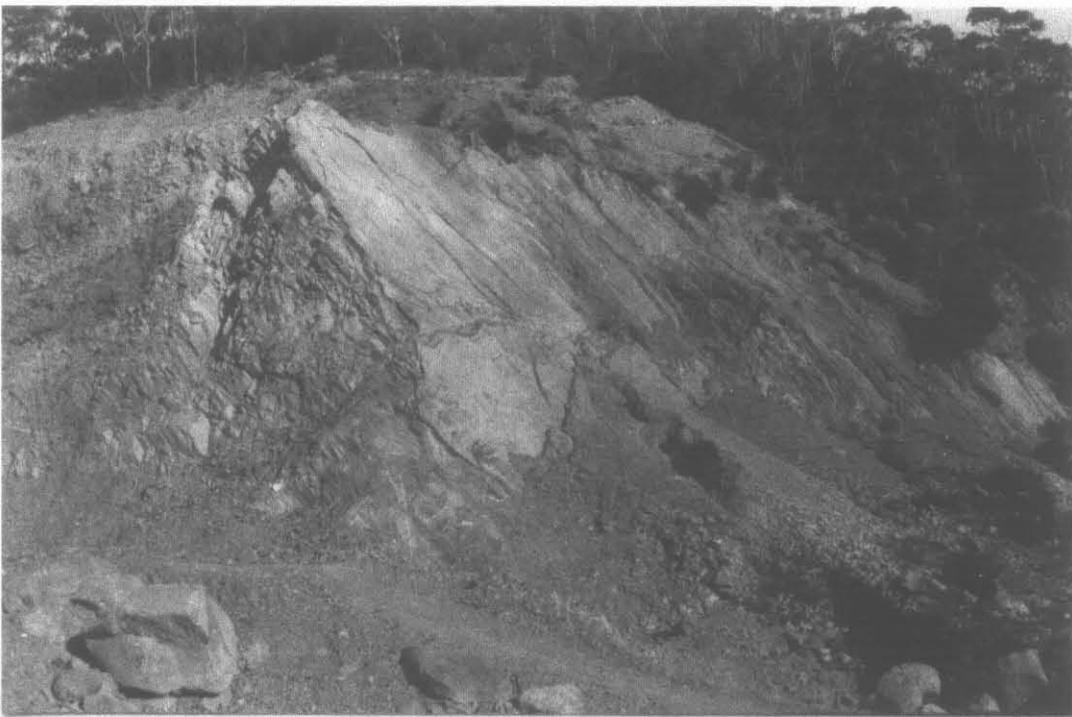
From the stereo-plot if the quarry face was striking in a N-S direction with a component of dip to the west, planar failure would occur even if the slope of this face was as low as  $30^\circ$ . Such a planar failure has occurred on a low angle face immediately south of Line 1 as shown in Plate 6.

Plate 6. *Line 1, showing planar failure.*

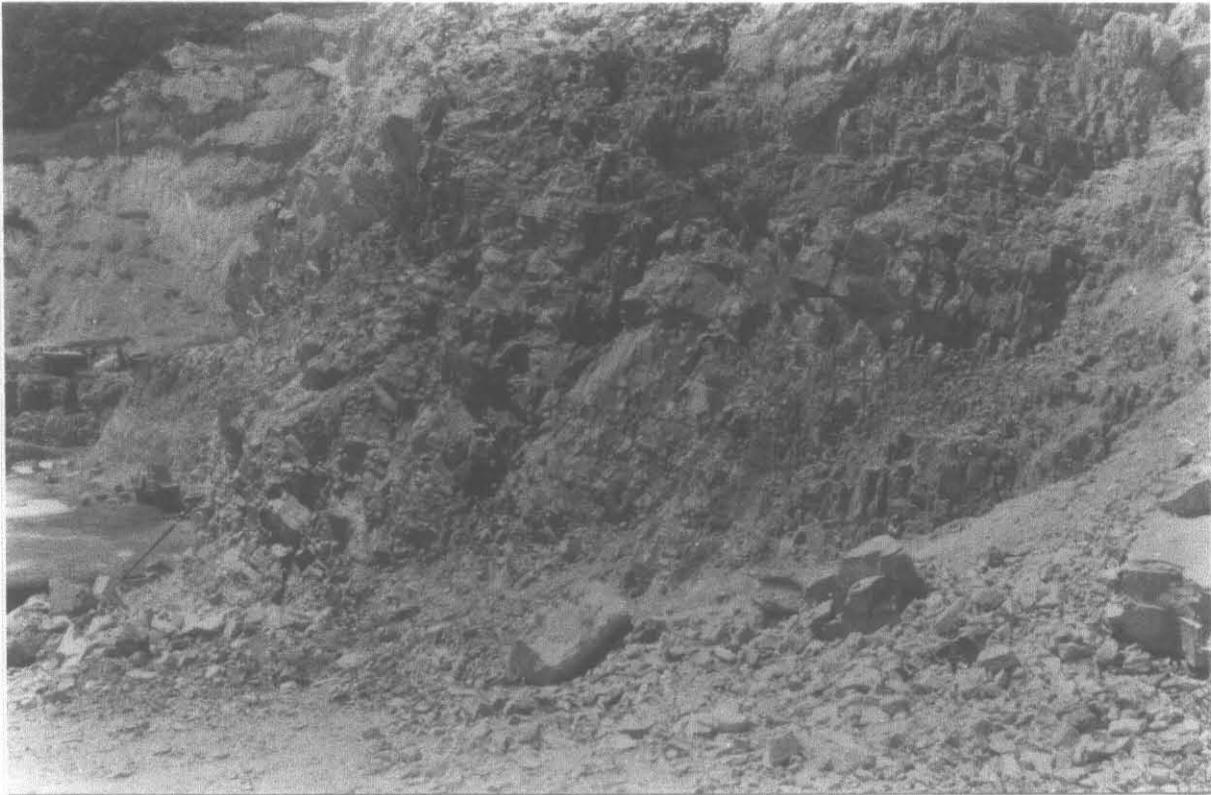
Line 2a. Two major discontinuities are present on Line 2a (plate 7) both of which are joints. Set B is a set of joints influenced by two parallel faults that are exposed close to the western end of this section. These faults have a dip of 70 and 75° at 046°.

Because of the scatter of the poles of Sets A and B planar failure may equally occur.

Plate 7. *Line 2a, showing two sets of joints.*

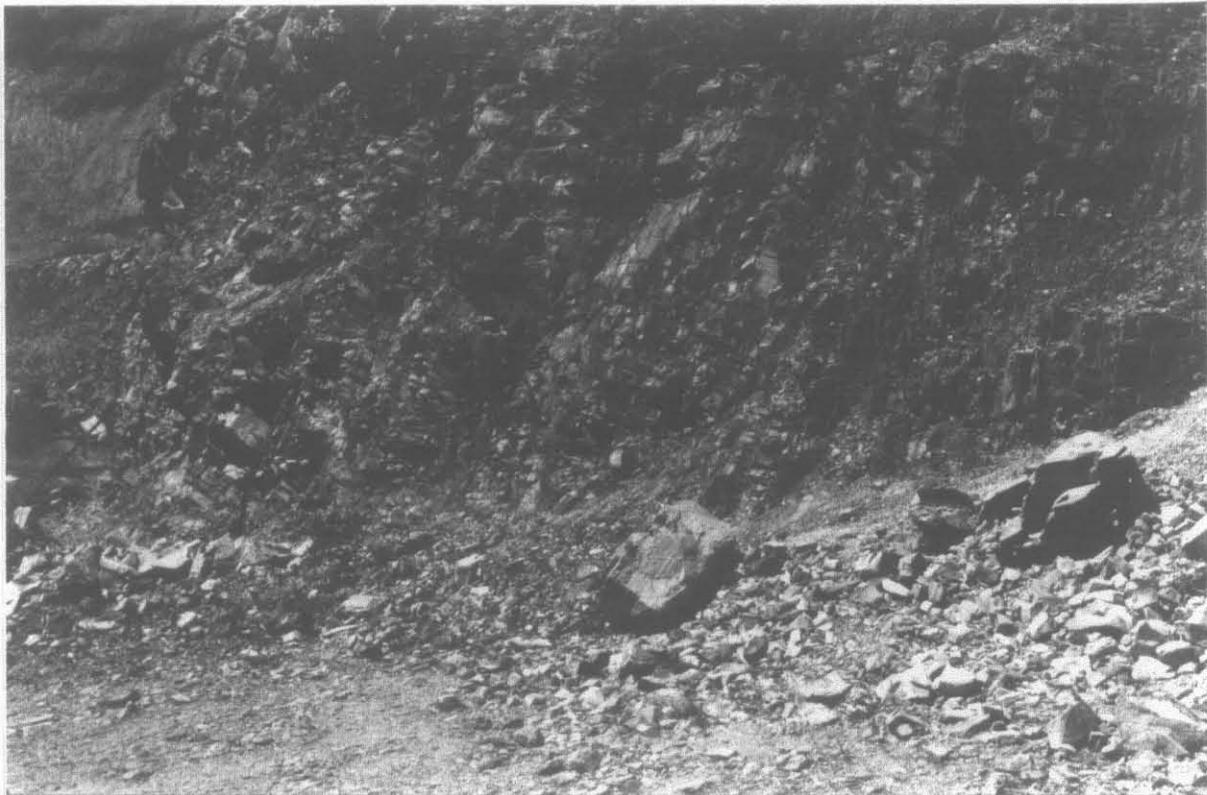
Line 2b. In this section (plate 8) two sets of discontinuities are found. Set A is sub-continuous set of joints and Set B is the bedding which because of the swing in quarry face direction appears as a concentration on the plots.

Because of a concentration of plots of Set A discontinuities planar slope failures are considered more likely. Such failures are visible above this section line (plate 8).

Plate 8. *Line 2b, showing small planar failures.*

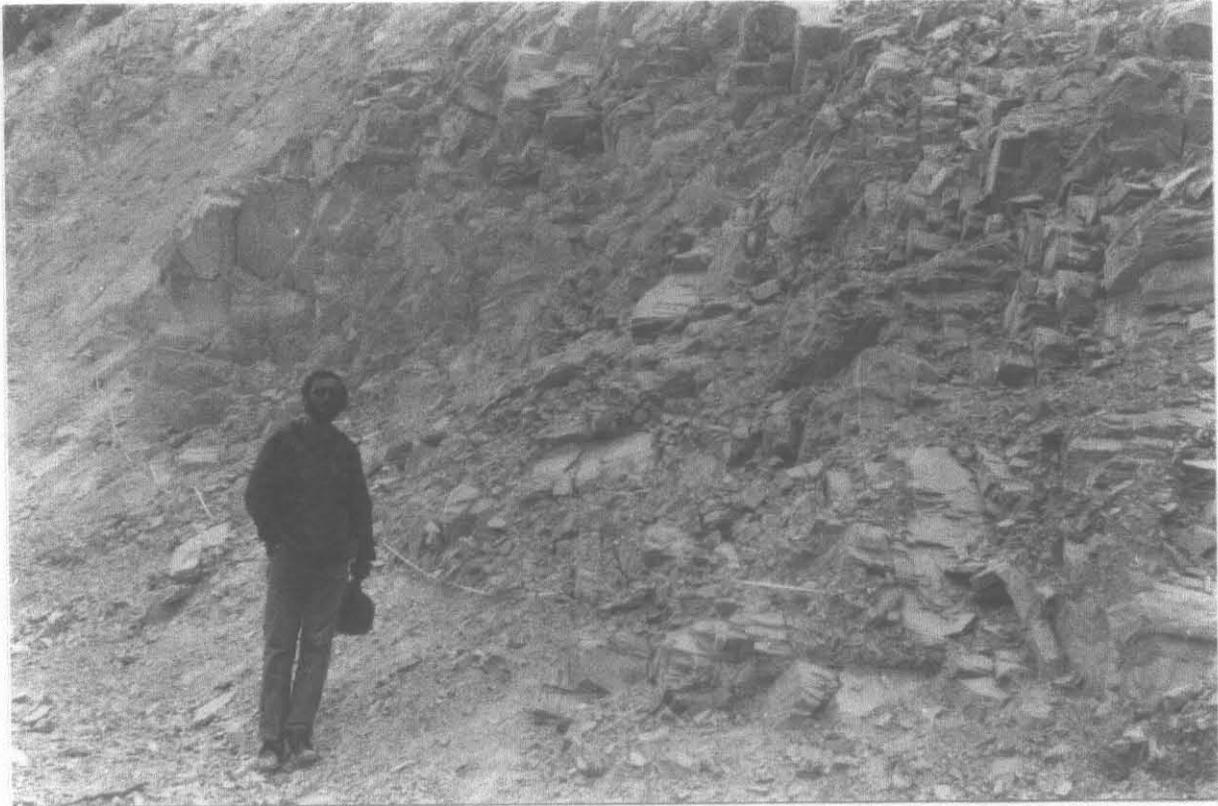
The stereo-plots show two major sets of discontinuities both of which are steep dipping sub-continuous joints (plate 9). The bedding dips 50° at 109° and appears as a wide zone of 2-5% concentration of poles in the NW quadrant of the plot. As the bedding dips into the face it does not contribute to slope instability.

Plate 9. *Line 3, showing two sets of steeply dipping joints.*

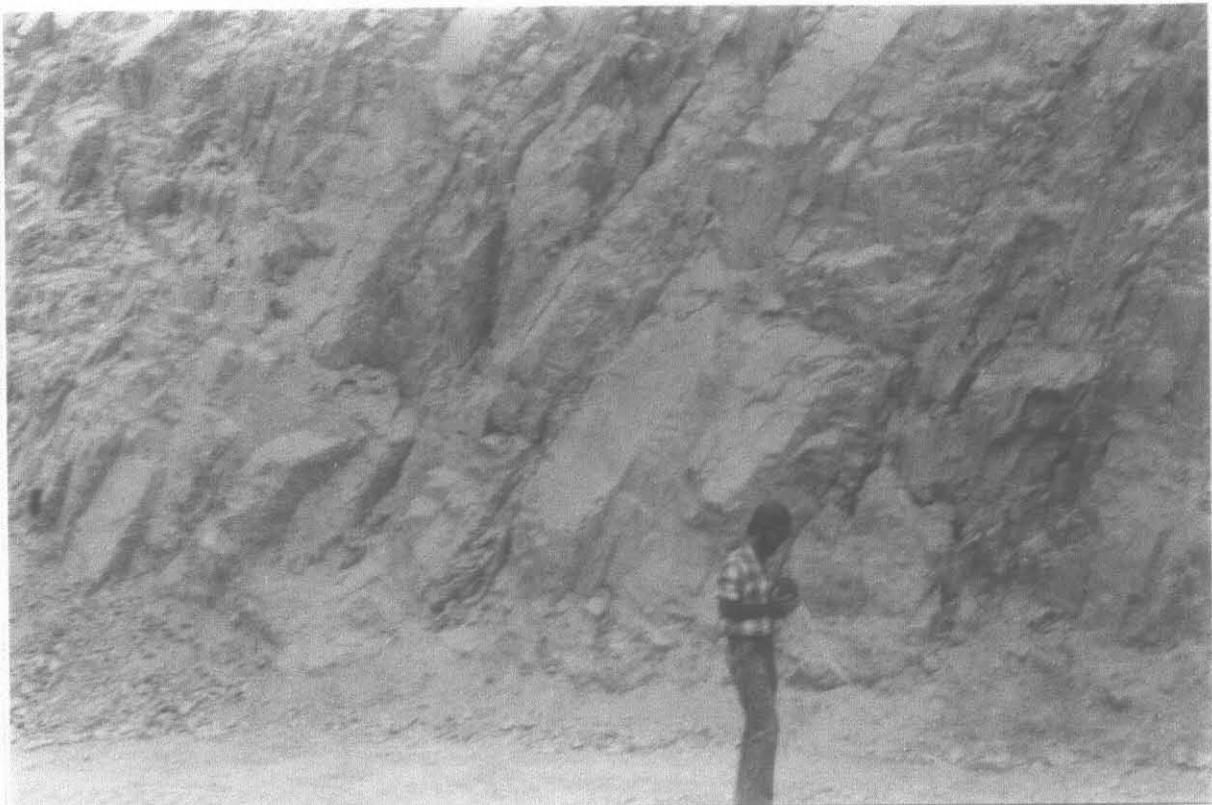
The stereo-plot of this line shows three sets of discontinuities. Set A and B are a well developed steep set of joints and Set C is the bedding (plate 10). The section is at the base of the SW limb of a fold exposed in the 20 m face of Holloway's pit which slopes at 80° (plate 11). The fold is cut off at the south-western end of the pit by a fault; the fault plane dips 85° at 336°. This fault separates the stable fold area of the pit from the unstable area (line 5) above the crusher.

Plate 10. *Line 4, showing bedding.*

As the joints of Sets A and B open and the angle of friction of the quartzite deteriorates because of weathering, the likelihood of such a failure increases. Even with the existing face direction the face angle should be lowered to 55° to ensure complete stability.

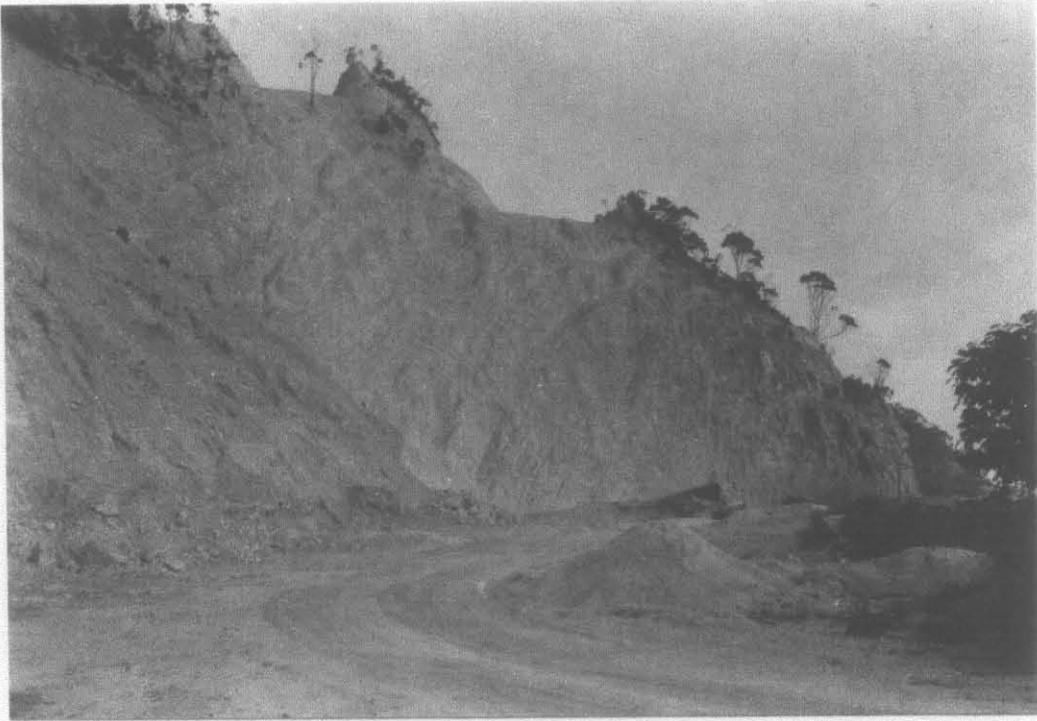
If quarrying was to continue at its present face direction and angle in Holloway's pit the bedding of the fold would swing and steepen in dip as a result of WSW plunge on this fold as it would pinch out against the NE-SW fault. This would result in a stable face becoming unstable as a direct result of the structural geology.

Plate 11. *Line 4, showing fold and fault.*

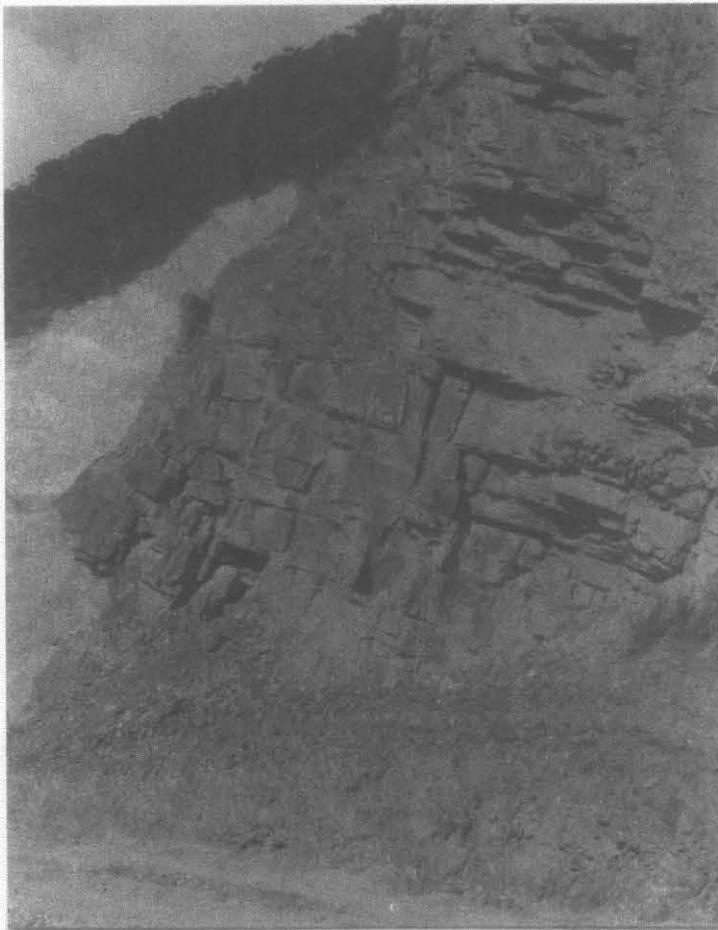
This line (plate 12) was measured above Holloway's crusher near the loading bin. Two sets of discontinuities are present. Set A, (the bedding), dips into the existing face. Set B, a major set of sub-continuous joints has a dip which ranges from 85° NW through the vertical to 85° SE.

The plots only emphasise what is clear visually and it appeared to the writer that some joints had opened during his successive visits. Movement of these joints should be monitored.

Plate 12. *Line 5, showing jointing and bedding.*

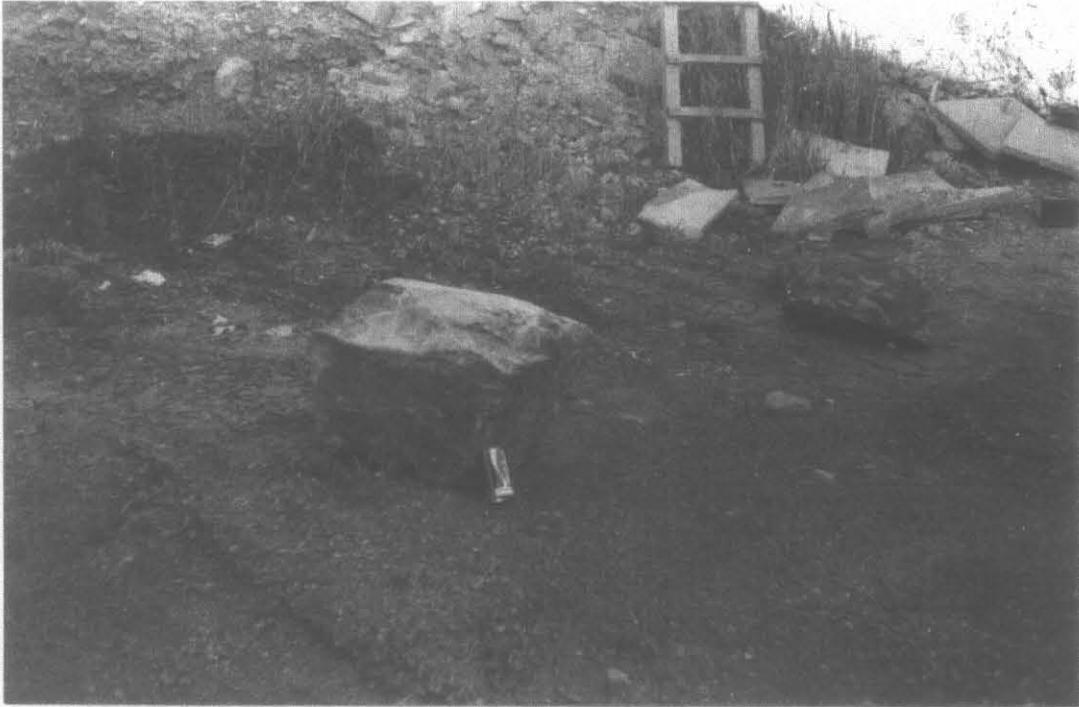
Plate 13. *Fallen blocks on Wreckair property.*

- (1) The geological structure is very important to the stability of the existing quarry faces. As more of the rock is quarried and blasting and pre-splitting techniques are used, the geological structure will become of over-riding importance.
- (2) If a general E-W quarry face direction is to be maintained and the unweathered quartzite is quarried on a large scale an overall face slope of 30° will need to be maintained to ensure long-term slope stability.
- (3) The maximum bench height should be 8 m and wide enough for access for machinery to clear fallen material (plate 13).
