1976/40. Further investigation of proposed roads near St Marys.

D.J. Sloane

At the request of the Forestry Commission, an investigation was made of further road works near St Marys. A brief inspection was made of sections of each route to determine whether geological and geomorphological factors would adversely affect road construction.

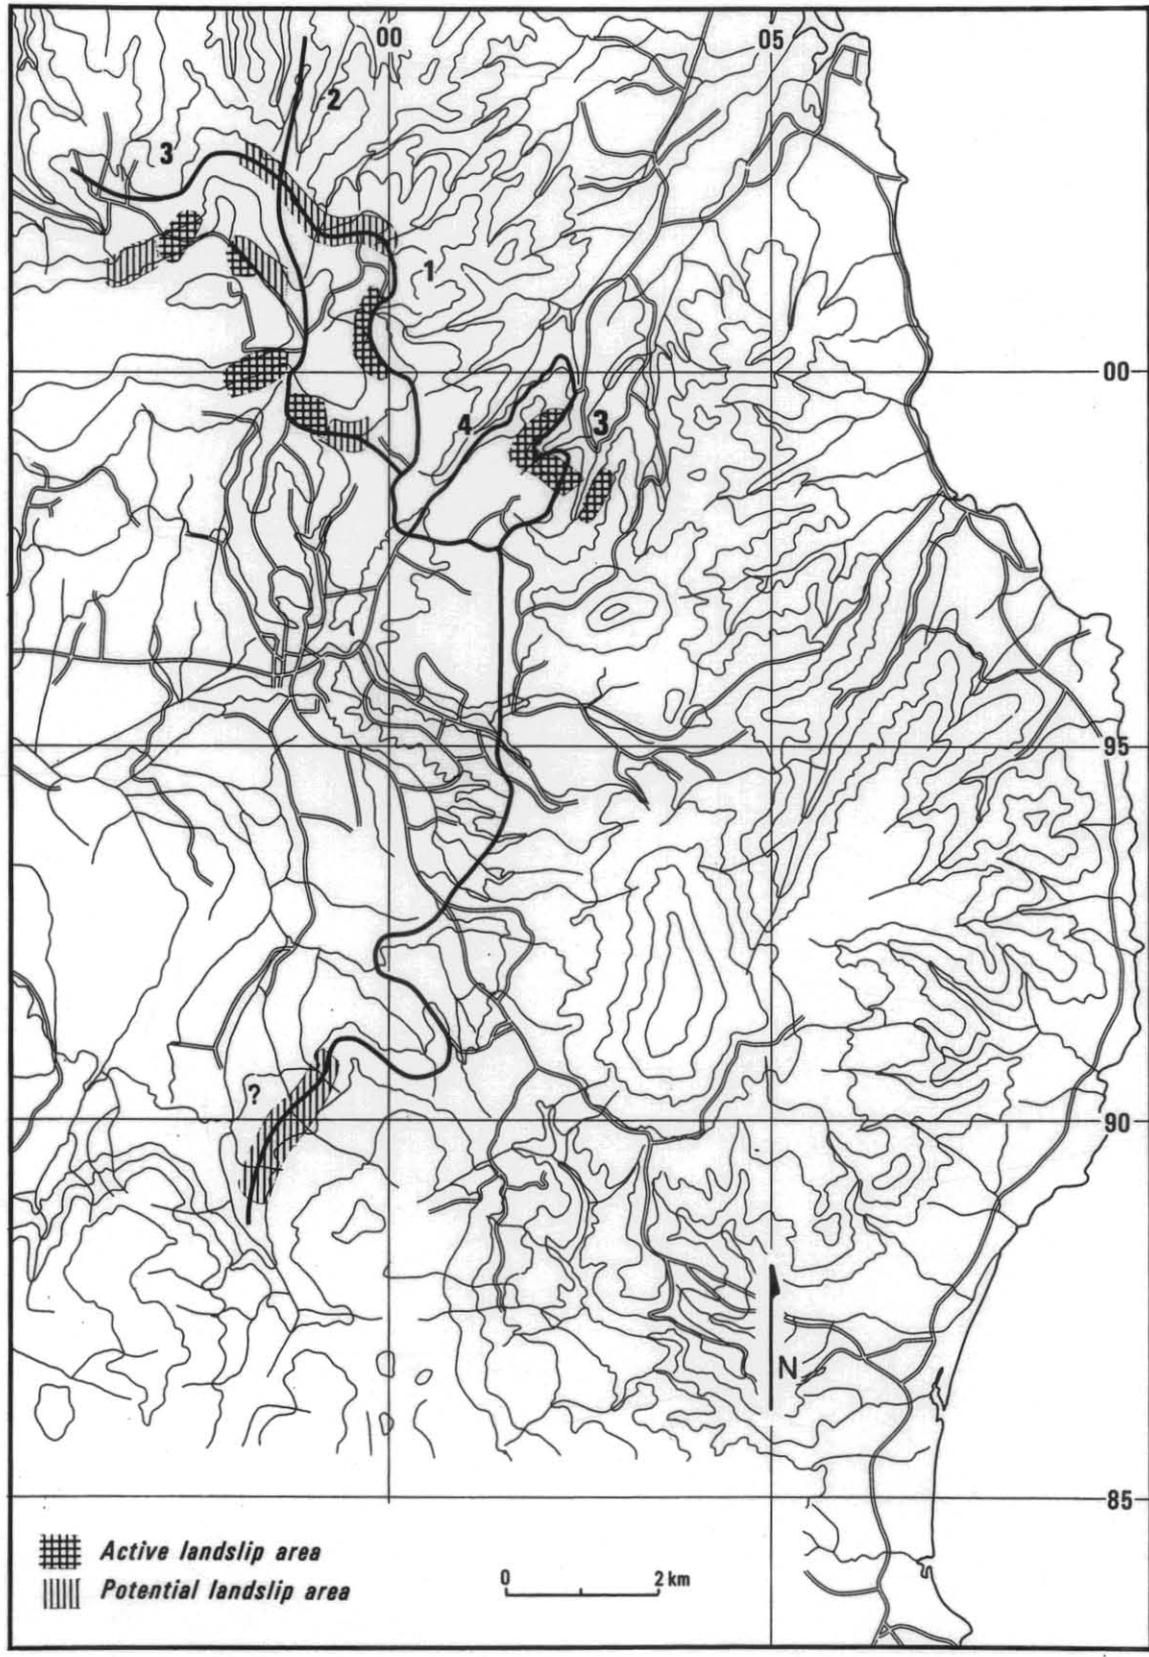
Figure 1. Road routes in the St Marys area, showing active and potential landslip areas.

The problem of instability associated with road construction along Routes 1 and 2 is largely confined to areas underlain by a sandstone-coal measures rock sequence of Triassic age. The angle of threshold natural slopes in these areas appears to be between 20° and 25°. It is therefore considered unwise to route roads across such areas. Areas underlain by Triassic rocks and with slopes of about 15° or less are considered reasonably stable but final inspection of these areas is advised. Roads should be routed to avoid all known and potential landslip areas. Such areas are marked on Figure 1.

Numerous recent landslips have been observed around the Mt Nicholas-North Sister-Cheeseberry Hill area, some of which are extensive (Sloane, 1976, in preparation). Recent 'fresh' landslips probably occurred during the winters of 1974 and 1975 when unusually heavy rainfall occurred. Several old landslips can also be seen in the area. Some landslips are reactivated older slips. This is indicated by the old landslip deposits, scarps, buried soil profiles and weathered remnants of bedrock entrained in the landslip debris.

All landslips have resulted from the failure of a dolerite talus or solifluction(?) deposit, present as a thin mantle on the sandstone and coal measures. Seepages and springs are associated with slips, the groundwater moving along the Triassic bedrock-dolerite talus interface. Failure has occurred as a result of the steep slopes and the saturation of the veneer of clayey talus material in seepage areas.

This route passes through a landslip area on the eastern flanks of

Cheeseberry Hill. The section of the route that passes north of German Town and North Sister, although not inspected, passes through areas considered to be of doubtful stability on the basis of rock type and slope. Route 1 seems impracticable and there is no alternative stable route in this area.

This route passes through landslip areas on the northern and southern sides of the saddle between Cheeseberry Hill and North Sister. On the southern side of this saddle the route passes partly along the existing German Town Road. This is essential as landslip areas are present both to the west, in the Jubilee mine area, and to the east along the eastern flank of the valley that extends south-east from the saddle. The route proceeds east along the side of this gully. This section was not inspected and requires further examination to confirm its suitability. North from the Cheeseberry Hill-South Sister saddle the route passes along the downhill side of an area of possible instability. No real problems are likely here but further inspection is advisable. The route then strikes north along a ridge towards Upper Scamander. This area north of North Sister is underlain by granite and Mathinna sediments. No problems are likely along this section provided slopes steeper than 20° are avoided. Conditions will be generally similar to those found along Catos Road to the west.

Several landslips have been observed in the Mount Nicholas-North Sister-Cheeseberry Hill-Lower German Town Road area. The landslips are confined to slopes of around 20° or higher in areas where clayey dolerite or solifluction deposits mantle rocks of Triassic age. The active and potential landslip areas have been outlined (fig. 1). These sections must be avoided as slips have occurred in both pasture areas and areas under natural vegetation. Landslip problems will be compounded because of road construction which will cause artificial oversteepening of slopes with subsequent removal of support and alteration of drainage conditions. Route 2 is the better route with regard to slope stability. Further inspection of two small sections is advised. This can be conducted when the route is correctly plotted at its required grade.

Of these latest routes examined, Routes 2 and 4 are favoured. Route 2 is preferred because of the problems associated with stability of Route 4 at St Marys Pass. Route 2 has only two short sections through areas of potential instability. Further cursory inspection of these sections is advised.

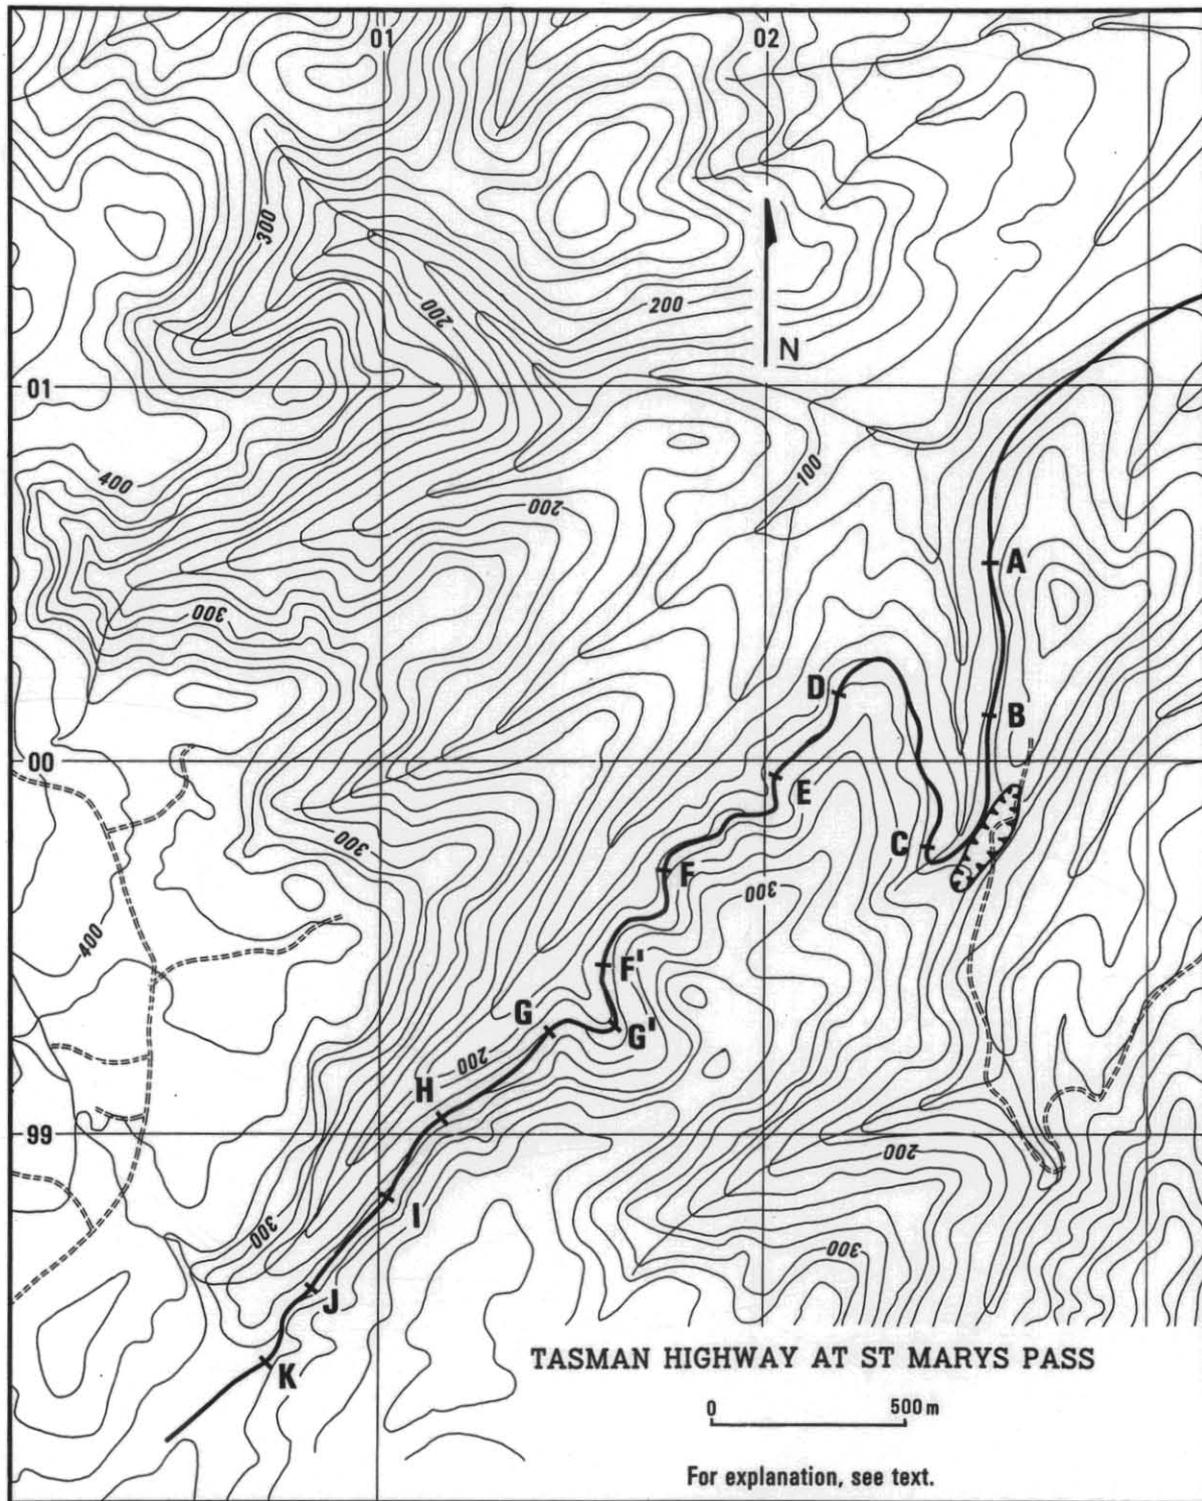
Figure 2. *Tasman Highway at St Marys Pass.*

A brief examination was made of the existing section of the Tasman Highway through St Marys Pass. This section of road has been affected by major roadslips and slumps during periods of high intensity rainfall of the winters of 1974 and 1975. The following notes were made on various parts of this road section (fig. 2). The entire route passes through granite of Upper Devonian-Lower Carboniferous age.

Section A-B. The hill slopes in this section are steep (about 30-35°) and two slumps have occurred on the upper side of the road. The granite is moderately weathered and little blasting would be required during road widening.

Section B-C. The granite is deeply weathered and closely jointed in the area around the gravel pit. Slopes are not steep in this section (maximum 23° near B). Some soil creep is evident from bent and leaning trees on the upper side of the road in steeper sections.

Section C-D. Two or three small slumps and a large slip have occurred in embankments on the upper side of the road. Slope angles are generally about 28° to 30° with 37° the maximum slope angle. The granite is deeply weathered and closely jointed.

Section D-E. The granite is not deeply weathered and slopes are about 40°. Extensive exposures of granite are visible on the upper side of the road. A small quarry at D has vertical faces which appear stable. Only a thin veneer of weathered granite is visible. Blasting would be required in this region and a fairly large embankment would be required on the upper side of the road.

Section E-F. This is a steep section with slopes between 30° and 40°. No major instability is evident. Minor slumps occur on the upper embankment and are associated with small patches of more deeply weathered and closely jointed granite. Blasting would be required during road construction. Large culverts are required where gullies are crossed.

Section F-G. A slip has occurred in the gully north of F. Slopes are about 30° to 40°. The granite is not deeply weathered or closely jointed. Blasting is required during road construction. Two slumps are present in the gully near F. The gully shows evidence of having carried large volumes of water, largely responsible for previous road destruction here. Two large gullies are present at G¹ and the granite appears more deeply weathered around this gully (F¹ to G). There are several embankment slips in this area and slopes are between 25° and 30°.

Section G-H. Slopes in this section are between 35° and 40°. There are abundant granite outcrops with little evidence of close jointing. Weathering is restricted to a thin veneer over solid bedrock. One or two minor embankment failures are present. Blasting would be required in this section.

Section H-I. This section is similar to Section G to H. There is only a thin veneer of weathered and fractured granite over solid bedrock. Minor slumping of this weathered material has occurred above the road. The granite appears more deeply weathered in the gully at I and minor embankment failures have occurred. Blasting is required in this section.

Section I-J. The granite is variably weathered in this section. Embankment failures are associated with areas of deeper weathering. The two gullies at I and J require large culverts.

Section J-K. The granite is deeply weathered but no problems are envisaged as slope angles become smaller as the road passes closer to the ridge top.

The St Marys Pass area is underlain by granite. Slope angles range generally between 25° and 40°. The granite is variably weathered showing moderate to deep weathering between A and D and I and K. The section D to I has the steepest slopes and a thin veneer of weathered and fractured granite overlies solid bedrock. Blasting would be required during road widening in this region. Embankments in the steeper slope sections will be high and benching may be required. Embankments can be steep in this section due to the solid nature of the bedrock, however, some retaining methods will be required to prevent failure of the veneer of weathered and fractured bedrock. This is especially so where patches of deeply weathered and closely jointed

bedrock are encountered. Large diameter culverts are required where the road crosses gullies. These gullies carry large volumes of water during periods of high intensity rainfall which occur in the St Patricks Head region.
