1976/42. Drilling at Casuarina Crescent, Glenorchy.

R.C. Donaldson

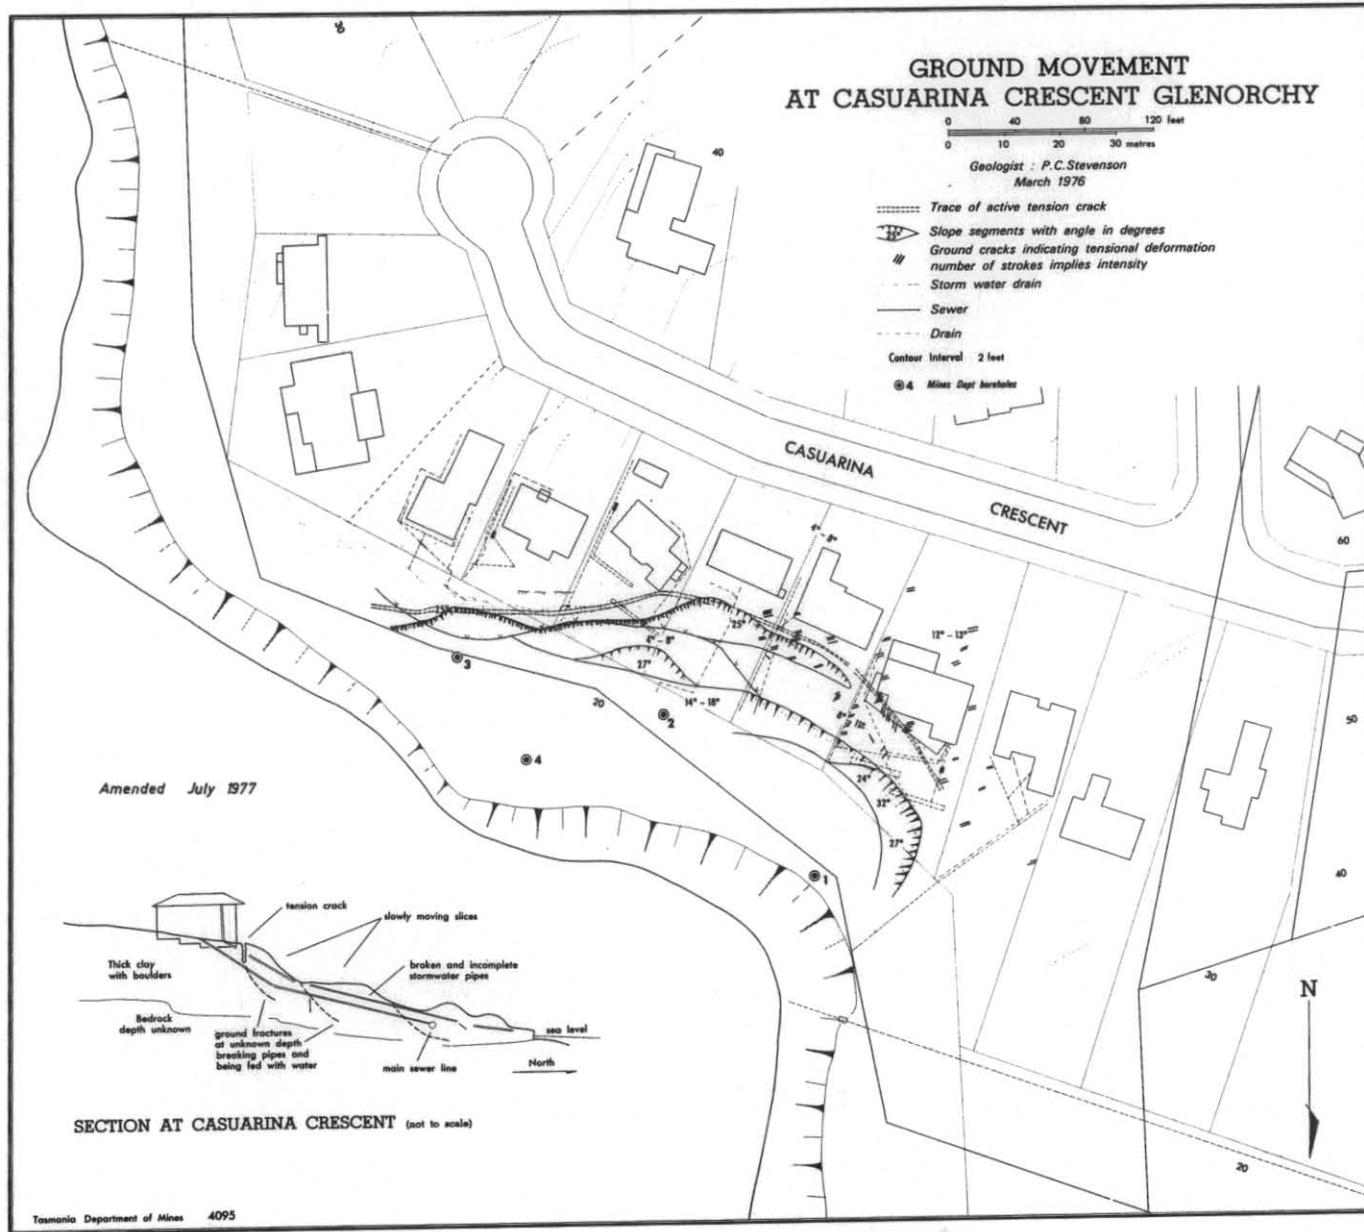
Figure 1.

A preliminary programme involving the drilling of four holes was undertaken on 29 and 30 April 1976. It is to be appreciated that there are inherent technical difficulties in selecting suitable drilling sites in residential areas on relatively steep slopes. Thus the positioning of the bore holes was partly pre-determined by accessibility to the slip area. Bore Holes 1-3 were sited in order to examine the nature and variability of the subsurface materials, the position of movement planes, and the groundwater conditions existing within the slip area. Bore Hole 4 was sited in the probable toe region of an old slip (fig. 1). The logs of the auger holes are given in Table 1.
