1976/47. Further inspection of road routes near St Marys.

D.J. Sloane

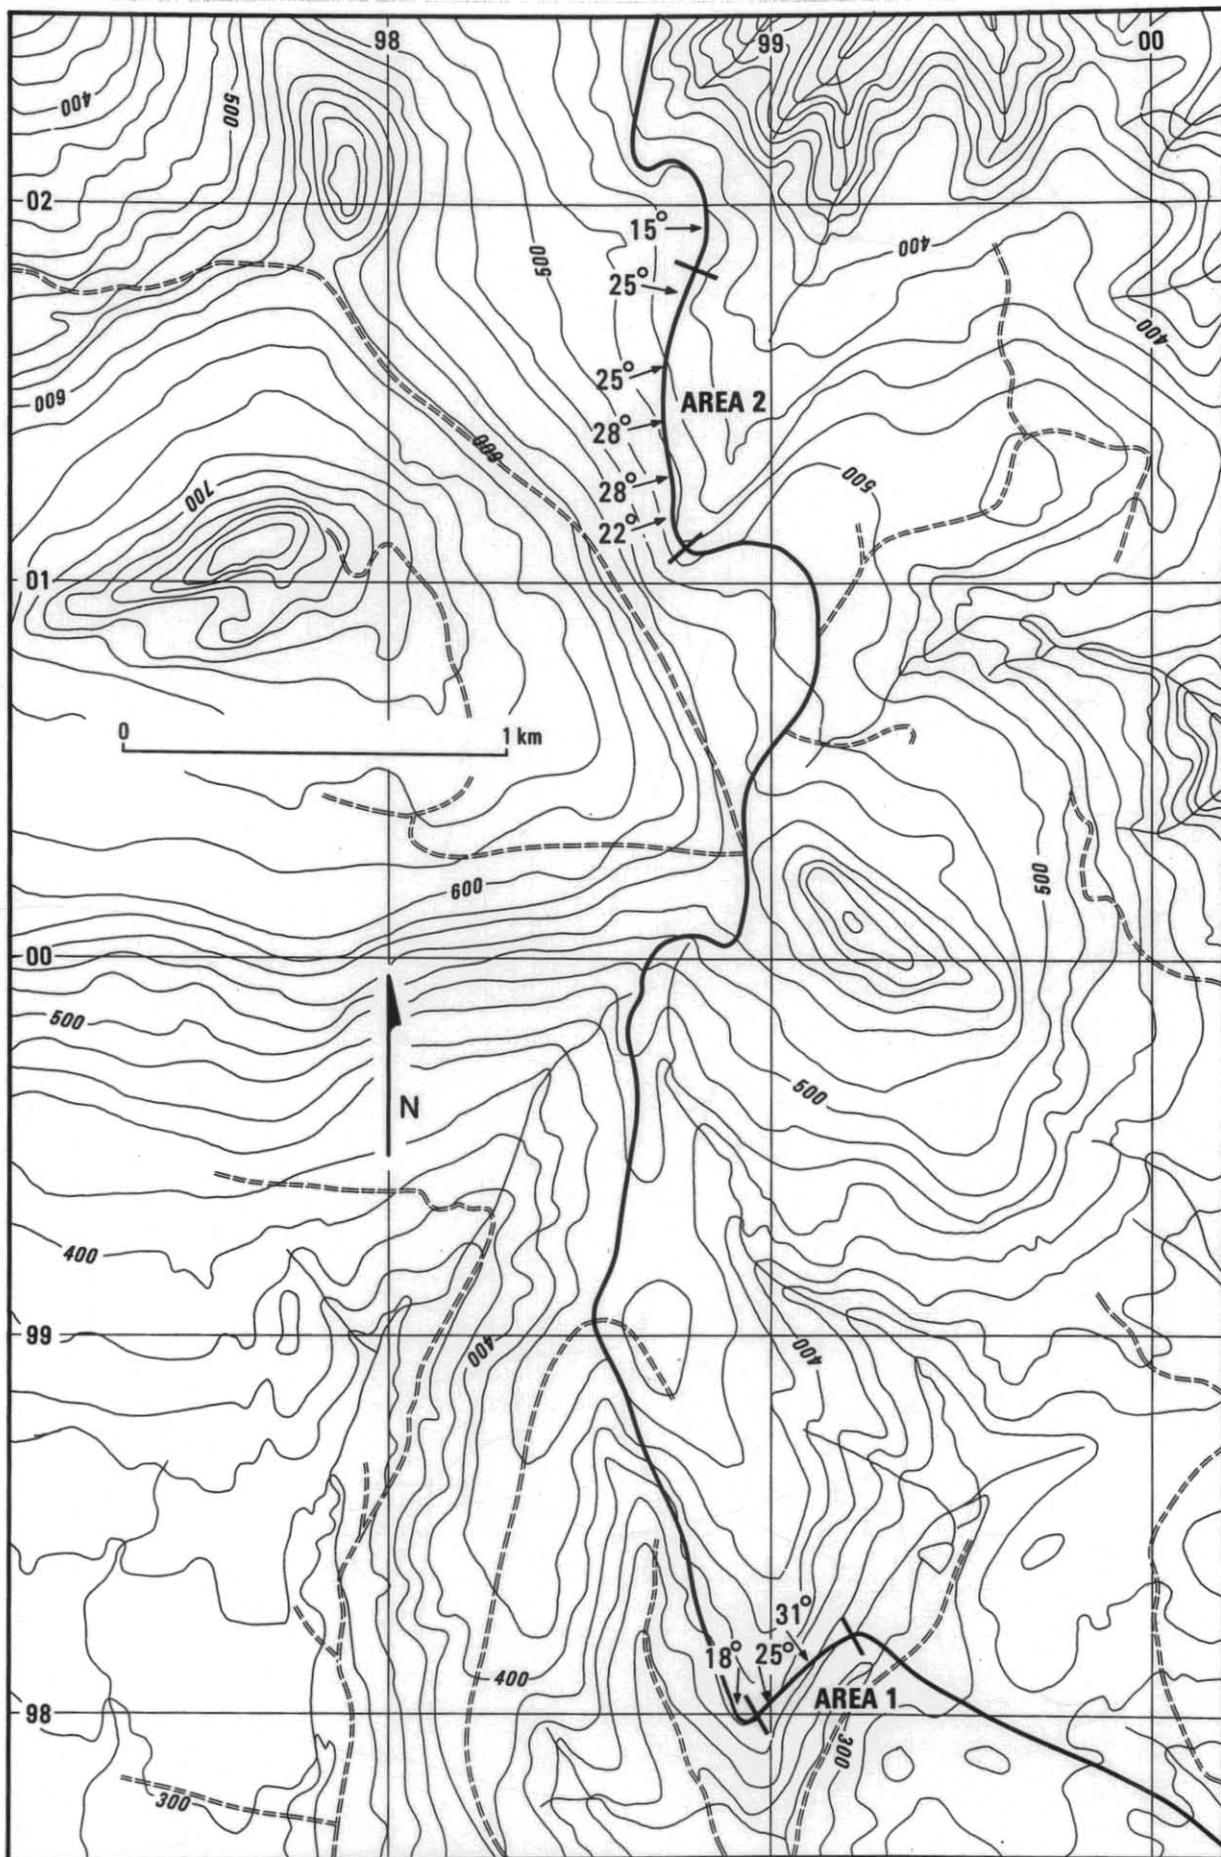
Figure 1. Areas of possible instability.

Route 2 (Sloane, 1976) has now been accurately delineated by the Forestry Commission, and areas of possible instability have been examined (fig. 1).

Area 1 lies about 2 km north of St Marys. The route passes around the toe of a spur and along a steep hillside. Hill slope angles have been marked on Figure 1; the maximum slope in this area is 31° . The slope is mantled by a scree of angular quartzite fragments derived from Mathinna sediments. Some weathered matrix is associated with this material below the surface but solid bedrock is likely to be at shallow depth.

Instability problems are generally minor on this rock type where solid bedrock is struck at shallow depth. However, the structural direction of the rock is important as the alignment of fractures may result in the need for benching embankments to prevent and control rock falls.

Area 2 lies about one kilometre west of German Town. Here the route passes around the head of a large creek and strikes north along the hillside. The area of doubtful stability is about 500 m in length and is underlain by dolerite solifluction(?) deposits 1-2 m in thickness, overlying a sequence of Triassic sandstone and coal measures. Failures have occurred in similar areas but no sign of old or new landslips has been seen in this area. The maximum angle of slope is 28° (average angle 25°).

This section, although steep, has the shortest length of all routes examined, which pass over an area of doubtful stability. If adequate drainage is provided during road construction then the potential instability of this section will be reduced. The sealing of all drains should be considered to ensure rapid surface runoff of rain water. Some retaining structures may also be required if slips occur on the upper embankment.
