1976/48. Diamond drilling at Macquarie Point sewerage treatment plant.

W.C. Cromer

DIAMOND DRILLING AT MACQUARIE POINT SEWERAGE TREATMENT PLANT

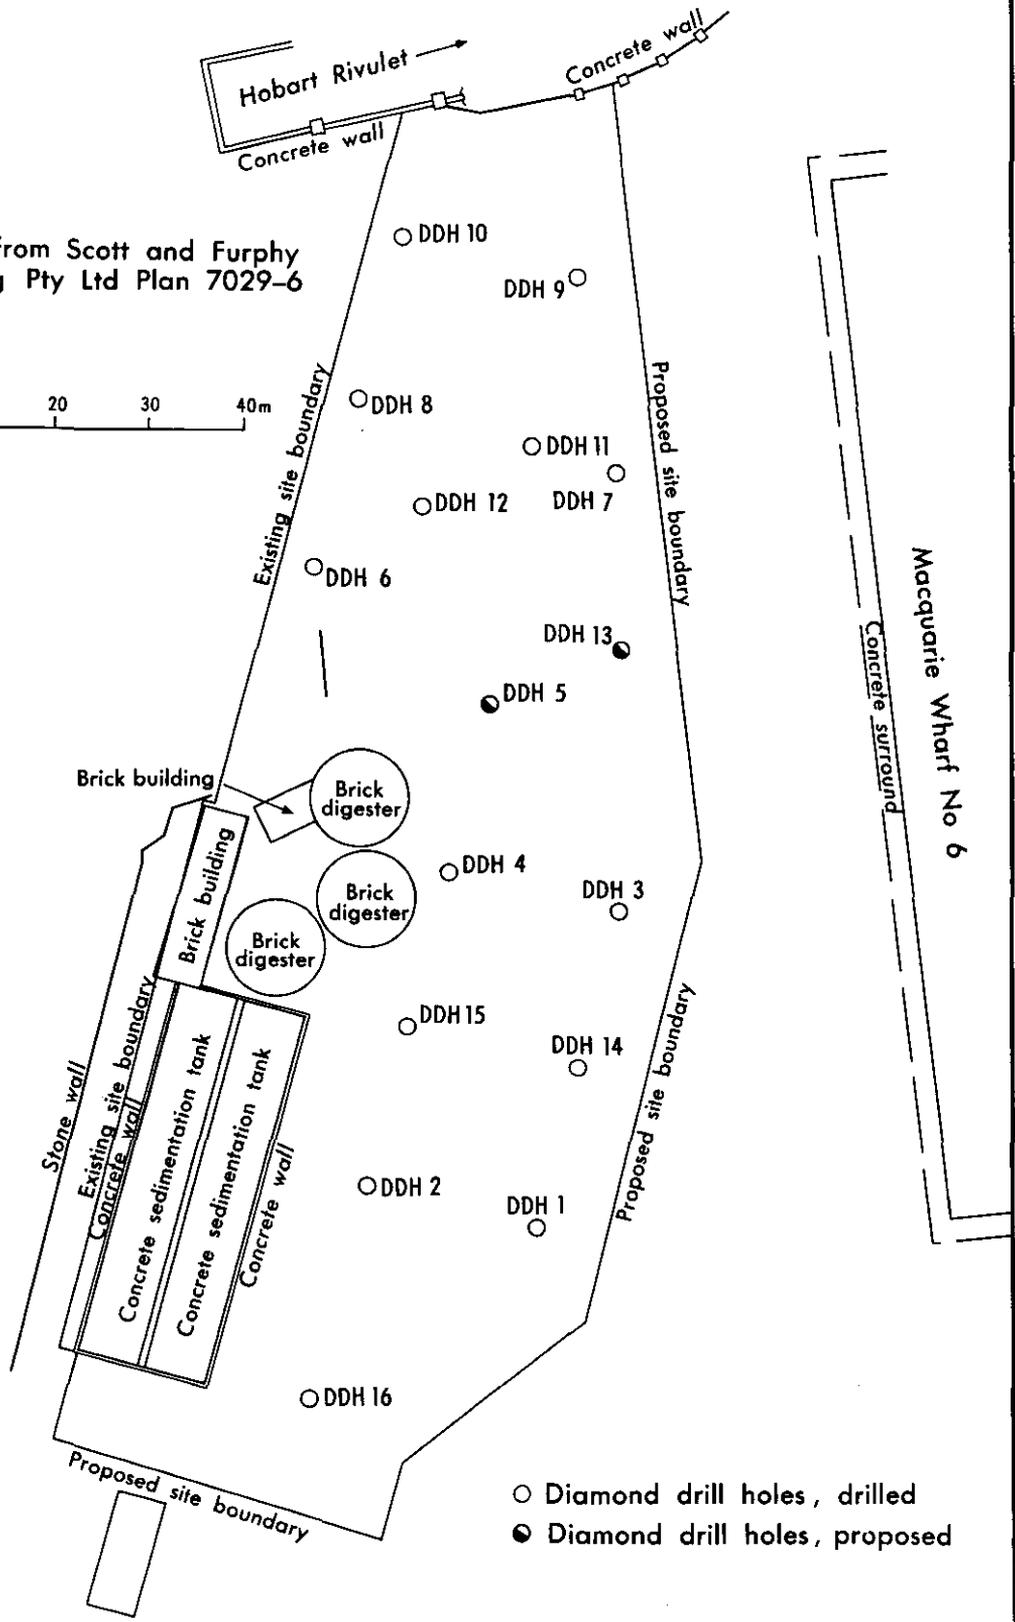
Figure 1.

Of the intended 16 holes, all but two were drilled. Holes 5 and 13 were omitted because of their proximity to underground power cables. In all cases the bedrock was Jurassic dolerite. The positions of the holes are shown on the consulting engineers' plan 7029-6.

Simplified from Scott and Furphy Engineering Pty Ltd Plan 7029-6
