1977/17. Examination of a proposed dam site on Camp Creek, Wynyard.

W.L. Matthews

The Rivers and Water Supply Commission requested a preliminary report on a possible dam site on Camp Creek, about 3 km south of Wynyard [CQ922580]. The dam is being considered by the North West Regional Water Authority as an alternative to a pipeline from Somerset to Wynyard. The dam, of some 15 m height, would impound about  $1.58 \times 10^6$  m<sup>3</sup> of water, enough to supply the town of Wynyard for one year. It is expected the dam would be of earth fill construction, with or without a clay core. The existing supply for Wynyard comes from further upstream on Camp Creek.

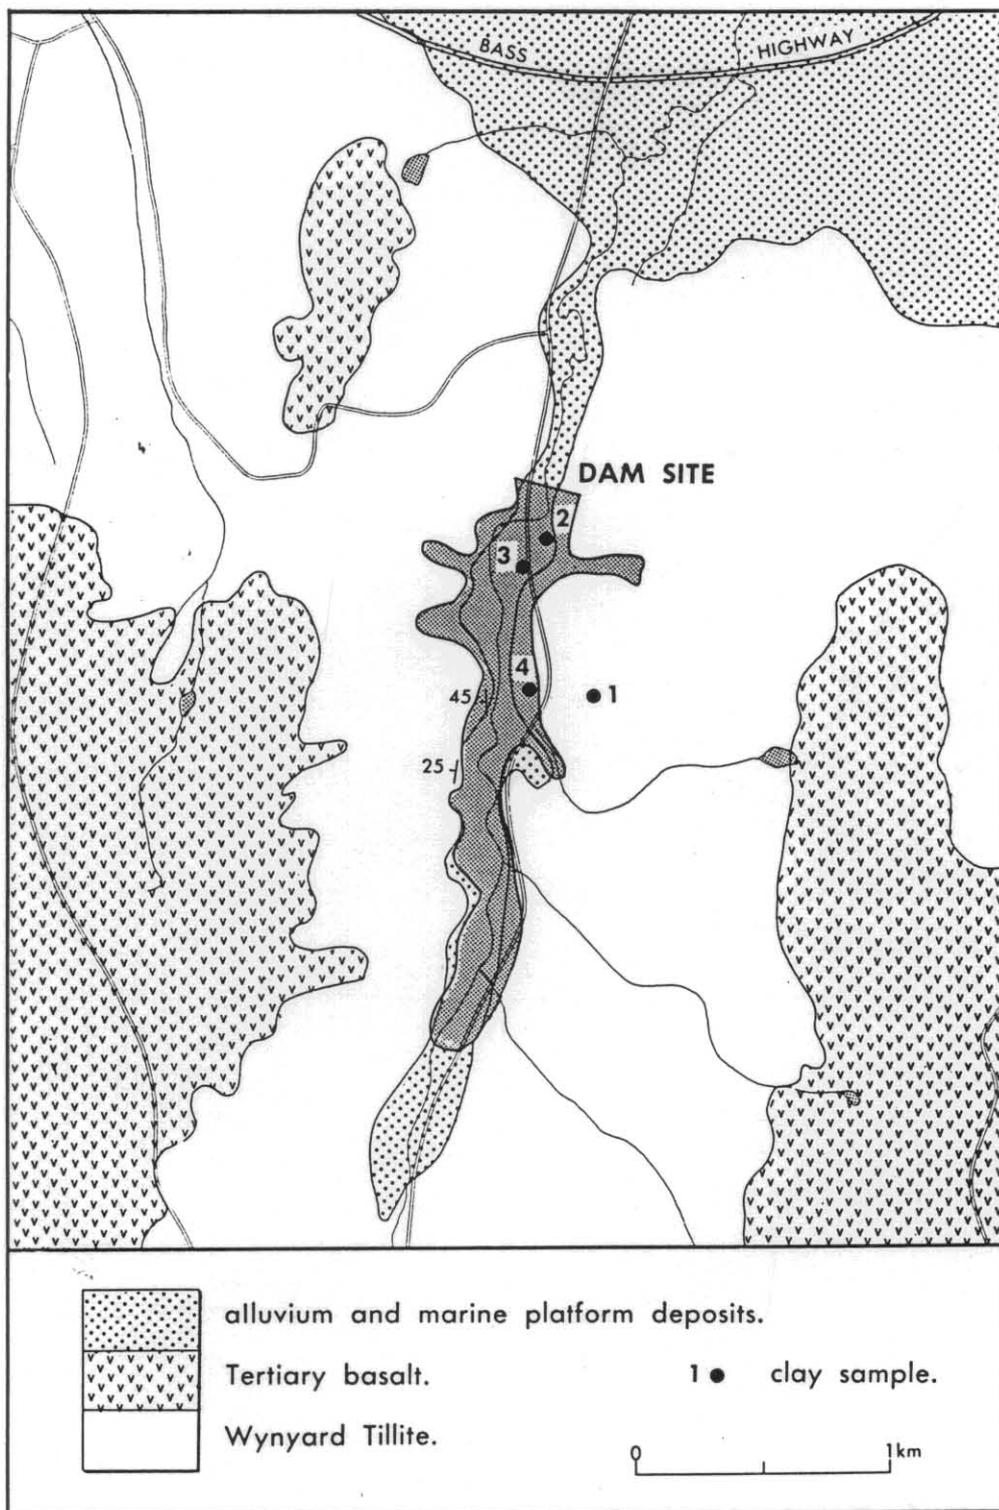
Figure 1

The dam site is about 30 m above sea level and is just inland from the coastal plain on which Wynyard is built. In the storage and dam area (fig. 1), the stream is entrenched into land which rises to about 180 m above sea level. It is surrounded by narrow flood plains which widen where small tributaries enter Camp Creek. The dammed water will extend about 3 km upstream from the dam in a long narrow strip of water.

Fine grained sediments which may be suitable for an earth fill dam occur within the storage area. The weathering of the Carboniferous-Permian fine grained sediments has resulted in accumulations of clay-like material on the surface. Samples from four locations (fig. 1) were tested for dispersion of clay minerals. No dispersion was noted either with water from Camp Creek or with distilled water. Although the materials are fine grained the actual clay mineral content may be low. There was little or no expansion or slaking of the samples after placing in water and they did not become very plastic when worked with water. All of the samples were obtained on the eastern slopes around the storage area. Similar material may underlie the flood plain surrounding Camp Creek.

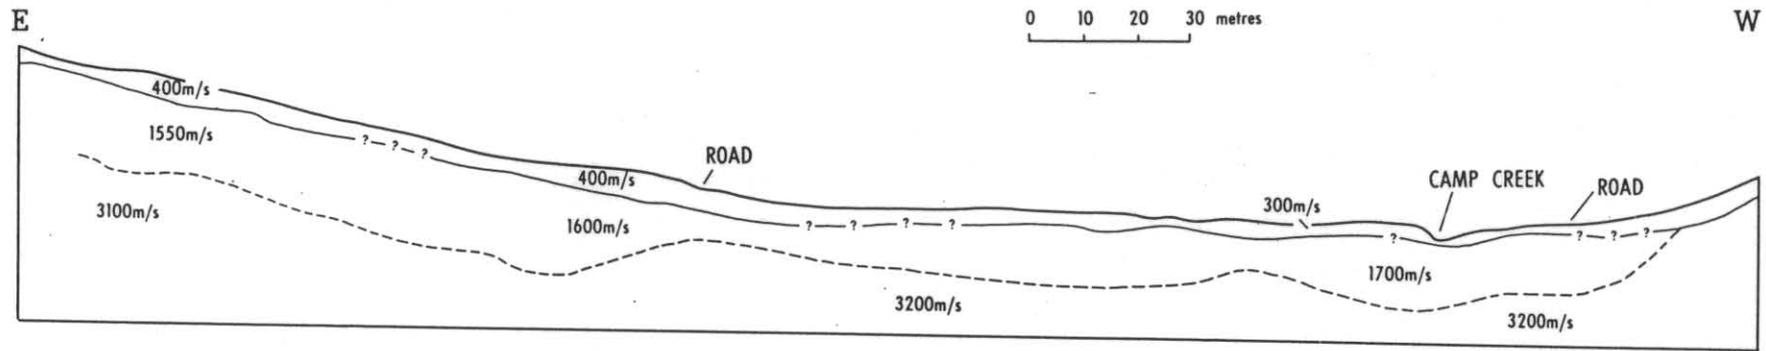
Figure 2

A seismic traverse was undertaken along the dam axis to gain an indication of the material underlying the site. Three main layers are present, the upper most has a seismic velocity of 300-400 m/s, the second has a velocity of 1550-1700 m/s while the deepest layer has a velocity of 3000-3200 m/s. The upper layer is interpreted as being soil and alluvium and the deepest layer relatively unweathered Carboniferous-Permian rock. The intermediate layer is most likely weathered Carboniferous-Permian rock but could be below water table alluvium, clay or a combination of all three. The thickness of the upper layer is about 2.5-4 m. The depth to the relatively unweathered rock was not precisely defined by the seismic survey but probably varies from about 7-20 m below the surface (fig. 2). The interface may be a little closer to the surface on the western side. A 5 m high tillite cliff occurs on the side of Camp Creek near the dam site. A narrow zone with a probable higher velocity occurs just west of the eastern road on the section. The seismic velocities are about 4000-4400 m/s which is high for the area and may represent a massive tillite bed.

The low points in the top of the highest velocity layer are probably due to deeper weathering of the underlying rock. This may be caused by differing lithology or possibly because of fracturing and weathering in fault zones.

A preliminary seismic survey indicates that the bedrock is overlain by up to 20 m of what is probably weathered rock, but which could also be clay or below water table alluvium, or a combination of all three. This material is overlain by 2.5-4 m of soil, alluvium and, on the hill slopes, talus.

*Stage 1.* A more detailed seismic survey is required to locate the relatively unweathered bedrock position more accurately. Sharp local variations may be important in locating possible fault zones. Backhoe holes could be dug along the axis of the dam and in the storage area to examine the nature of the alluvium. These should extend into the material with the intermediate seismic velocity and determine its nature wherever possible. A backhoe could be used to prospect for dam construction material and extensive tests should be undertaken to determine the suitability of this material. The suitability has added importance because of some housing development downstream from the dam.

*Stage 2.* If the above investigations indicate that the dam site is suitable, diamond drilling should be undertaken. This should be used to examine the material with the intermediate seismic velocity and should extend into the relatively unweathered bedrock. Permeability tests should be undertaken on these holes. The number and location of the holes would depend largely on the results of the first stage investigations.
