1977/24. Foundation investigation for proposed Davey Street telephone exchange, Hobart.

R.C. Donaldson

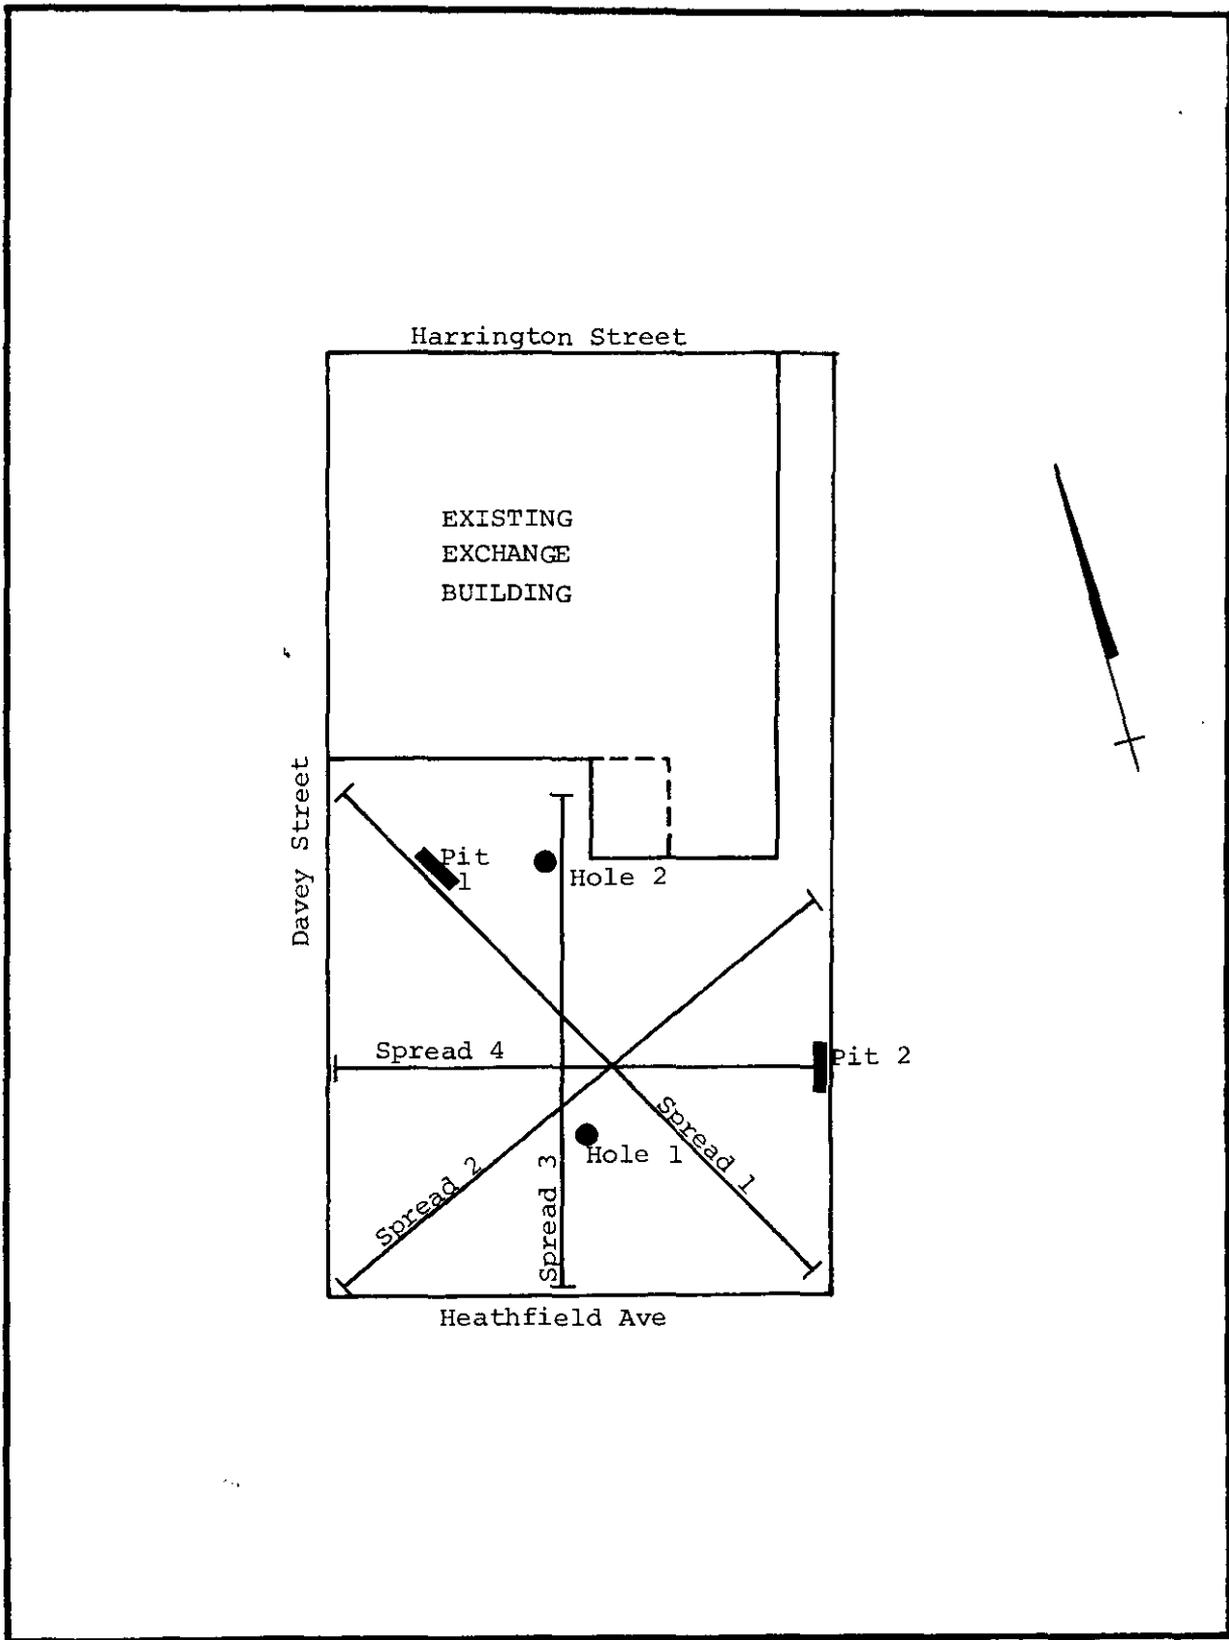
Figure 1. Drill hole, test pit, and seismic spread locations.

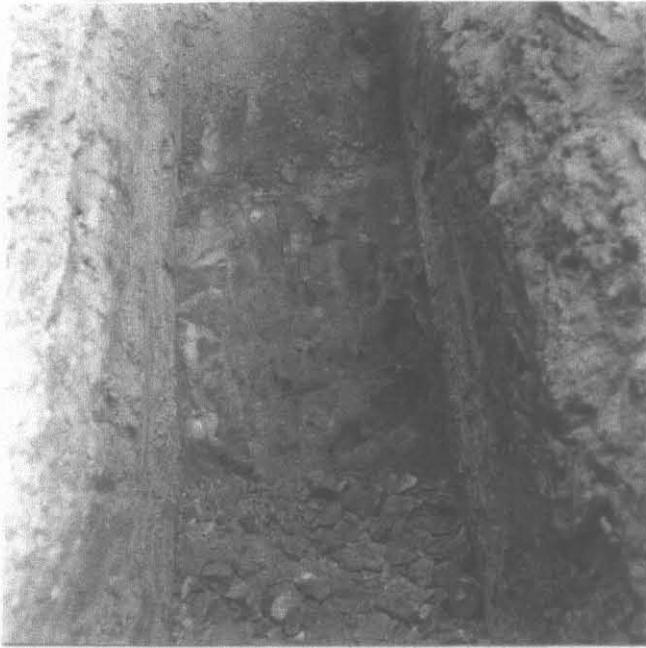
Plate 1. *Test pit 1 showing slightly weathered, closely jointed sandstone [CN5148].*

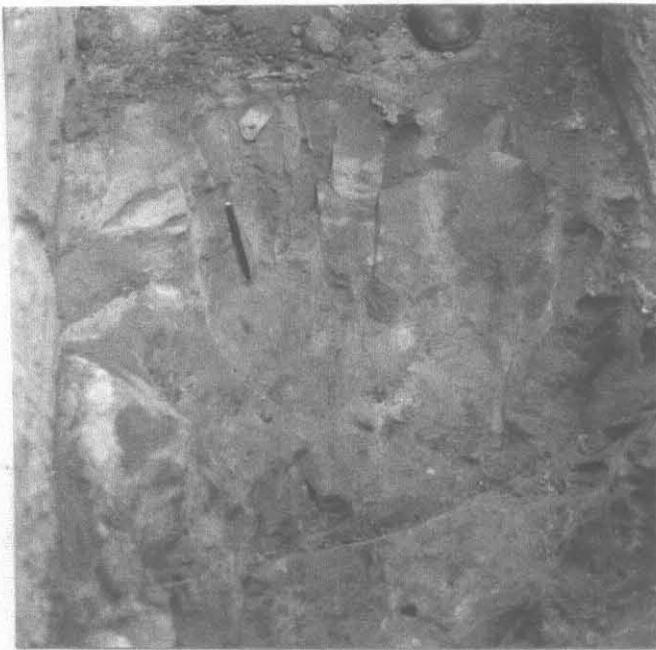
Plate 2. *Detail of jointing in Test Pit 1 [CN5144].*

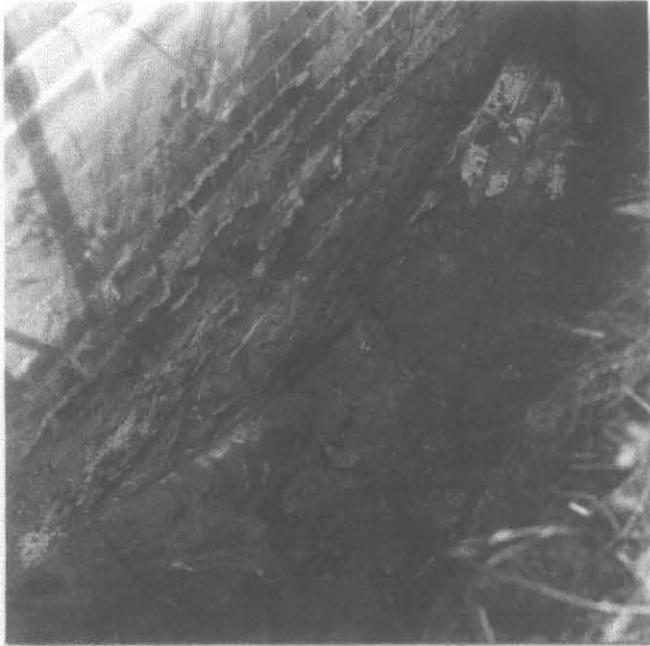
The second test pit had one metre of clay fill overlying a moderately to highly weathered sandstone bedrock. The rock was completely stained with iron oxide and signs of physical disintegration were evident. The back-hoe easily excavated the pit to 1.5 m. The sandstone was partially friable, to the extent that a hand shovel could be used to deepen the test pit. The nature and orientation of defects were similar to that encountered in Test Pit 1. The minor joints were tight but the joint spacing was less (ranging between 20-60 mm). The major defect plane (65°/150°) had the same general orientation and spacing (c. 400 mm apart) as the counterpart in Test Pit 1. However, the joints were open and filled with up to 30 mm of brown to black sandy clay.

Plate 3. *Test Pit 2 showing the moderately weathered nature of the bedrock. The pen points to a major joint plane infilled with clay [CN5146].*

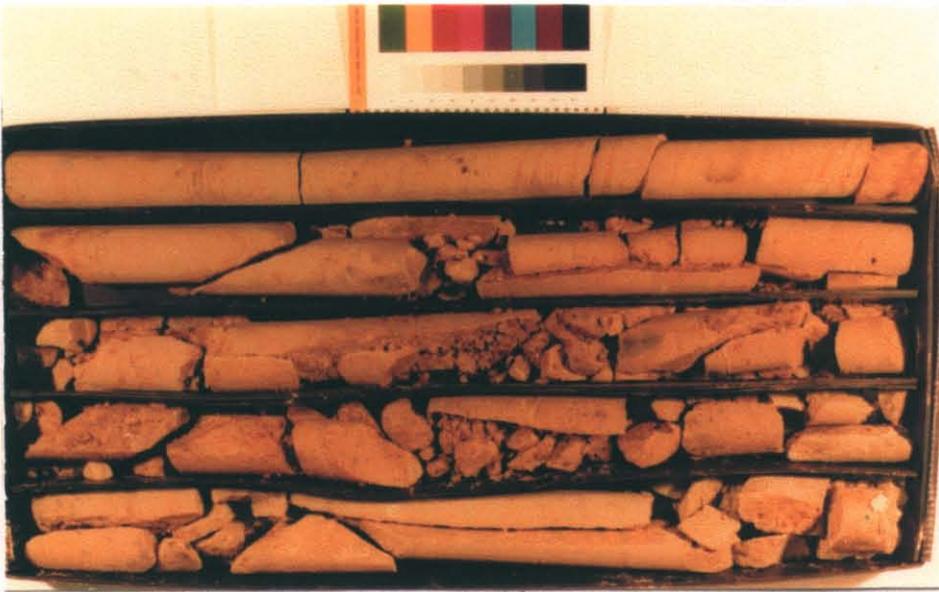
Plate 4. Core from Hole 1,
1.5-5.5 m [CN5051].

2.5-4.8	<i>SANDSTONE</i> : Moderately weathered, very closely jointed to highly fractured. Fe-oxide staining extends throughout the whole rock. Defect spacing is 60 mm or less. Jointing generally vertical to sub-vertical and sub-horizontal.

4.8-5.45	<i>SANDSTONE</i> : Fine- to medium-grained quartz sandstone intercalated with a coarser sandstone. Rock is slightly weathered and very closely jointed. Staining beyond joint surfaces is minimal. Joints essentially sub-vertical (0-15°), sub-horizontal (70-85°) and 30-40° to core axis.

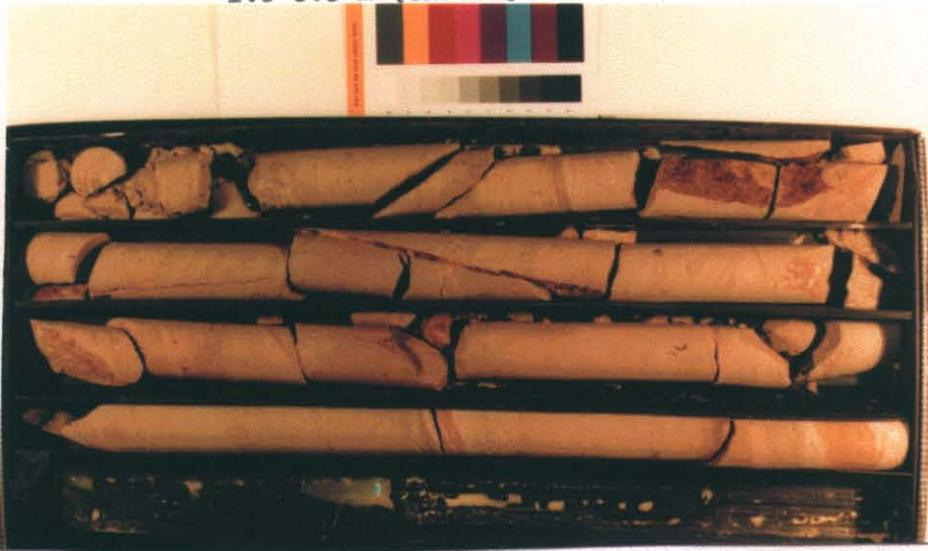
Plate 5. Core from Hole 1,
5.5-8.75 m [CN5052].

5.45-5.50	<i>CLAY</i> : Fawn gritty soft clay with fragments of extremely weathered sandstone dispersed throughout.
5.5-7.8	<i>SANDSTONE</i> : Slightly weathered and closely to very closely jointed.

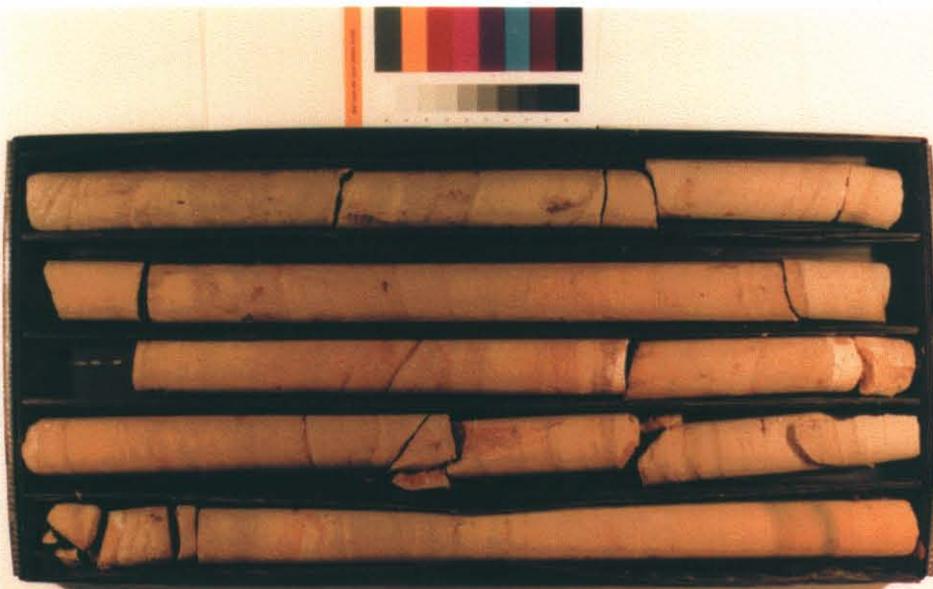
Plate 6. Core from Hole 1,
8.75-12.75 m [CN5053].

7.8-12.9	<i>SANDSTONE</i> : Slightly weathered to fresh. Defects are dominantly sub-horizontal to core axis and generally moderately widely spaced (200-600 mm). Jointing tends to be very close at 9.2-9.3 m and 12.3-12.4 m in particular. Slight Fe-oxide staining on joint surfaces although bulk of rock unaffected by weathering.

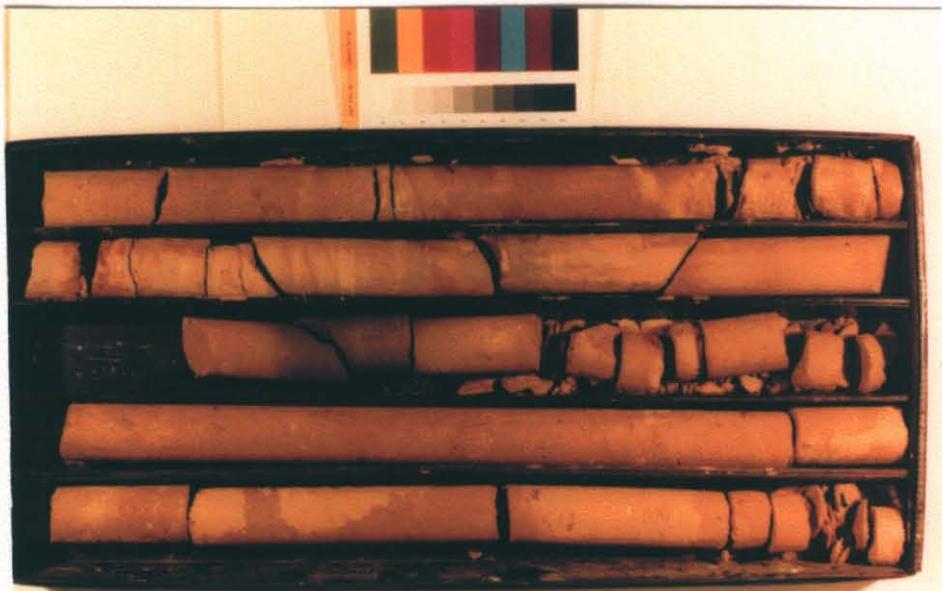
Plate 7. Core from Hole 1,
12.75-16.75 m [CN5054].

12.9-14.6	<i>SANDSTONE</i> : Moderately to highly weathered and closely jointed. Abrupt colour change to Fe-oxide brown. Joint planes either sub-horizontal or between 50-70° to core axis. <i>CLAY</i> seam at 13.6 m: 50 cm of fawn soft gritty clay followed by 150 cm of very closely jointed extremely weathered sandstone.

14.6-14.9	<i>SANDSTONE</i> : Moderately-highly weathered as above but fractured.
14.9-16.6	<i>SANDSTONE</i> : Moderately weathered bedrock exhibiting moderately widely spaced horizontal joints.

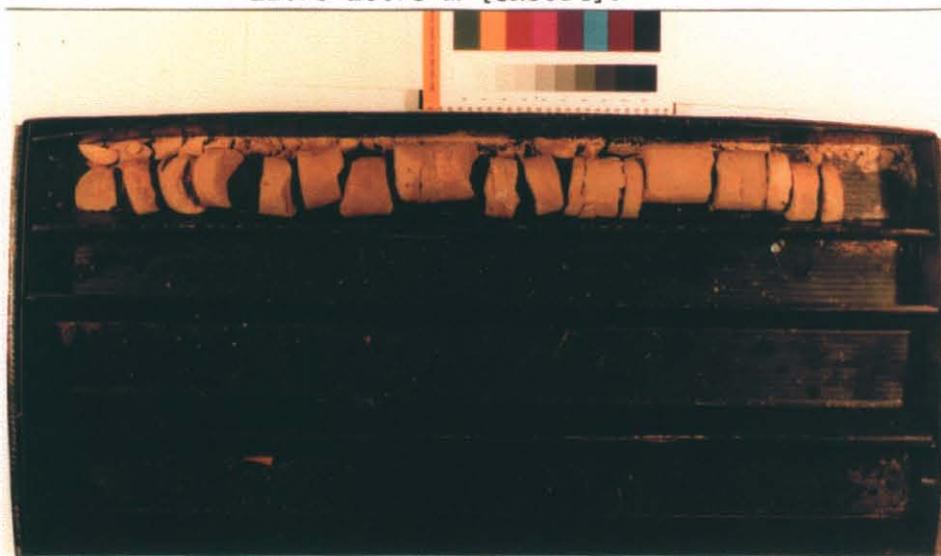
Plate 8. Core from Hole 1,
16.75-17.75 m [CN5055].

16.6-17.75	<i>SANDSTONE</i> : Moderately-highly weathered. Defect spacings generally at right angles to core axis with a frequency spacing of 20 mm or less.
	Hole terminated at 17.75 m.
