1977/30. Investigation of a proposed Marina site, Prince of Wales Bay.

*D.E. Leaman; W.R. Moore*

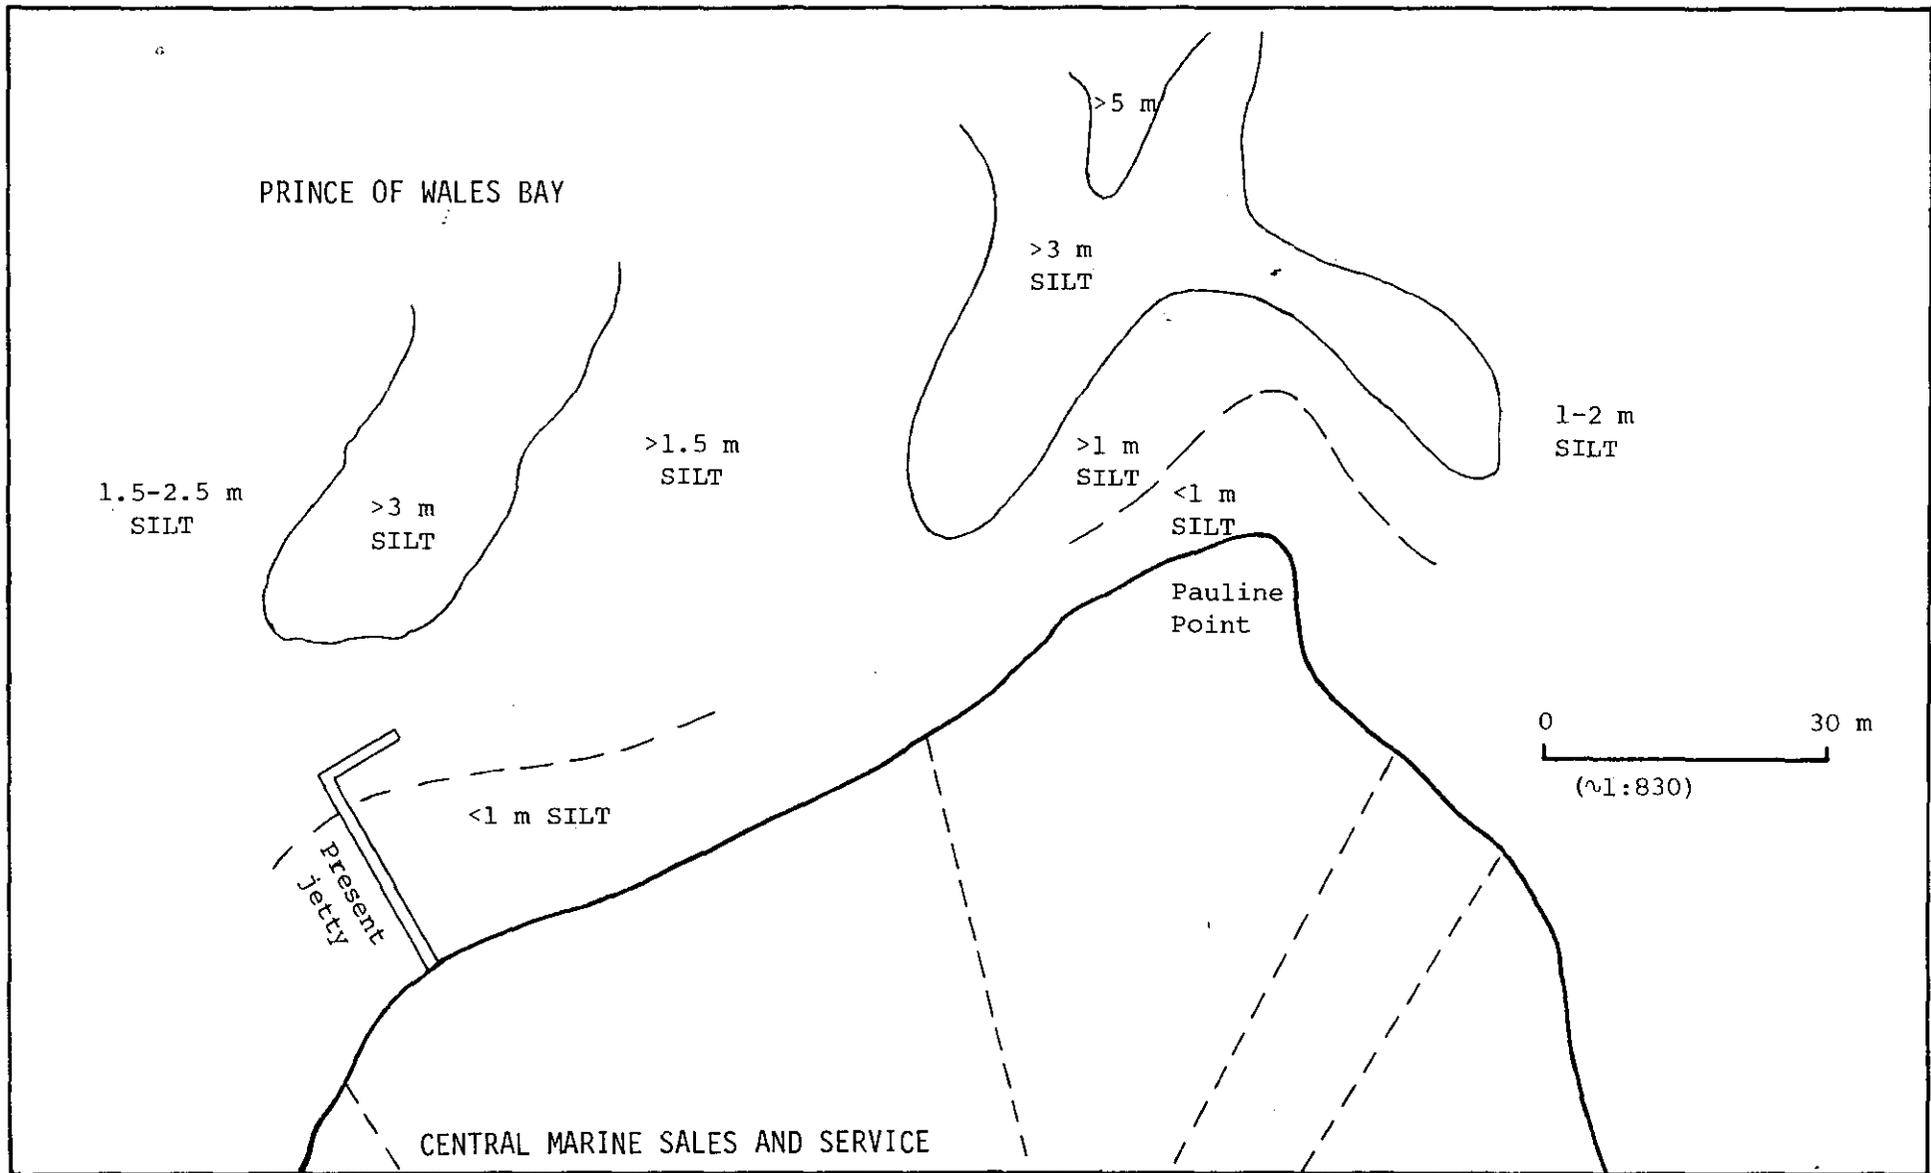
The time distance graphs obtained during the survey were irregular and stepped, indicating irregular water-bedrock or silt-bedrock interfaces. Since detailed bathymetry was not available and was not possible during the survey, only an approximate idea of the water-silt interface could be included in the interpretation.

The velocities determined for the materials present were 1500 m/s for water and 3000-3500 m/s for basalt. The silt velocity was not measured during the survey due to thinness and low velocity ( $\sim 1000$  m/s) but it has been deduced from interpretation exaggerations and Dowsings Point data. No intermediate velocities were observed. Figure 1 presents an interpretation of silt thickness over the area inspected. The depth of water must be added. This varies from an average of 1.5 m in the west to more than 3.25 m in the east. The water is shallow off Pauline Point. The thicknesses presented in Figure 1 should be considered as approximate only, as detailed water depth corrections could not be included. Pockets with thicker deposits are indicated.

The basalt velocity recorded indicates that the rock is quite massive although somewhat weathered. It will not accept driven piles unless these are tipped and the rock shattered before driving. The thickness of silt is not very great and would nowhere support piles. It would seem that a rigid structure including solid piles resting on rock and with a well distributed load factor is required.

Figure 1. Provisional results, seismic survey, Prince of Wales Bay.
