1977/35. House damage in the Taroom area.

C.J. Knights

Expansive clay, combined with change of moisture content and inadequate foundations is the major cause of house damage in the area studied. Less commonly, damage may be caused by dispersion and settlement of the clays, by consolidation of peaty layers, or through landslip.

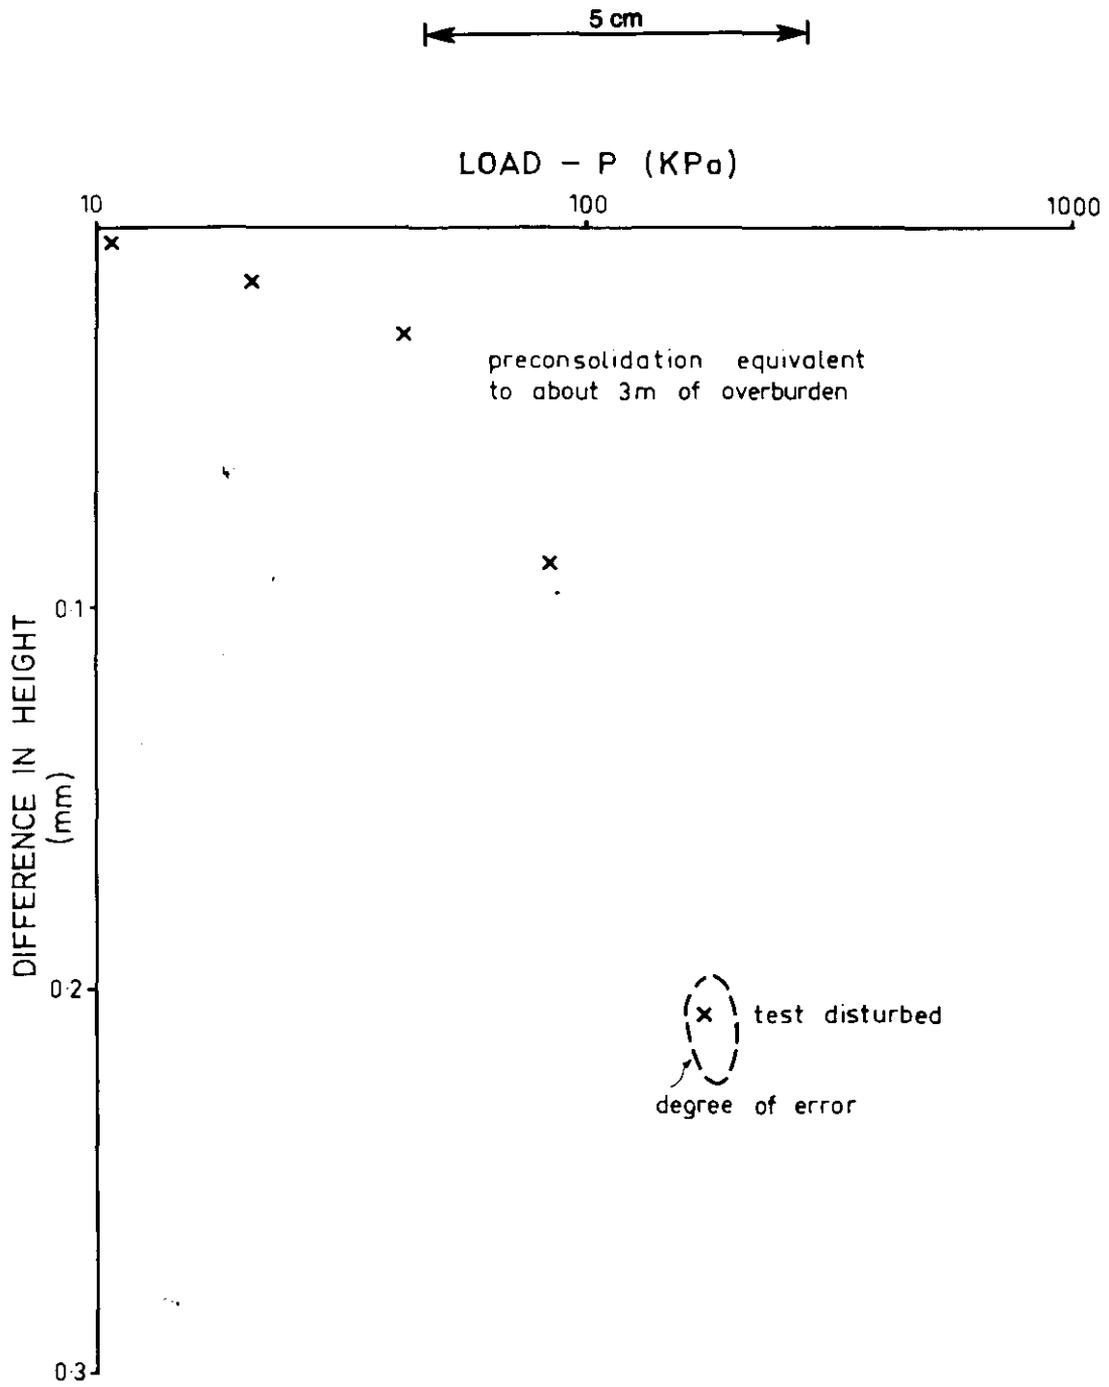
Figure 2. Consolidation test on a sample of brown clay from 14 Norwood Avenue, Taroom. Sample from hole P8, depth 0.85 m.

The graph (fig. 2) shows that this clay is normally consolidated, with a small preconsolidation equivalent to about 3 m of overburden.  $m_v = 0.435 \times 10^{-3}$  (kPa). Therefore a double brick dwelling with 0.5 m wide foundations is unlikely to settle more than 4 mm.

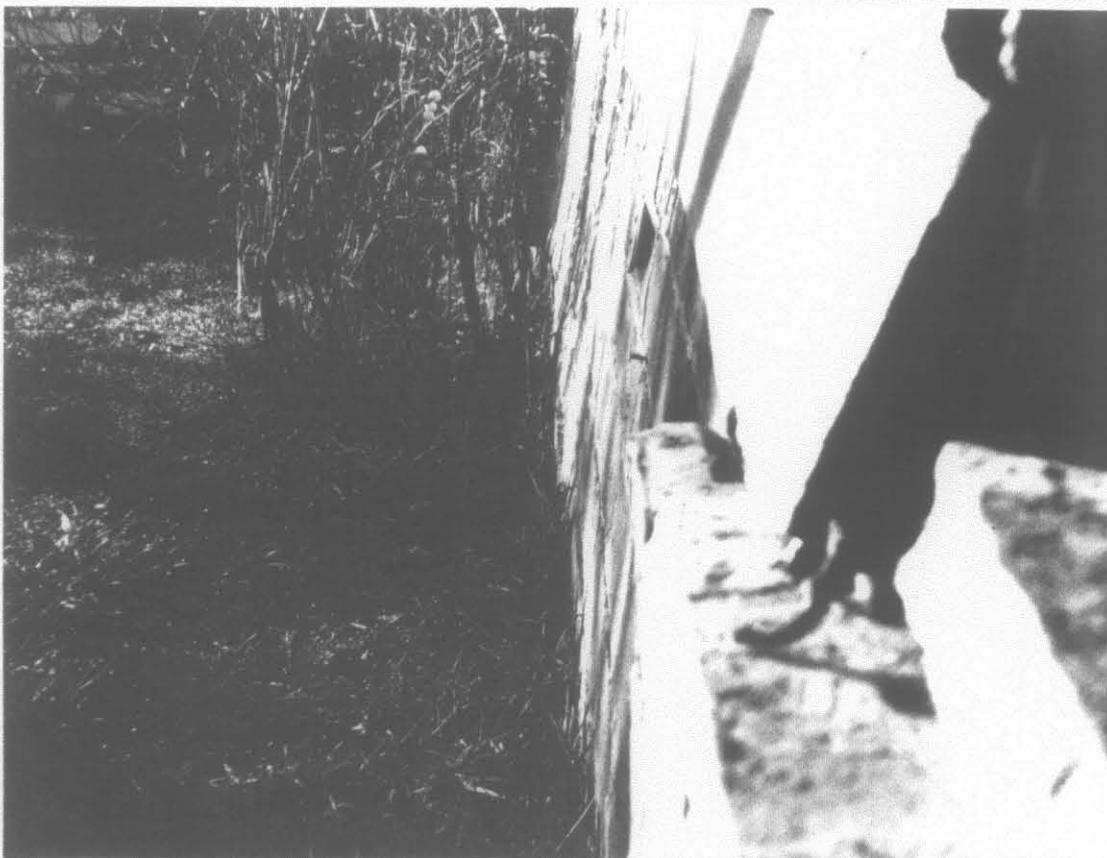
This weatherboard house has single brick foundation walls one metre high, founded on moist, black peaty clay ( $m = 38-44\%$ ). Serious damage commenced in 1973 and is restricted to the northern half of the house. It appears that the footings beneath the northern wall have been pulled outwards, away from the house, so that the foundation wall leans in towards the weatherboard above it (plate 1). On the east side of the north-east corner there is a hatchway leading under the house. Here the footings have an open crack several centimetres wide, and the top of the hatch is pulled apart by about 30 mm (plate 2), again suggesting that the northern foundations are being pulled away (fig. 3). Excavation of the corner footings show them to be 46 cm deep and 46 cm wide at the top, narrowing downwards. The internal piers tilt towards the damaged wall.

Plate 1. 15 Meath Avenue. View of northern wall. Footings have moved outward, causing wall to lean.

the foundation has been laterally moved outwards. In the front garden there is a large willow tree with roots extending to the house footings. Roots from this tree form a mat which interacts with the clay so that in summer suction by the roots causes dessication, but also the interwoven roots allow the whole front wall to be moved.

Apart from the action of the tree, the footings are insufficiently deep for an expansive clay area.

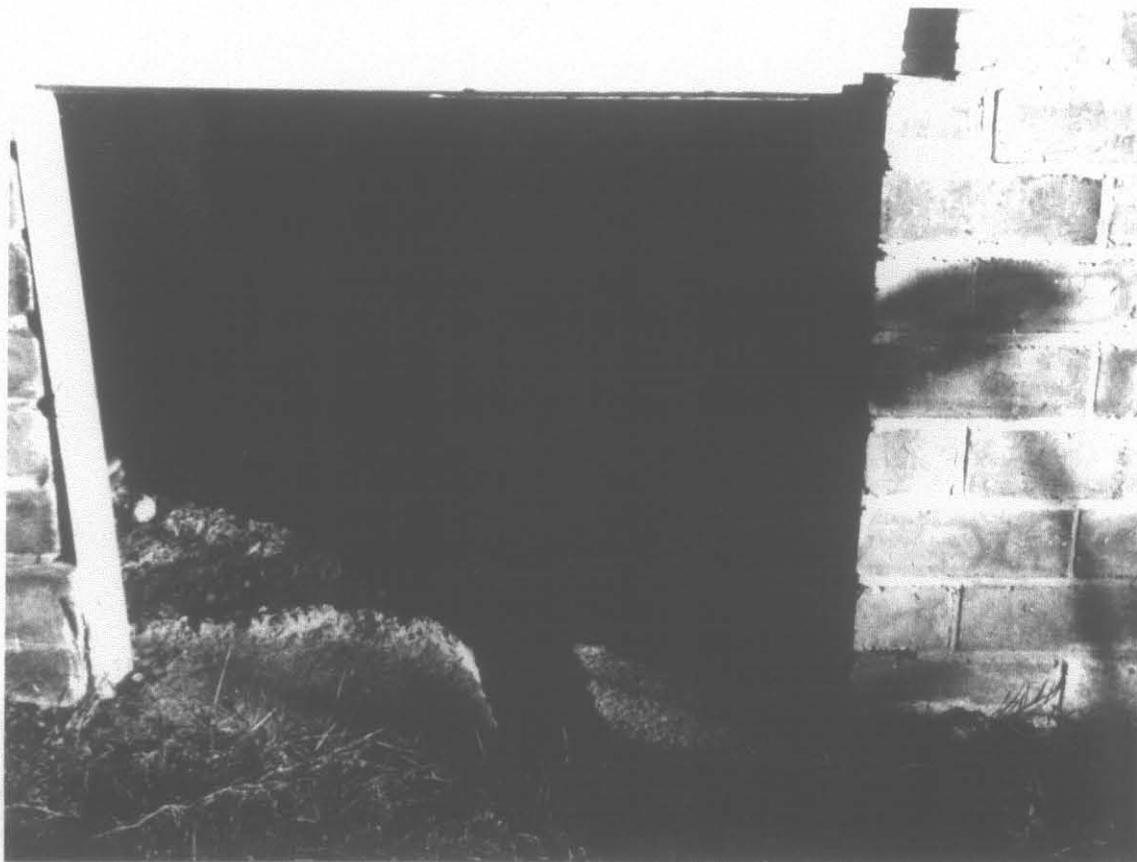
Plate 2. 15 Meath Avenue. View of hatchway in eastern wall. Note tension crack in footing and separation of hatchway frame from brickwork.

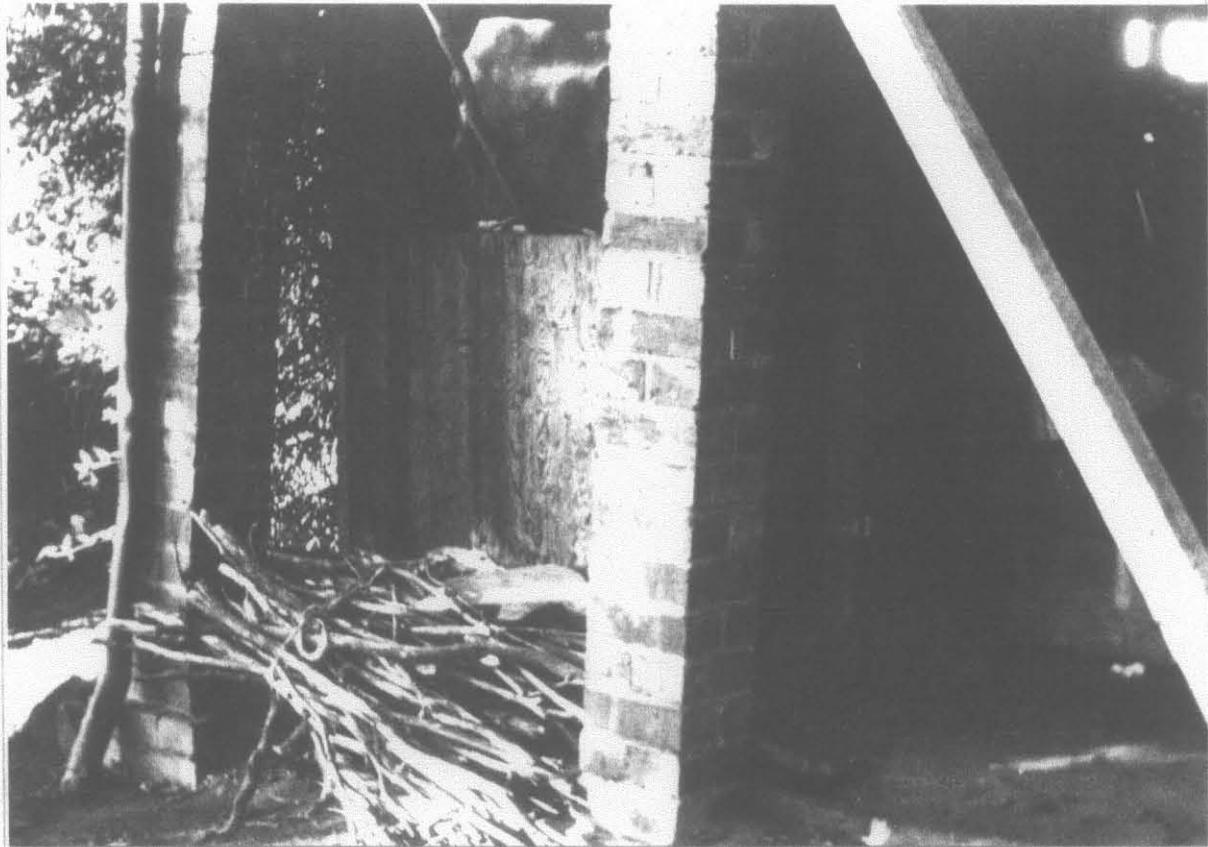
Most of the damage is caused by movement of the pillars supporting the extension. The main building is structurally sound. The pillars which are about 3 m high, appear to have moved down the slight incline away from the house so that they tilt inwards towards the extension (plate 3), they also have a sideways lean. Most movement is in the pillars furthest away from the main building (fig. 4).

Ground beneath the extension is open to the changing elements. In winter it becomes damp and swells, in summer the sun can dry the ground out so that it shrinks. These seasonal alternations cause the pillars to rise and fall and there is also a downslope creep so that the pillars become damaged and tilted.

Plate 3. 4 Belhaven Avenue. Supporting pillars beneath north end of extension have a strong lean due to stress imposed by seasonal heave and shrinkage of underlying clay.

If a concrete slab is laid to cover the ground and for one metre outside the extension, then seasonal moisture variations will be subdued. Such a slab is likely to lead to a long term moisture increase beneath it which will produce lifting of the pillars. This lifting will take place over several years and may be allowed for by using removable wedges.

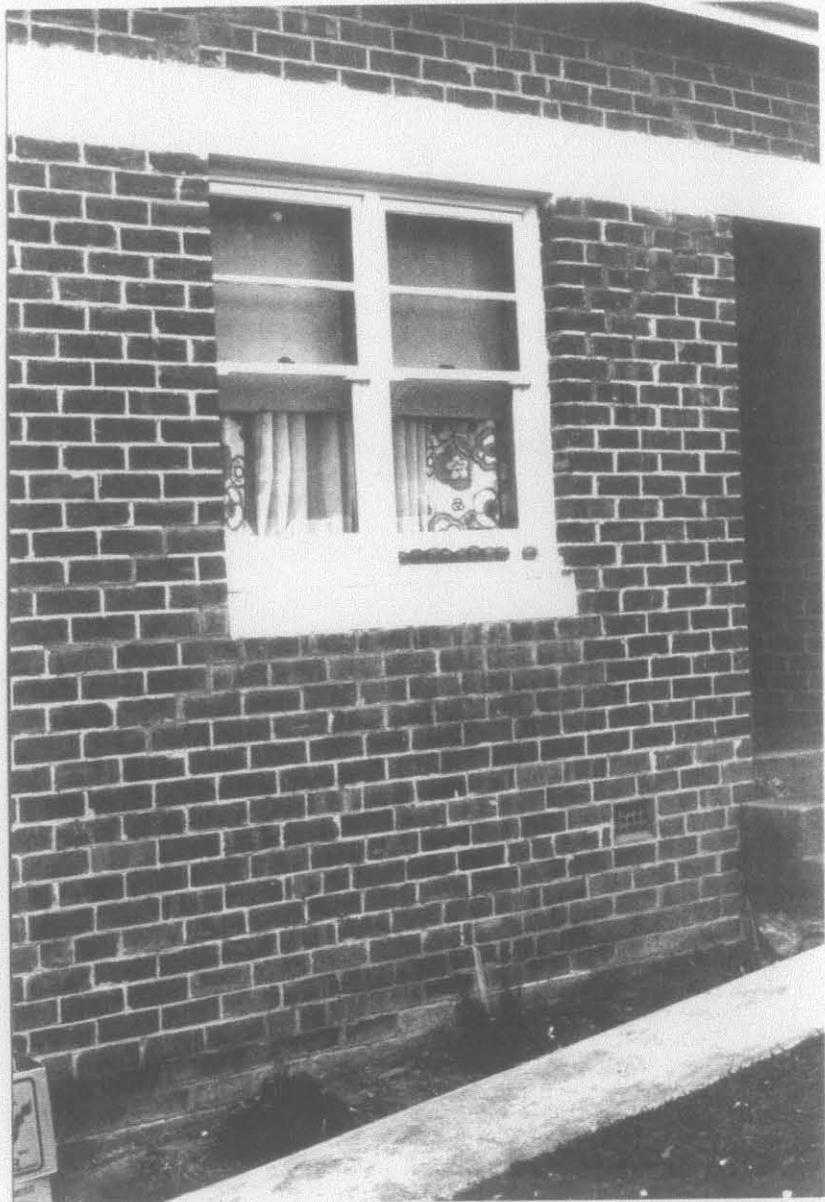
- (2) It is inadvisable to grow shrubs next to a house, particularly on the north, west and east sides.
- (3) Recessed gardens adjacent to house walls trap water in winter and promote transpiration in summer, thus causing damage (plate 4).

Plate 4. Cracked wall and recessed garden. Recessed gardens encourage seasonal moisture variations below footings.

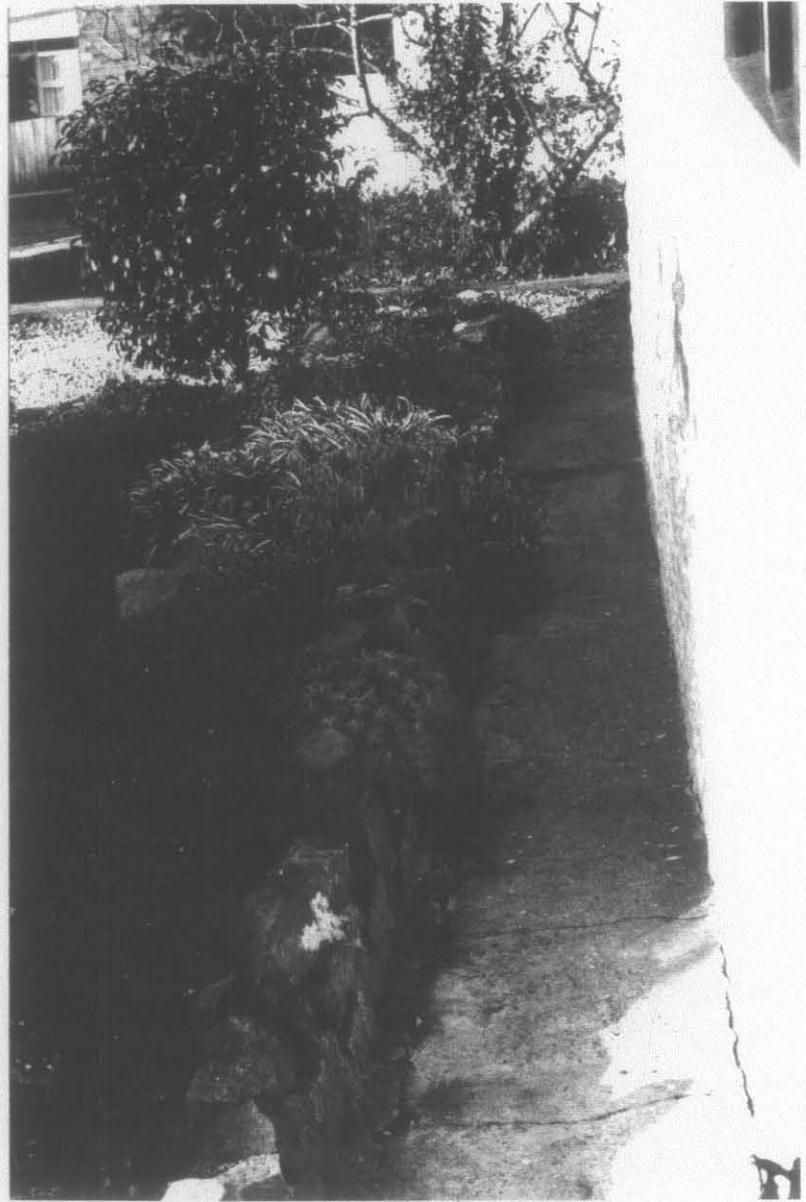
Plate 5. Concrete apron around house reduces seasonal moisture variations below footings.

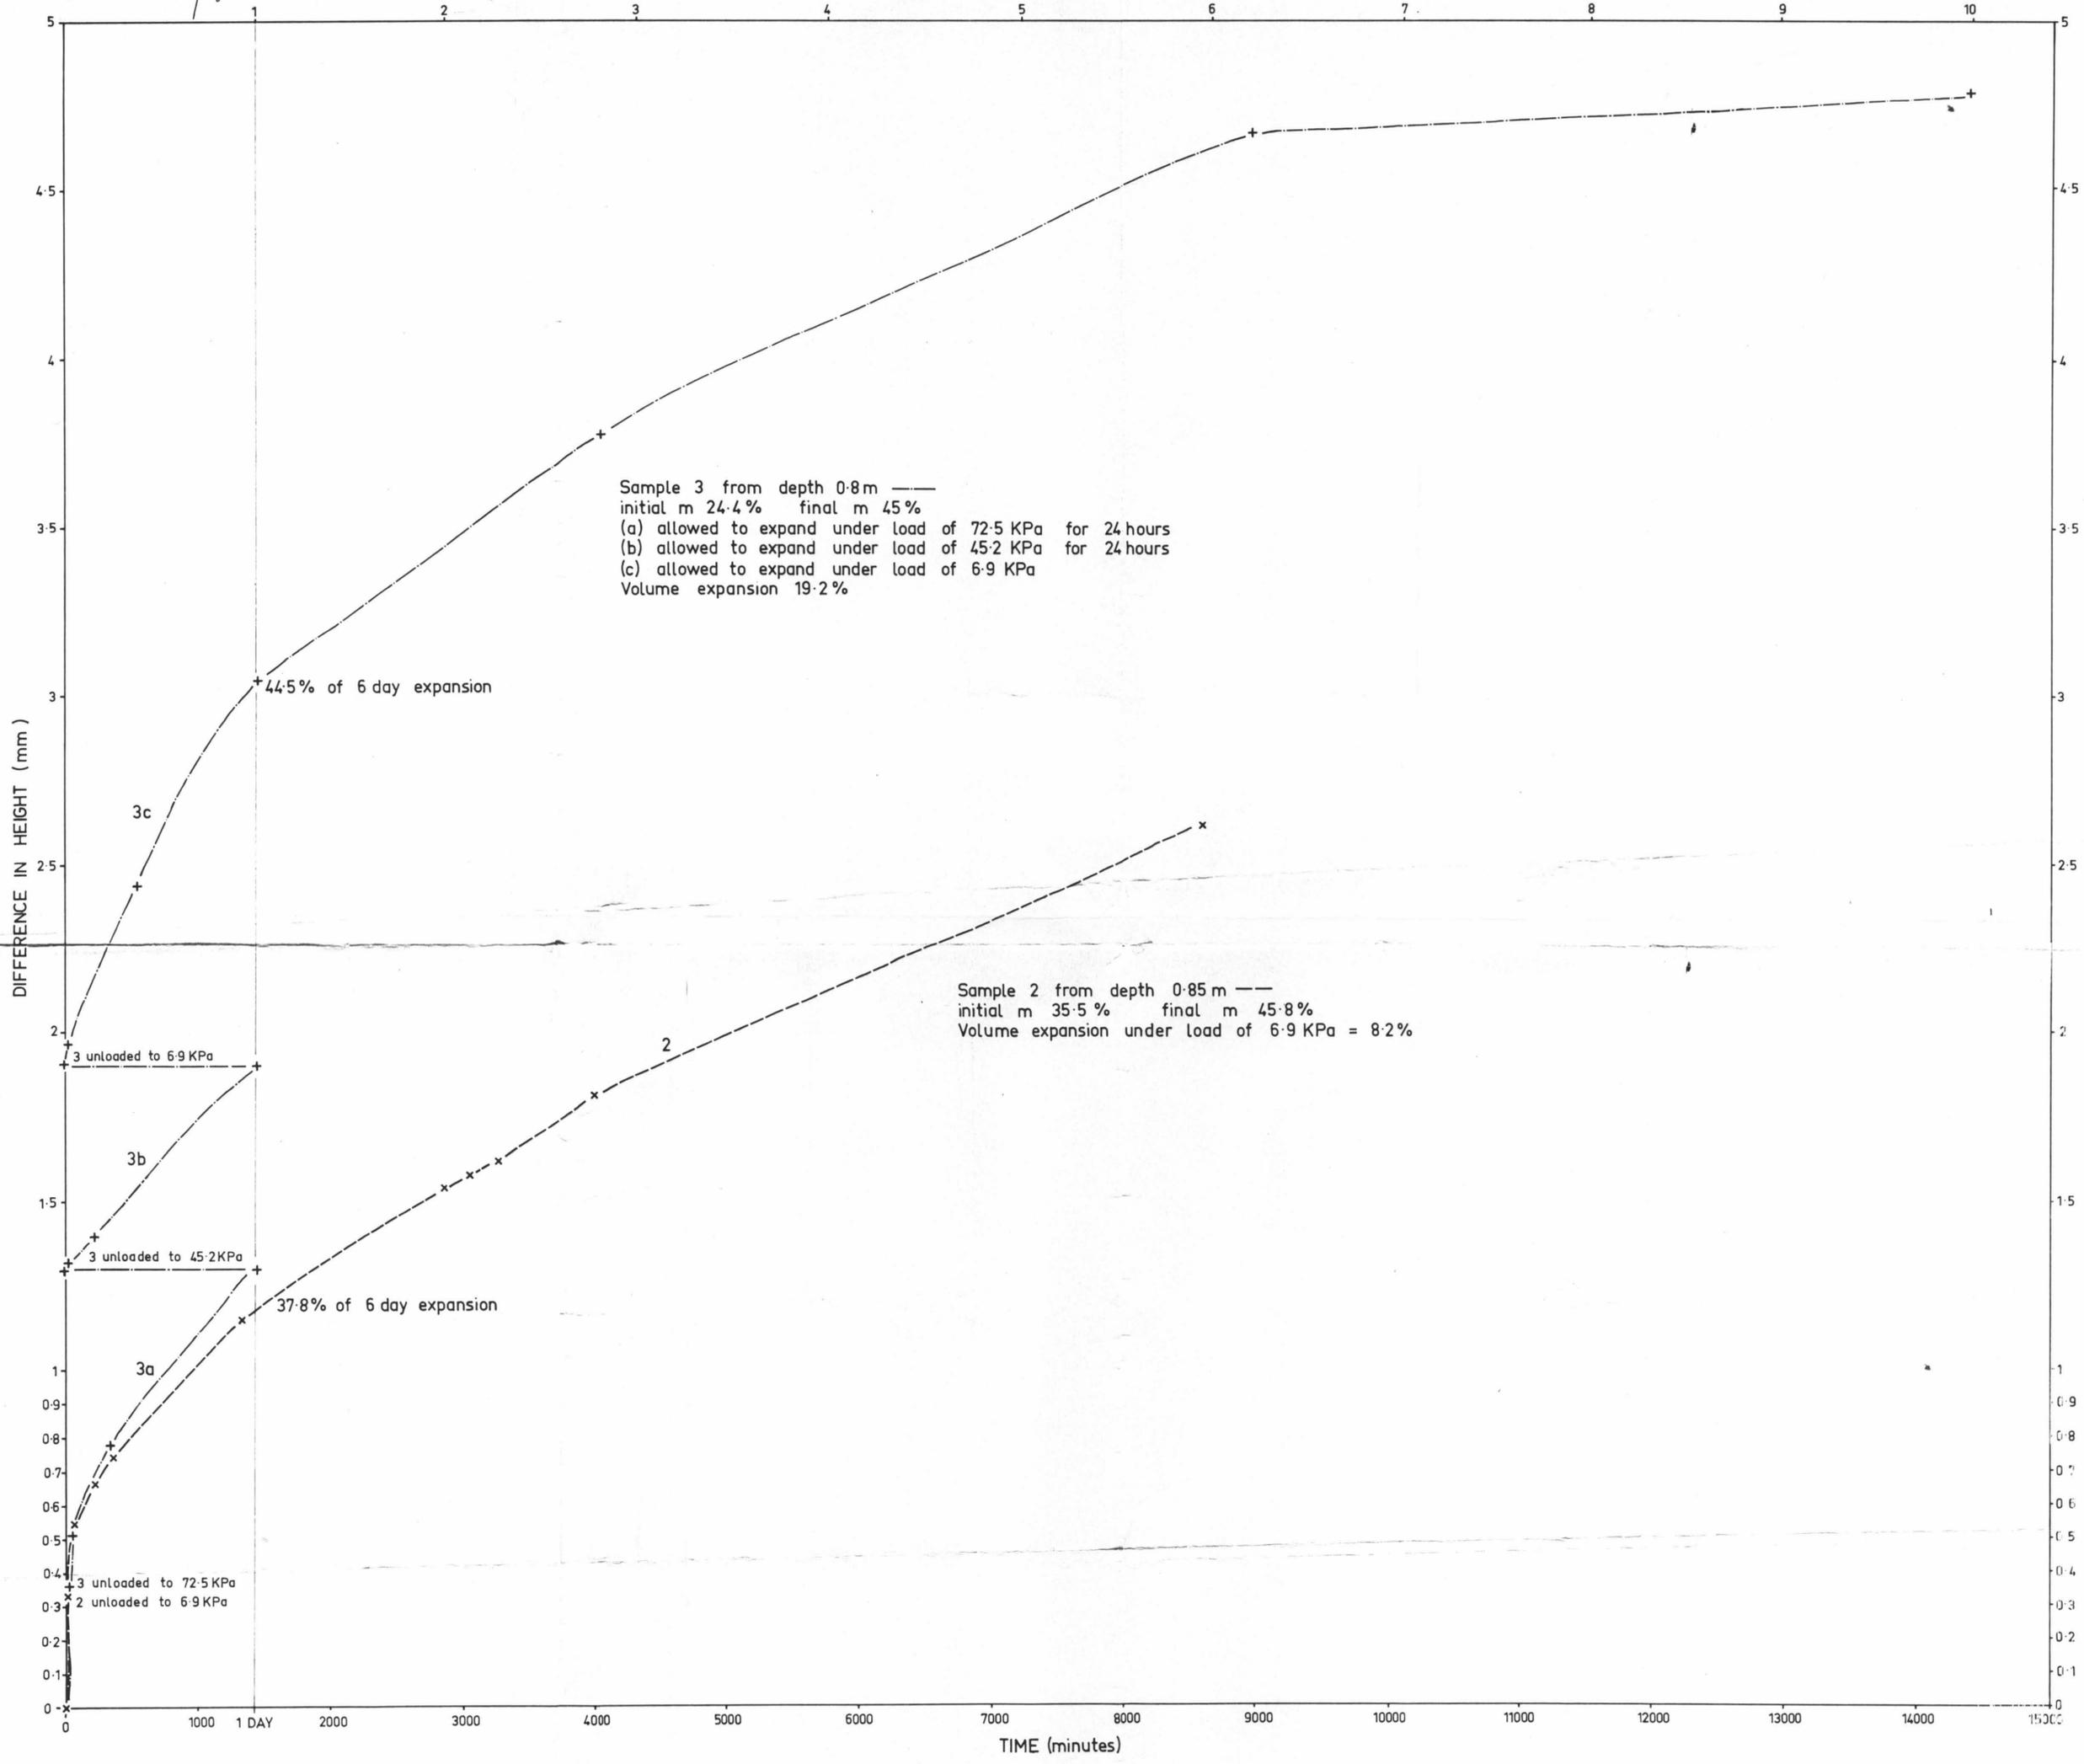
VOLUME EXPANSION OF CLAYS FROM TAROOONA  
Figure 1

An expansion pressure test was started, then abandoned at a load of 138 kPa. Whilst under this load the sample expanded by 0.3 mm before it was unloaded. The sample was unloaded and allowed to swell for 6 days (fig. 1).

Sample 3 (undisturbed, air dried) from a depth of 800 mm was loaded during the expansion pressure test to 255.5 kPa, it expanded by 0.32 mm before it was unloaded. The test was undertaken in three stages (fig. 1).

- (a) Unloaded at  $t = 0$  to a load of 72.5 kPa and allowed to swell for 24 hours. The expansion was 3.8%.
- (b) Unloaded to 45.2 kPa and allowed to swell for 24 hours. The expansion was 2.4%.
- (c) Unloaded to 6.9 kPa and allowed to swell. After 24 hours the expansion was 4.6%.
