1977/36. Road foundation failures, Channel Highway, Tarooma.

Abstract

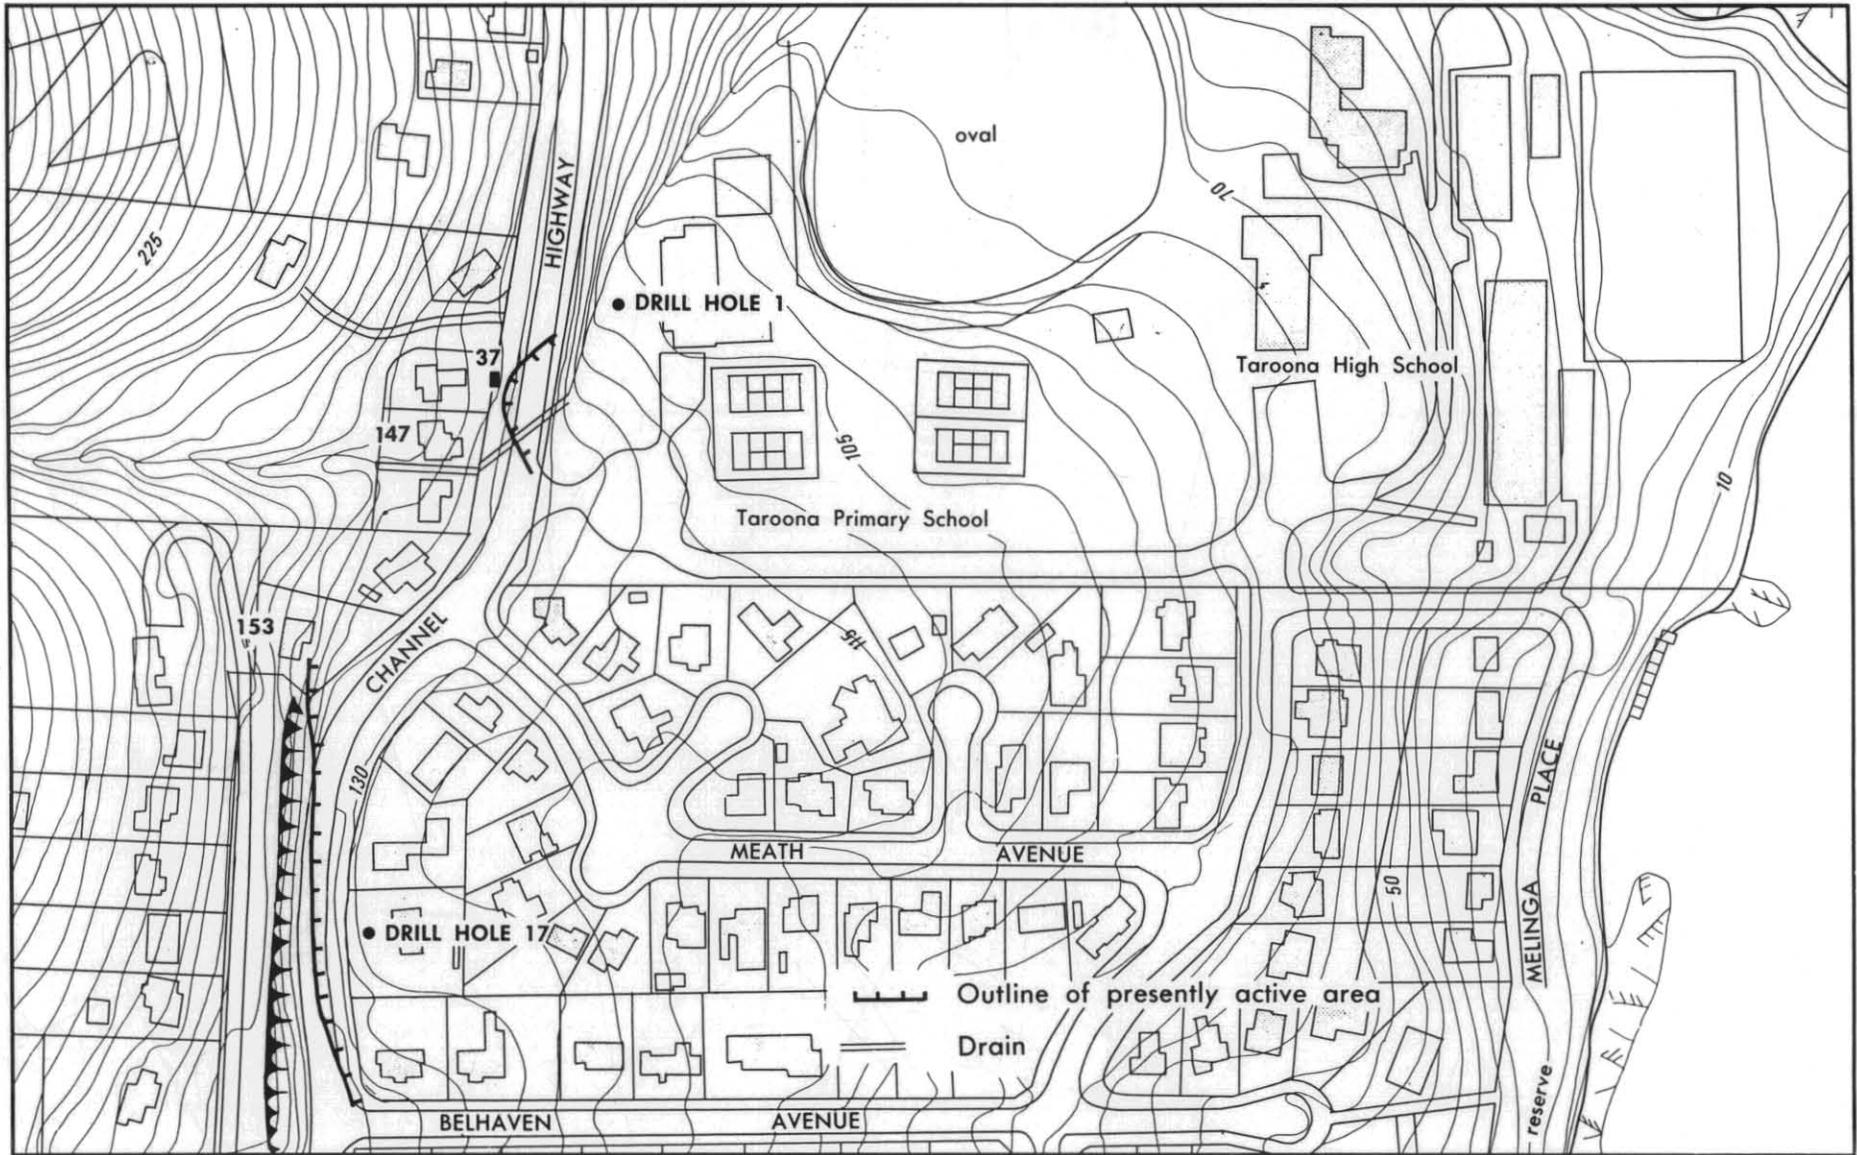
For the purpose of this report, it is convenient to consider the road movement between the Tarooma High School and Belhaven Avenue as two separate failures: the Bus Stop 37 road failure and the Belhaven/Meath Avenue road failure (fig. 1).

Figure 1. Location of active areas.

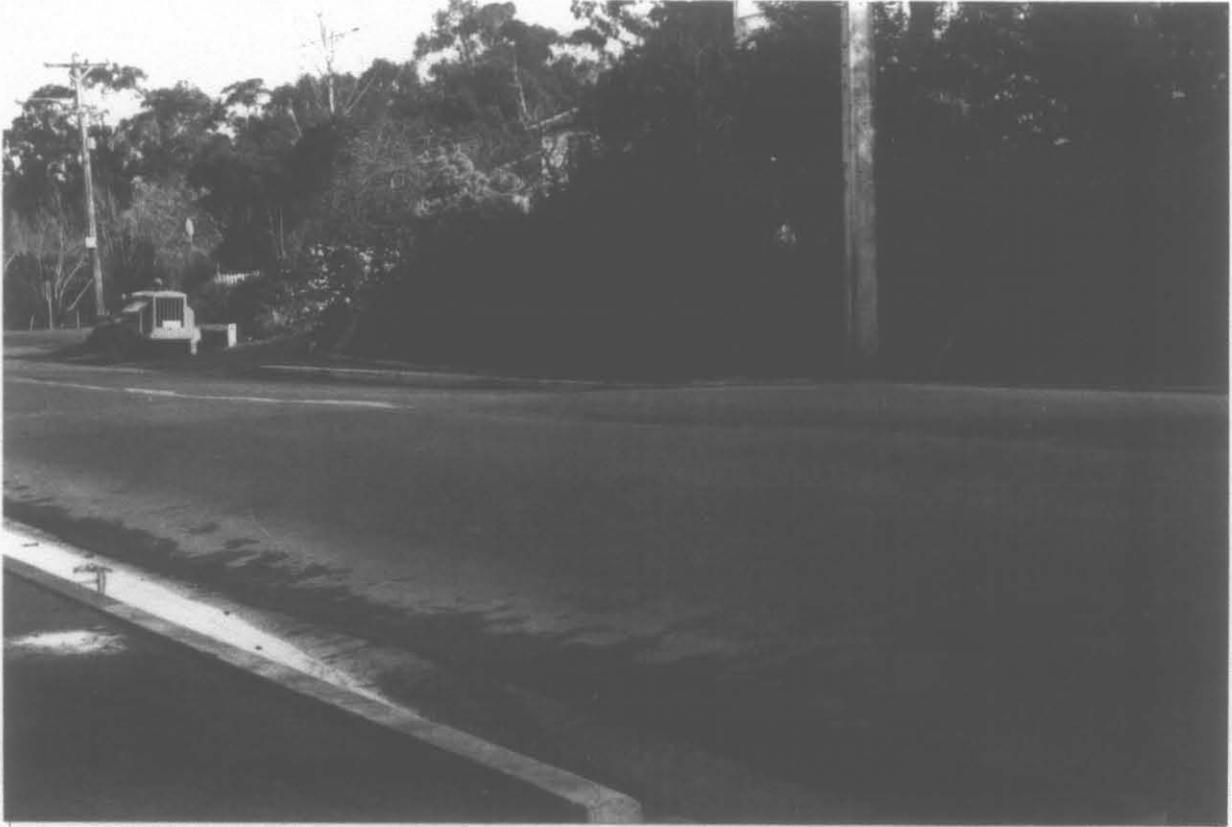
Severe cracking, disintegration and settlement of the road pavement is evident along a 60 m section of the highway. In plan, the failure has a semi-circular form; defects are highlighted by the repairs to the surface treatment. An indication as to the order of magnitude of vertical deformation that has occurred is observed in the downward curvature of the curbing on the upslope side of the road (plate 1). Relative settlement of up to 200 mm is evident.

Plate 1. *Settlement of road pavement, Bus Stop 37, Channel Highway.*

In summary, the major factor contributing to the Bus Stop 37 road failure, is the drainage system. Failure is considered to be due largely to a decrease in soil strength associated with an increase in moisture beneath the pavement.

An effective road drainage system is required to deal with both surface runoff and subsoil water. Existing drains should be repaired where damaged and checked regularly.

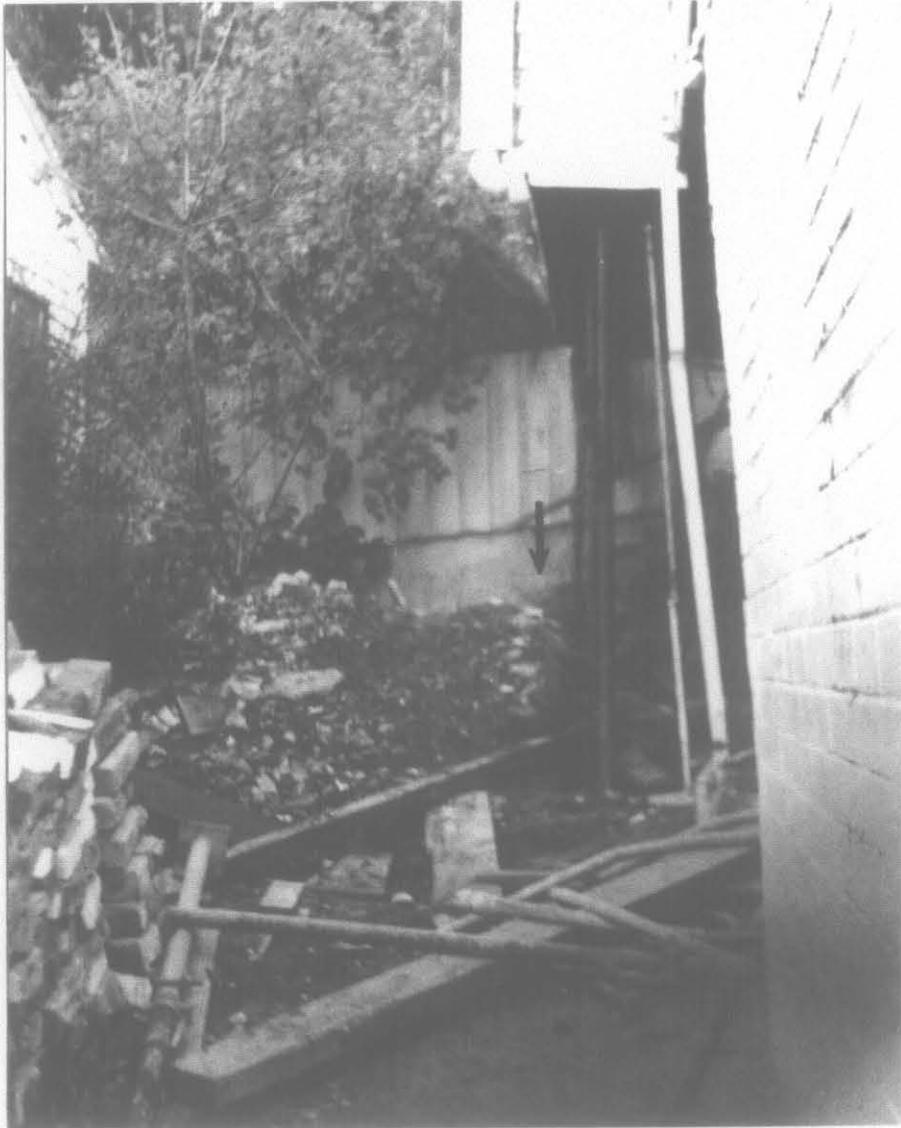
This house has a long history of movement, resulting in considerable cost to the owner for the remedial works carried out. The most extensively damaged section is along the southern side and in particular towards the south-west corner. Several years ago, pier foundations were used to support this side of the house, presumably in an attempt to isolate the building and substructure from differential seasonal movements associated with moisture changes in the expansive clay subsoil. This programme proved unsuccessful.

More recently (June 1977) two additional piers were added, involving excavation by pick and shovel to between 4.0 and 5.0 m in depth. This revealed 1.0-1.5 m of expansive brown/black clay overlying a light green/brown clay containing dolerite boulders in various stages of weathering. These clays are derived from the dolerite and Permian rocks which crop out upslope. Excavation, especially at lower depths, was hampered by the excessive inflow of water into the partially dug holes; a pump was necessary to keep water down to a satisfactory level for working. Water was entering through fissures at a rate of 3-4 l/min. The source for this water was found to be associated with the concrete drain carrying water from the creek which flows down from the steep slopes behind the block (fig. 1). This water subsequently crosses the highway at Bus Stop 37. The section of drain running across the block and the foundations of the dwelling on the southern side virtually coincide (plate 2). The drain has been constructed at a relatively shallow depth and has cracked extensively as a result of seasonal soil movements (plate 3). This has allowed water to penetrate under the house foundations which has subsequently lead to failure.

Plate 2. Foundations of house at 147 Channel Highway, with drain location arrowed.

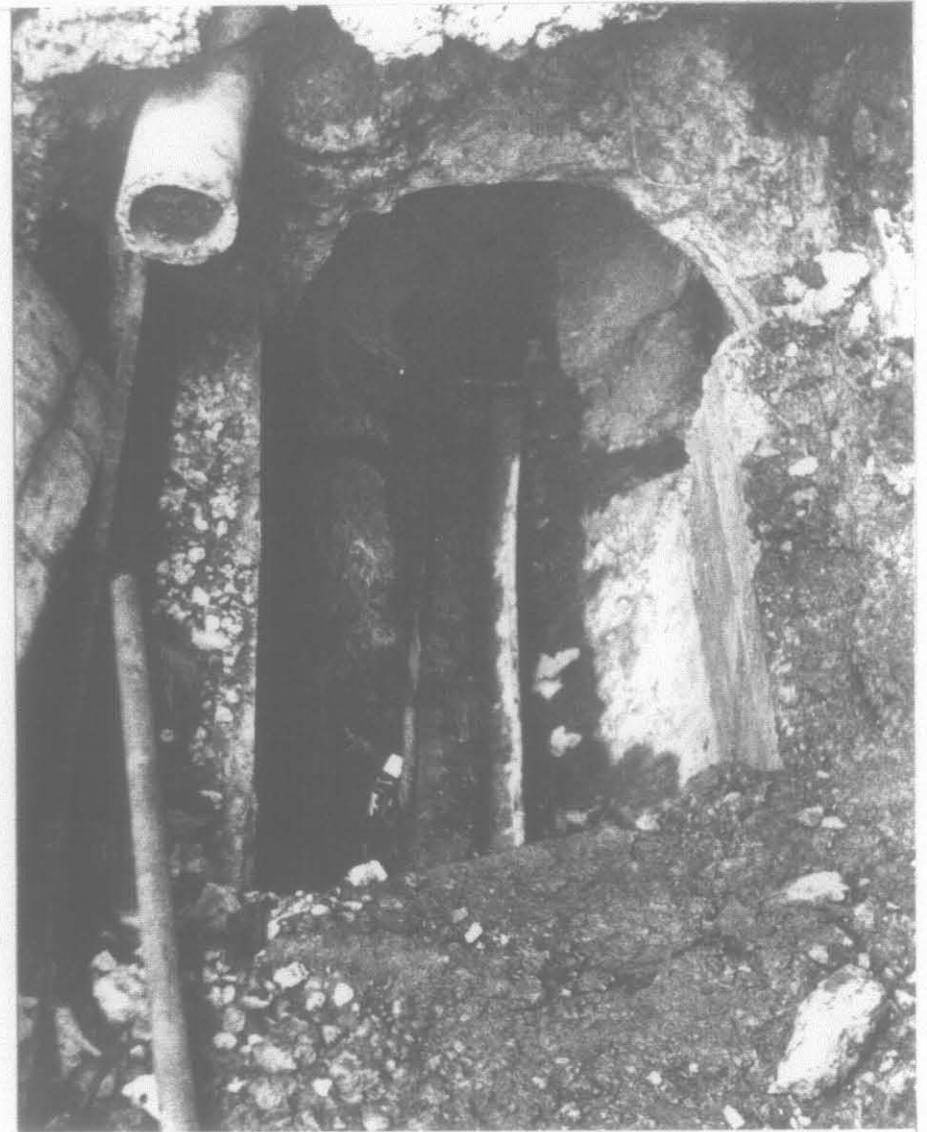
It is pertinent to note that the inflow of water into the excavation ceased within minutes of temporarily plugging the major cracks in the drain with clay. This suggests a well developed deep fissure system. The ground is in a state of tension, having the potential to create a landslip situation.

Plate 3. Fractured drain at 147 Channel Highway.

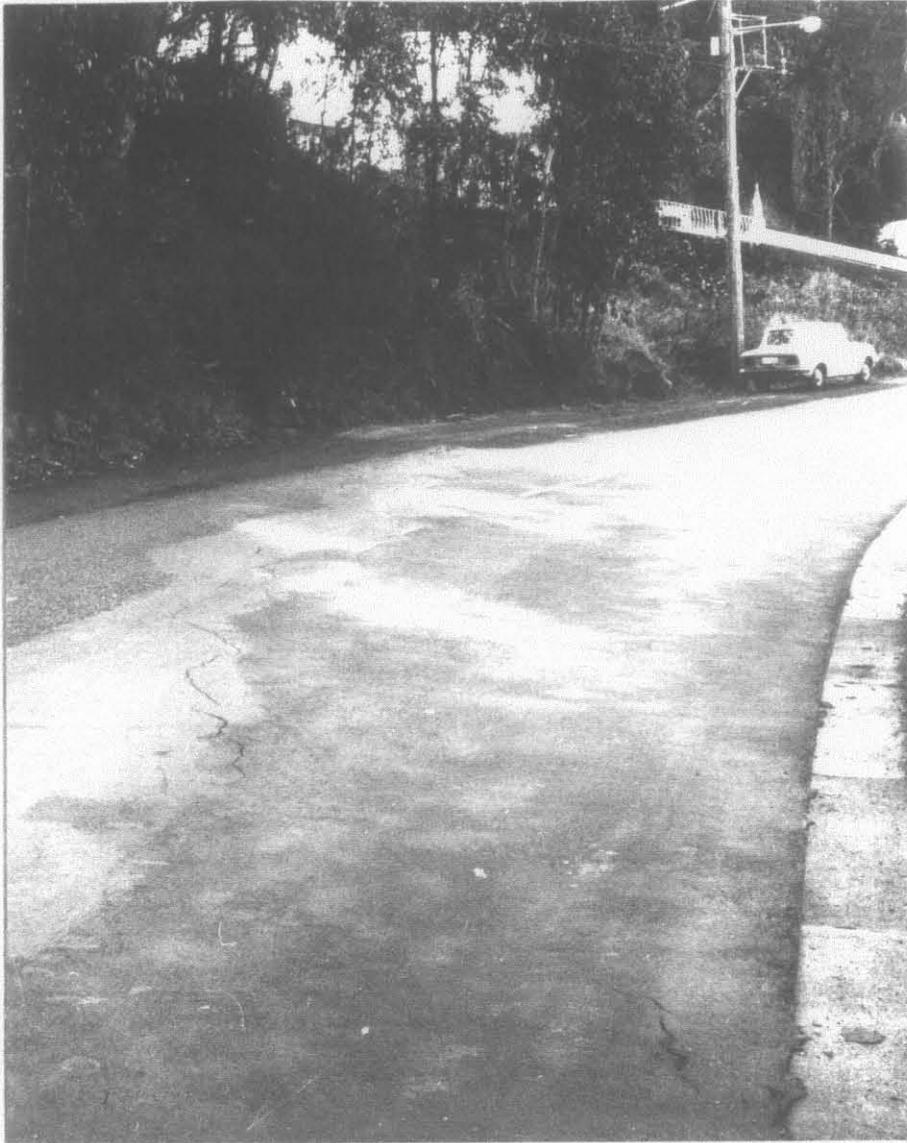
Movement in the road foundations along this section of the highway is shown by a series of longitudinal cracks developed in the surface treatment (plate 4). These cracks are the result of a lateral movement in the embankment and, or, subgrade. Widths of up to 5 mm were noted, amounting to a total lateral movement in the vicinity of 35-40 mm across the width of the road. Significant vertical movement has occurred, as is shown by the

Whilst it is not clear which mechanism initiated failure, it is apparent that movement is being accelerated by the ingress of water through unsealed cracks in the road surface and from the seepage of water into the subgrade from the higher ground adjacent to the road. The existing spoon drain is in a general state of disrepair, channeling surface runoff water directly into the slip zone. The bottom side of the highway is ill-drained; the row of poplar trees are possibly accentuating seasonal moisture changes in the subgrade beneath the embankment.

Plate 4. *Longitudinal cracks developed in road surface.*

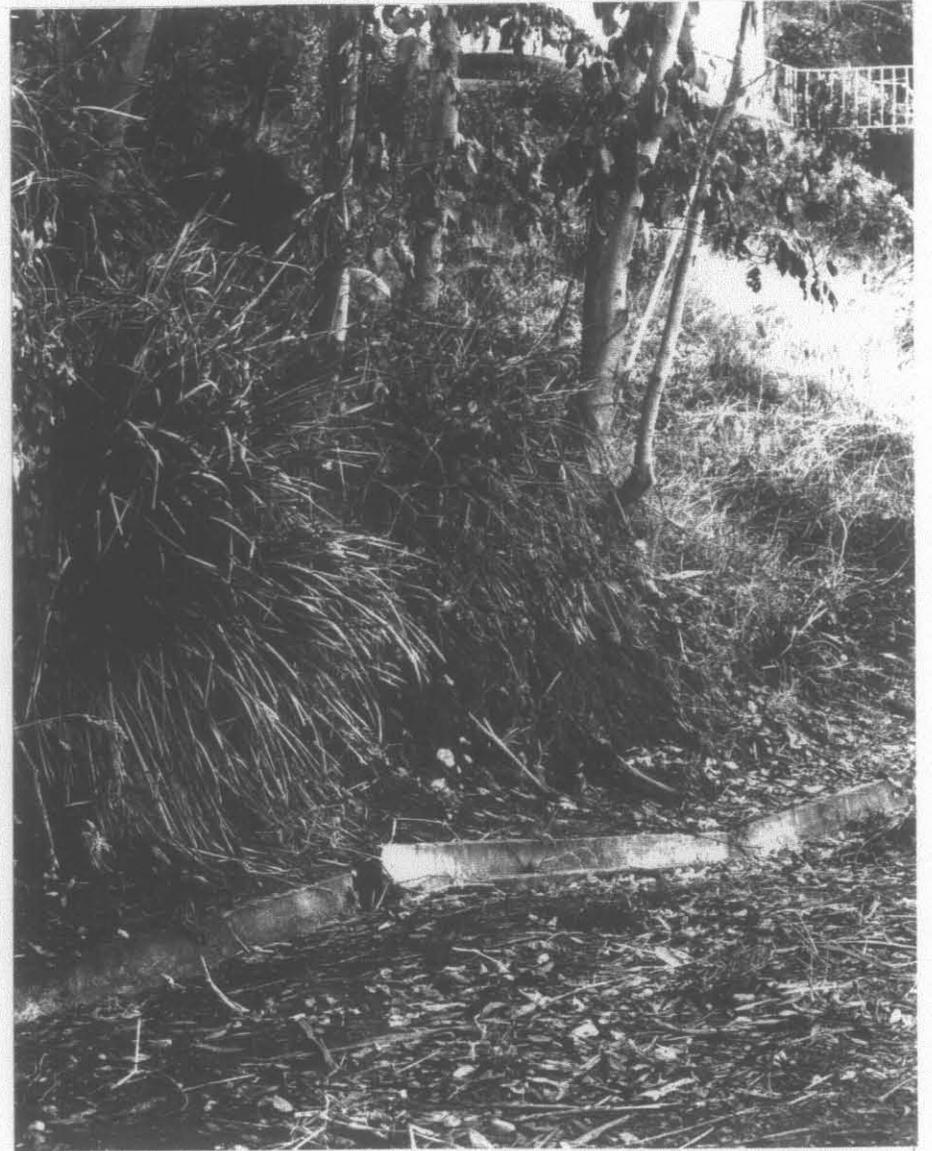
What is apparent and of greater concern is that movement is not confined only to the highway embankment. A series of tension cracks has developed in the cutting and ground above the highway, extending northwards from the roadway through to the driveway of the dwelling at 153 Channel Highway (plate 5). This house shows signs of structural damage. It is therefore necessary to consider the road failure as part of a landslip complex having the potential for further development if corrective measures are not taken.

In summary, what may have commenced as a simple road failure, has now developed into a landslip involving ground on the upper side of the highway.

Plate 5. *Tension crack in ground above highway. Note disruption to spoon drain.*

Ground movements should be monitored, including the area in tension above the highway.
