1977/39. Investigation of the stability of land at Legana Beach Road, Legana.

C.J. Knights

The stability of a block belonging to A. Rosevear at Legana Beach Road was examined. The land [EQ038228] is situated between two developed blocks on the lower side of Legana Beach Road, and extends from the road to the foreshore reserve. A complex of landslip features occur in the vicinity of the site and it has been zoned as unsuitable for building.

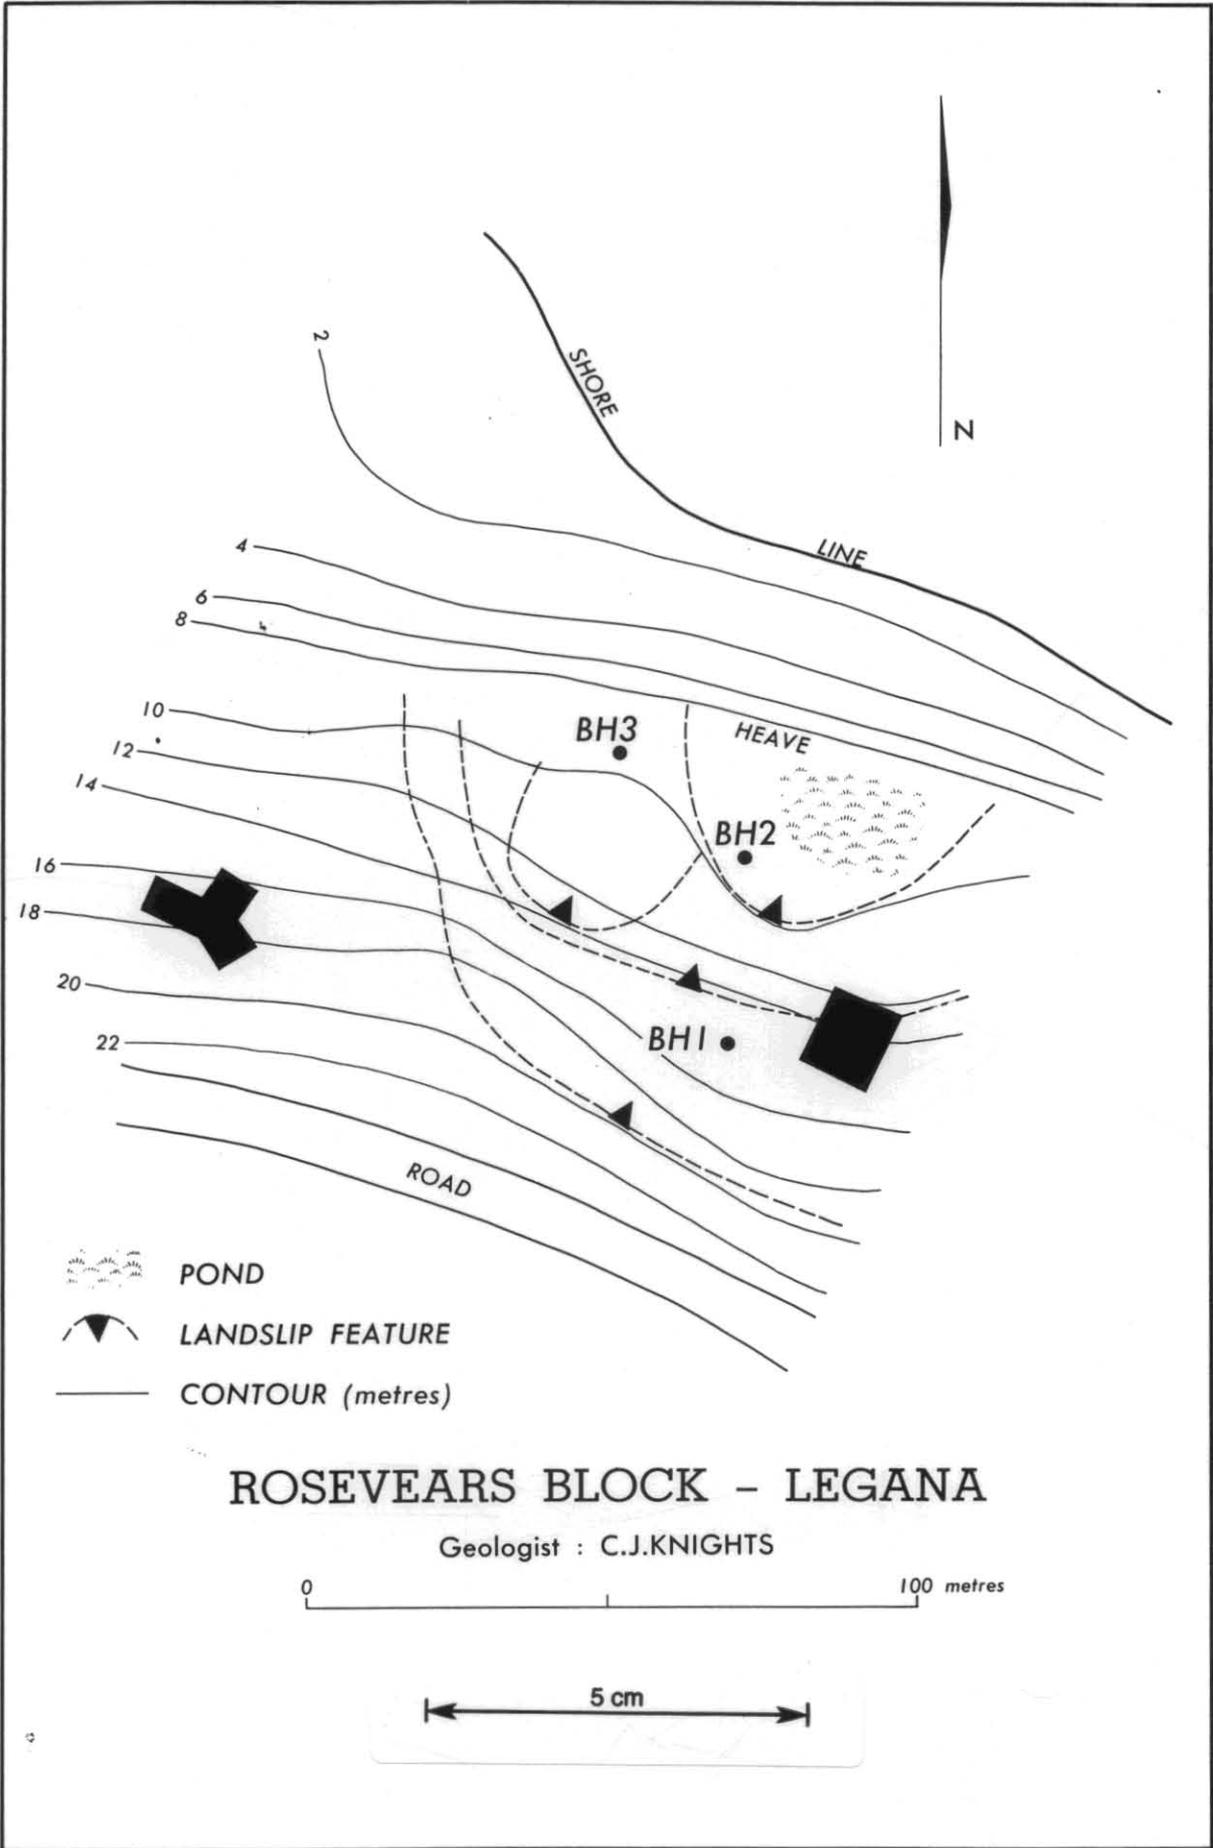
Figure 1.

A complex of landslip features which have the appearance of being relatively recent occur on Rosevear's block (fig. 1). Ponding behind a heaved toe area marks the north-easterly scar. The other scars show defined steepes and flats. Landslip features indicated on Figure 1 are not distinct, but merge into each other.

For stability analysis of the upper slip feature, the dimensions of the proposed slip plane were taken by fitting a semicircular arc to the topography and to the base of the soft zone in BH1. Other factors in the analysis were estimated from previous knowledge of Tamar clays.

Assumed factors are $C'_r = 0$, $\phi'_r = 13^\circ$, $\gamma_{sat} = 1.9 \text{ g/cm}^3$. With these inputs, the calculated factor of safety is 0.9.

Dimensions of the lower slip were chosen by assuming that the wet sand bed is horizontal and forms a basal slip surface and that the piezometric surface is also horizontal. Other factors were taken as above. The calculated factor of safety was 1.05.

There was insufficient information to analyse the western slip feature, but visual examination suggests that it is more stable than the other two.

However the analyses given are based on reasonable estimations of the factors involved. As a factor of safety of less than 1.0 indicates that the slip is actually moving, in the case of the upper slip it is evident that the analysis has slightly under-estimated the restraining factors.

Both safety factors are so close to 1.0 that they suggest stability is marginal. Safety factors of over 1.5 would be necessary before the re-zoning of this block could be considered.
