1977/40. Investigation of road movement at Strickland Avenue.

A section of Strickland Avenue traverses steep valley slopes above a deeply incised section of Hobart Rivulet [EN215493]. The road is subject to tension cracks and progressive road failure.

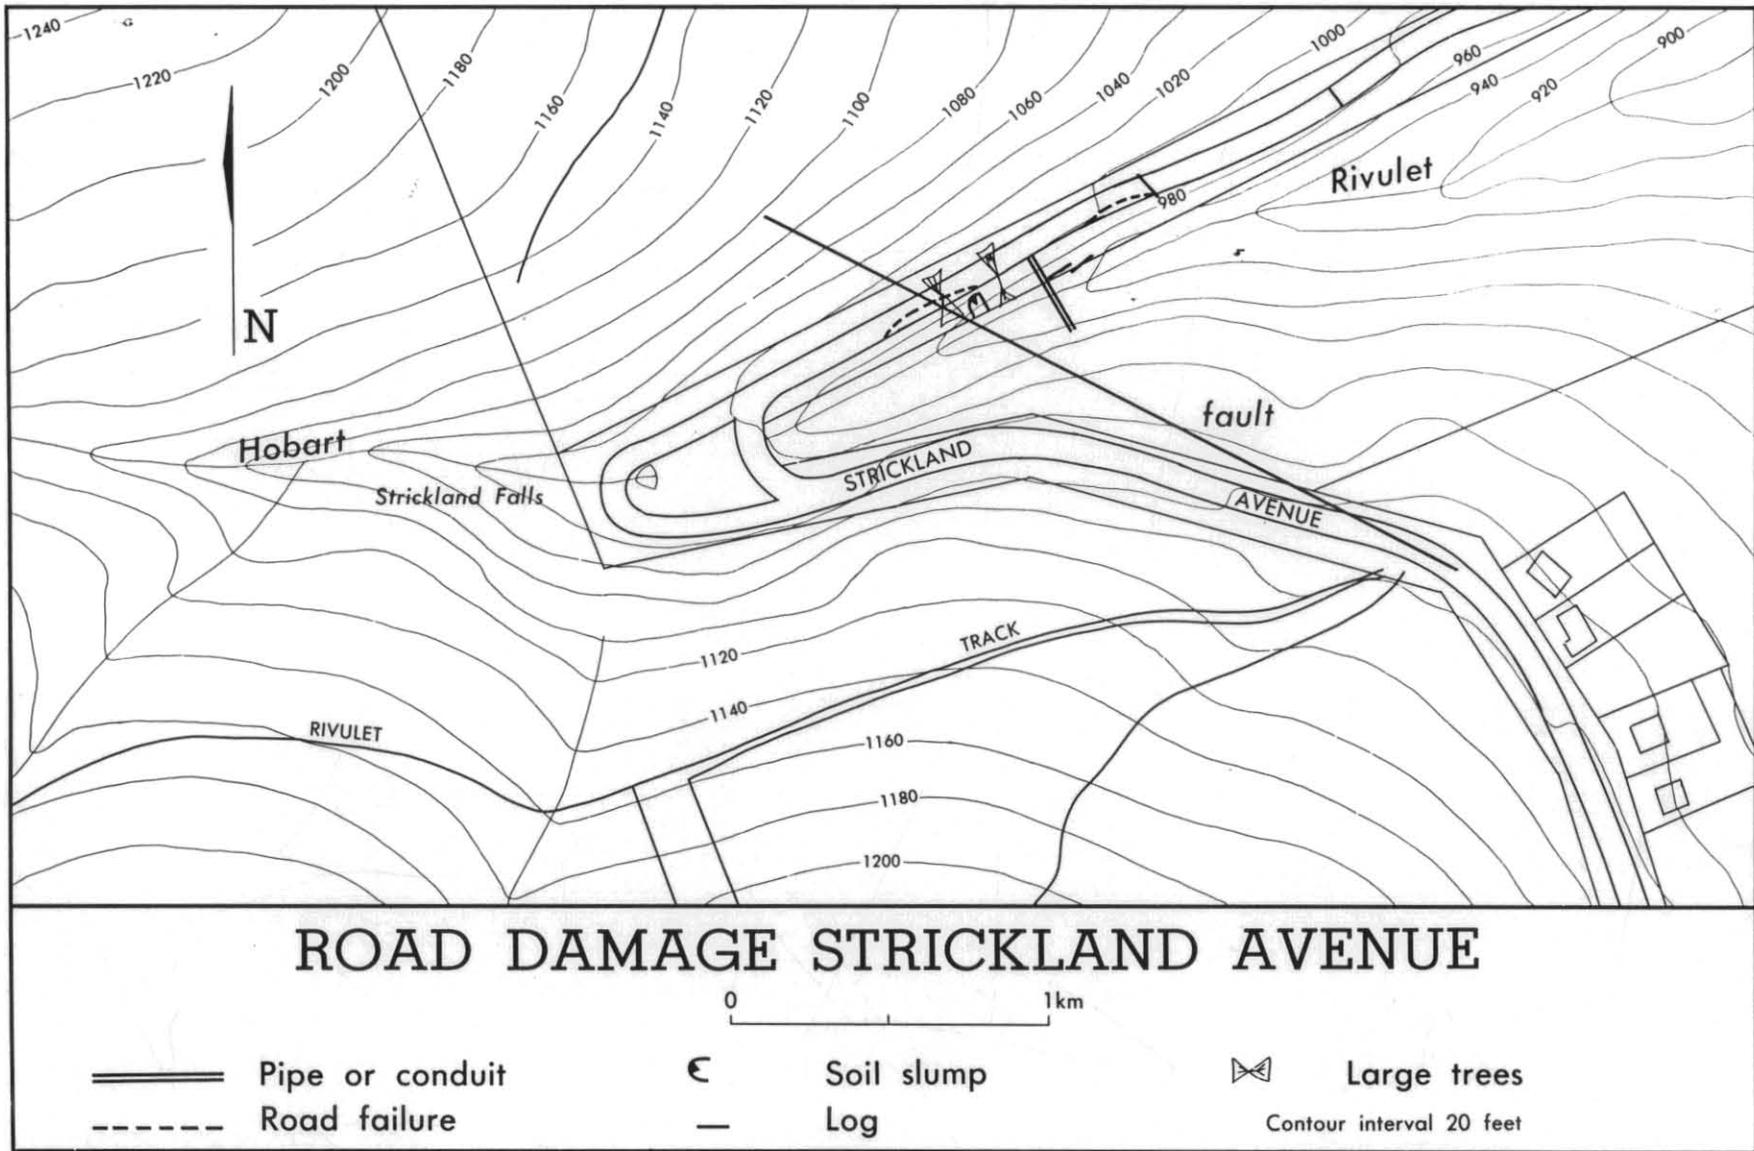
Figure 1.

The eastern drain pipe marked on Figure 1 is blocked and needs cleaning.

Between the eastern end of the fence, and the next drain the heel of the slope movement is close to the fence but does not cut the road. This section is well vegetated.

The next drain issues its water onto an unprotected slope. In time this may cause significant erosion.

West of this drain the road is failing, and the slope below the road is poorly vegetated. The lower part of this slope is not so steep and it should be amenable to having tree trunks lain on it, and planting of saplings.

Between the road failure and the conduit pipe is a relatively stable and well vegetated slope. At the base of this section there are large fallen tree trunks which have provided natural protection against stream erosion.

West of the conduit pipe are two large, dead trees, on either side

of a slump failure. Roots of these trees are stabilising the slope, but their great weight when blown by wind must be transmitted to the roots stressing the ground. Should one of these trees be blown down and its roots torn up, it would cause severe disturbance. These trees should be lopped to a low level, leaving the roots intact.

The slump failure between the trees probably marks the transit of the geological fault. There is rapid toe erosion by the stream at the foot of the slump and some protective measures are required.

Above the slump and to the west, the road is failing. Downslope of the western end of the failure the slope is very steep with only thin vegetation cover.

A priority must be to lop the two large trees. This will not be easy, but it should be carefully supervised to ensure that the roots are not damaged and that the surrounding soil and vegetation is disturbed only minimally.

Where vegetation is sparse the slope should be protected against erosion and vegetation encouraged. This may be achieved by laying tree trunks down exposed sections of the slope and planting with local bush saplings.

A drain constructed along the bottom side of the road or the top of the slope, will lessen slope wash and soil saturation. As the drain would need regular inspection and repair, it would have to be a lined, open drain.

Sections of the slope, particularly below the active slump, need to be protected against stream erosion, particularly during flood. This may be done by binding bundles of sticks back onto the base of the slope, or by constructing a toe protecting wall or boulder pile, or by constructing groins to divert the channel flow.

There should also be a lined protective channel from the road culvert to the stream.
