1977/41. Foreshore instability near Tarooma High School.

R.C. Donaldson

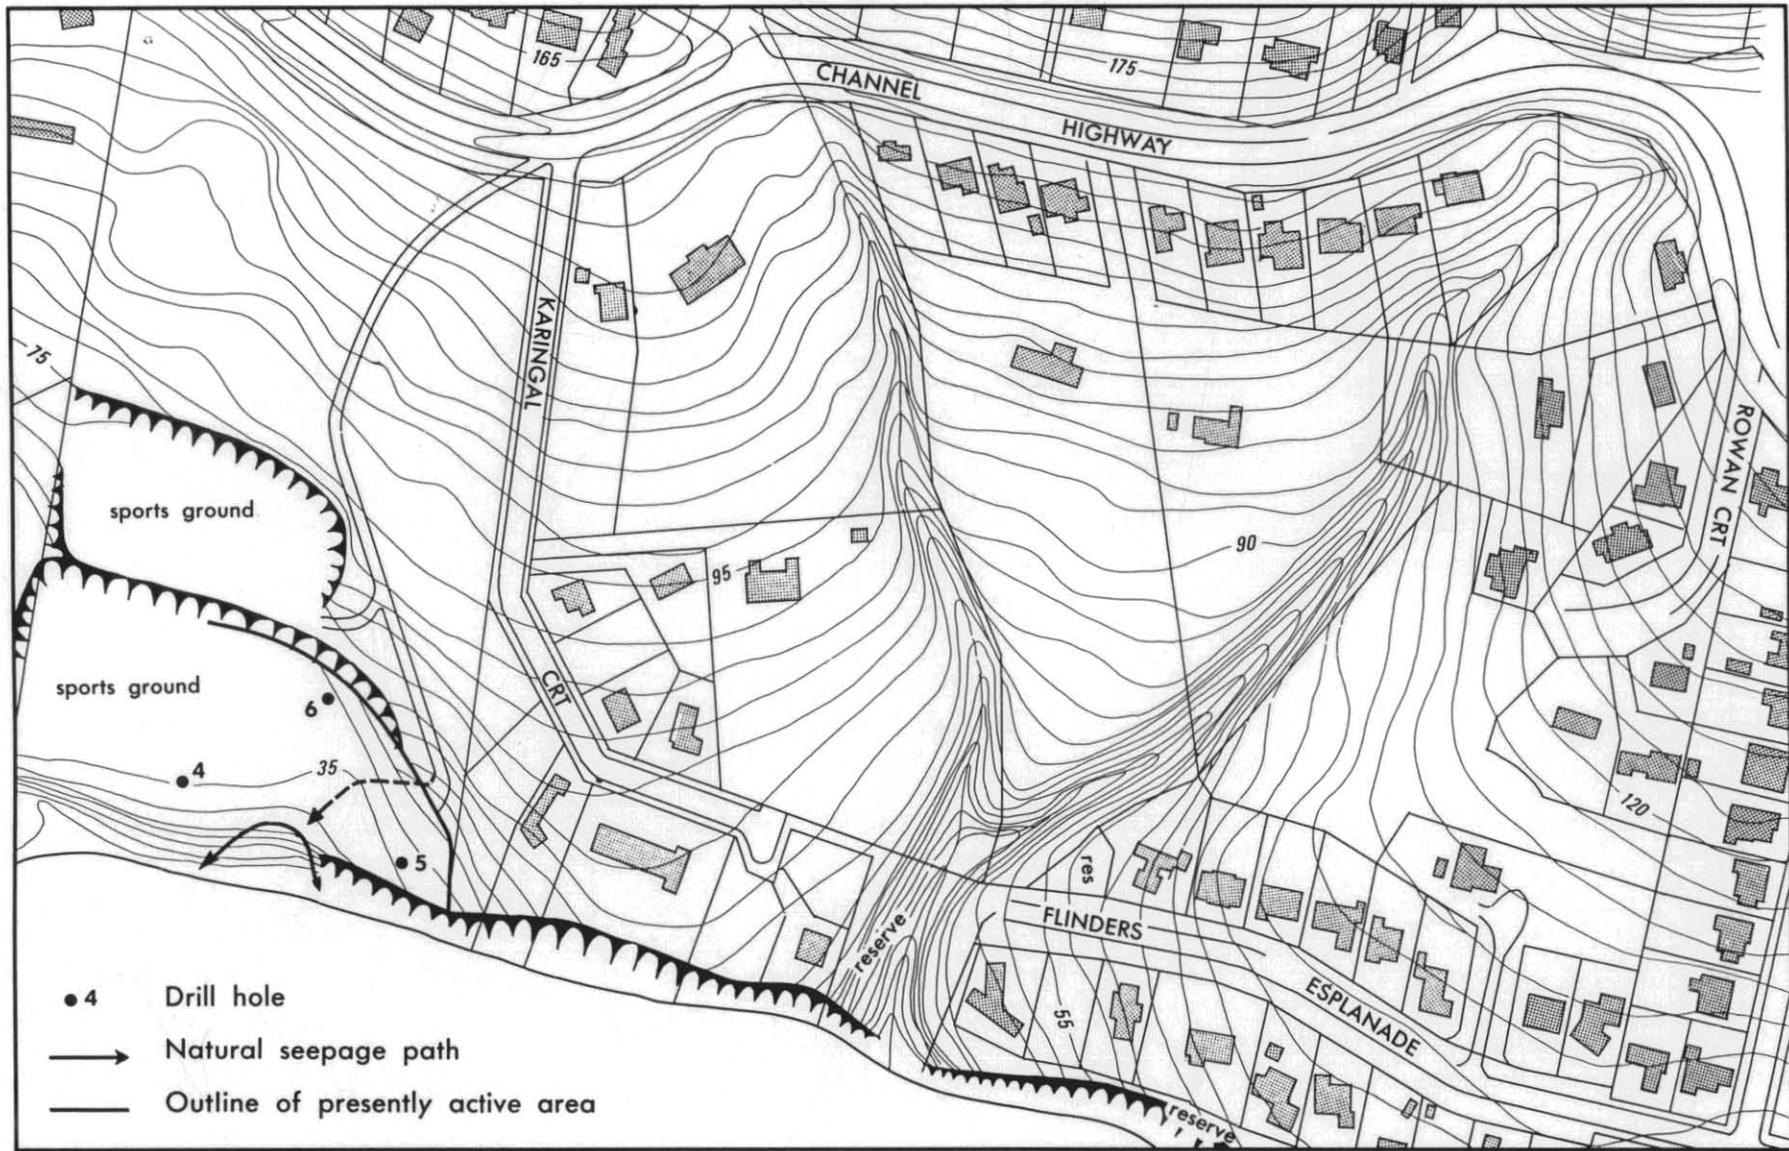
Evidence of active landslip activity is seen in the Taroona High School sports ground area. A series of fissures have developed in the base of the cut along the western edge of the lower oval and extend around the foreshore to the north (fig. 1). Horizontal and vertical displacements of between 0.15 m and 0.3 m are typical of the order of movement (plate 3).

A short drilling programme was carried out to determine the nature and cause of movement. Considerable ground water pressure was encountered in Hole 6 (fig. 1). Water was struck at 10.0 m; this rose rapidly and is currently at 4.40 m. Regular monitoring will be continued and variations noted. Unfortunately, water was not encountered in Holes 4 and 5, due to an insufficient number of auger lengths to enable drilling to continue to greater depths.

Figure 1. Location of active areas.

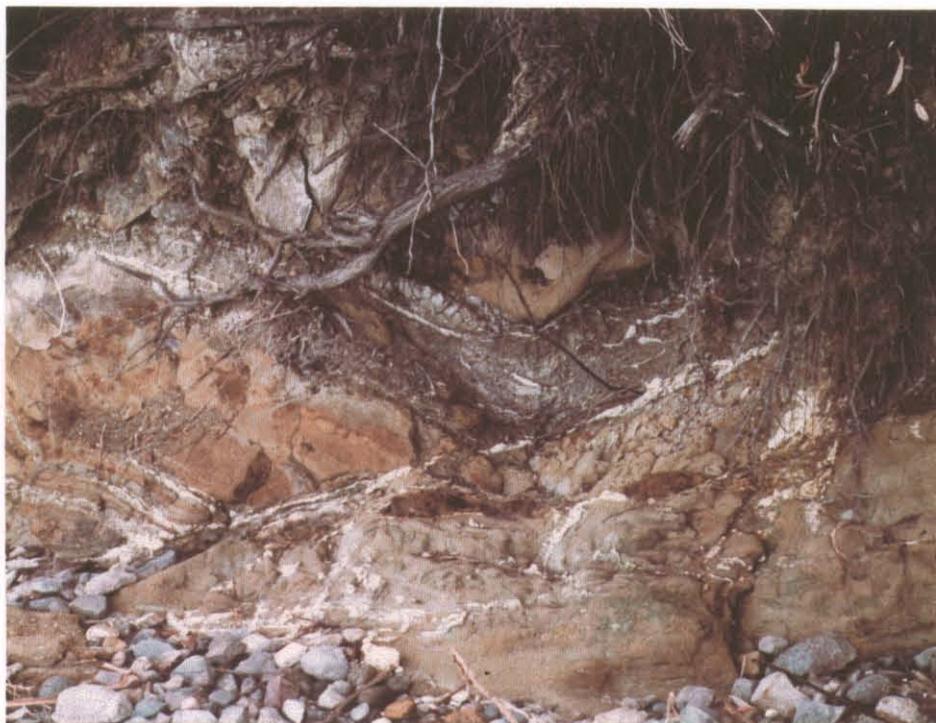
In contrast, the Tertiary sequence seen in the cliff below the oval is devoid of the coarser fractions and consists largely of interbedded clay and sandstone. The clay, up to several metres in thickness, is typically fissured and behaves plastically. Considerable disturbance and deformation is evident, with relative movement having taken place along the incompetent clay horizons (plate 1). The whole area is draped by a thin surface veneer of brown/black dolerite-derived soil and clay.

In principle, a decrease in pore water pressure gives rise to increased stability. This is usually accomplished by drainage. The fissured clay and permeable sand beneath the sports ground could be drained, but an effective drainage system could not be easily installed at a realistic cost. The concept that the most permeable materials should be drained requires that all water bearing beds should be crossed. This is not often feasible in disturbed ground where beds have sagged, or fractured, as evidenced in the cliff section (plate 1).

Plate 1. *Tertiary sediments exposed in foreshore cliffs north of Taroona High School. Note disturbance and movement associated with fissured clays.*

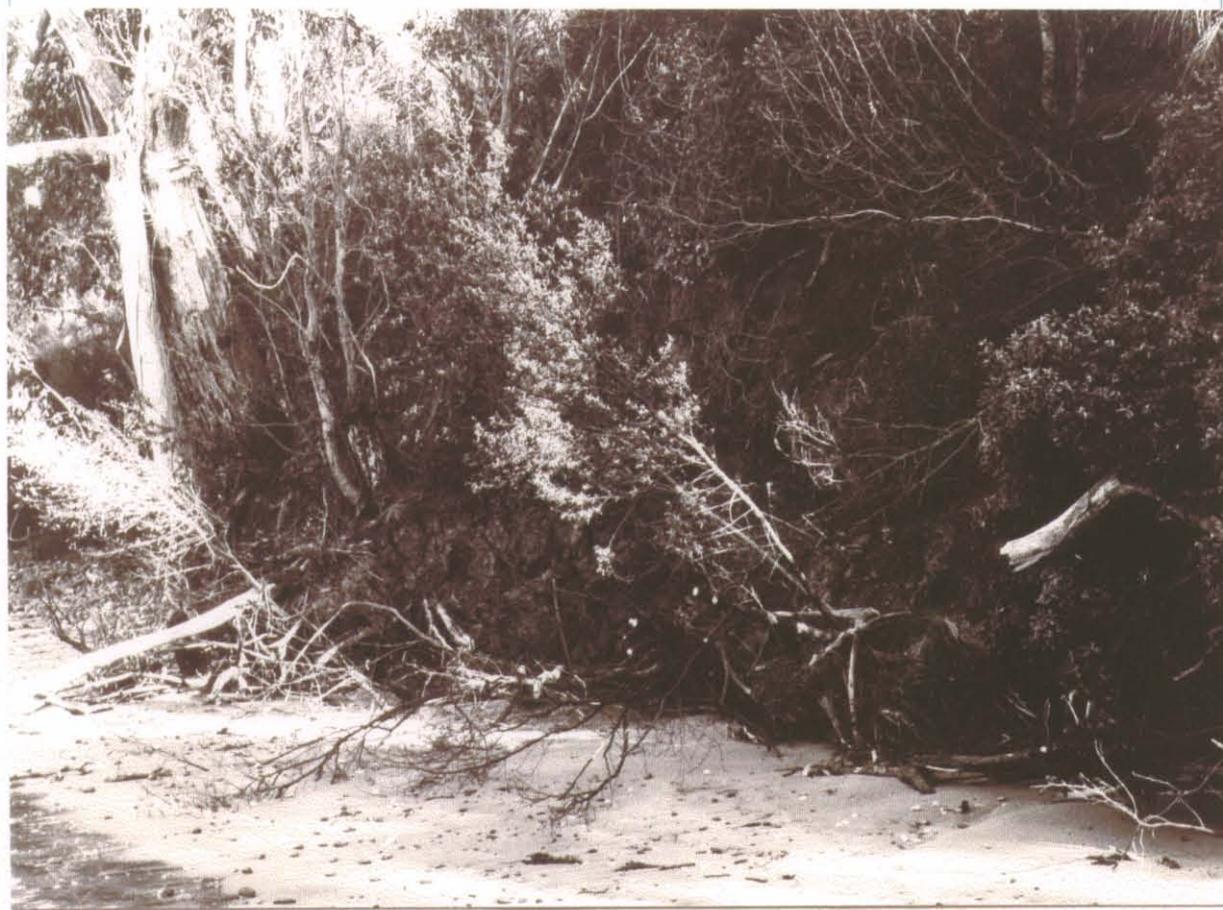
Mass movement is also prevalent along the foreshore cliff section which forms the eastern boundary of the sports ground. Earthen material has slumped onto the beach over a distance of approximately 30 m, taking trees and scrub with it (plate 2). Further movement is imminent along this section of the foreshore; fissures in various stages of development have formed in the zone of tension behind the main head scarp (plate 4).

Plate 2. *Slumping of Tertiary sediments onto beach below sports ground.*

As an economic compromise, it is recommended that an effective drainage system be constructed to divert all surface run-off water away from the area, and preferably into the creek to the south of the sports ground. It is not anticipated that this will completely stabilise movement, but it will considerably reduce the potential for future mass movement. Existing fissures which allow the ingress of water into the sub-surface should either be plugged or the ground re-modelled by earth moving equipment to an even gradient, especially to the north of the sports ground. Natural vegetation should remain along the foreshore.

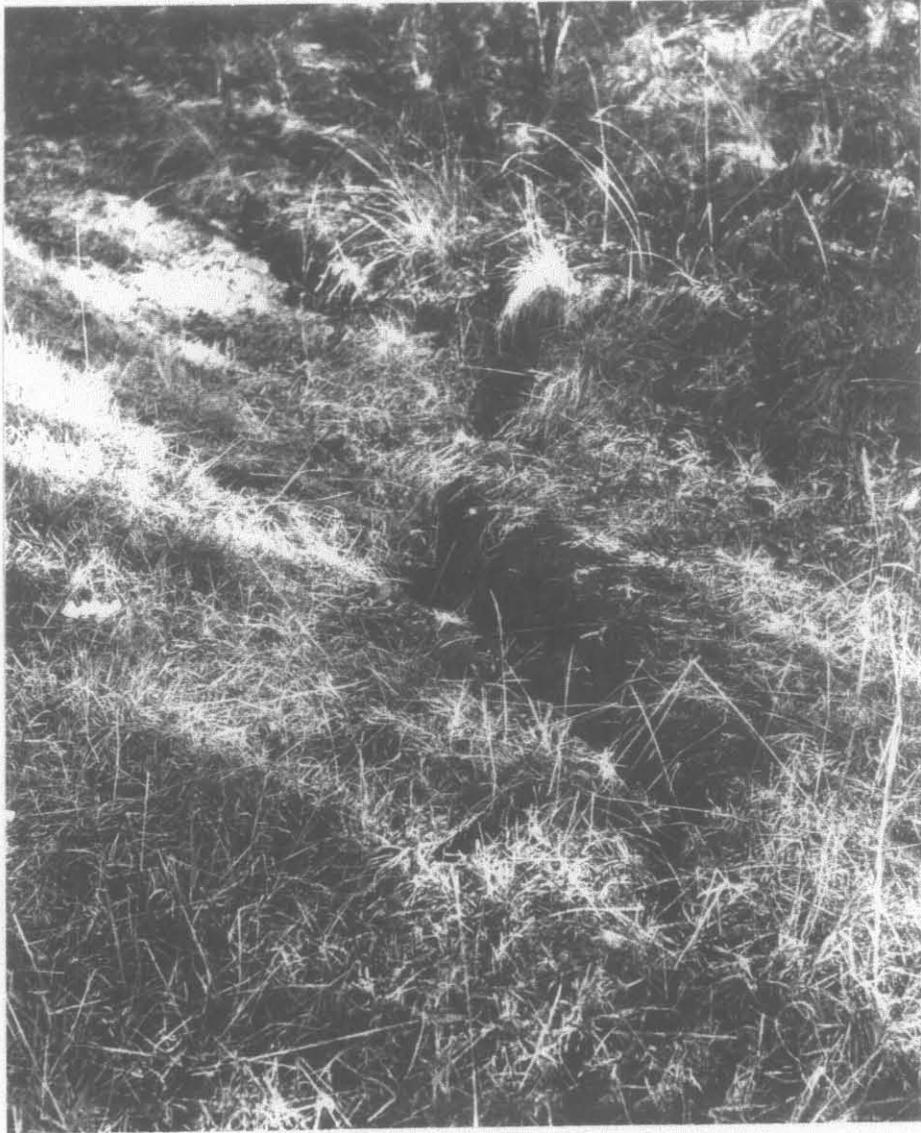
The surface water drainage system is virtually non-existent, adding considerably to the landslip problem. The rear of the sports ground is ill-drained; surface run-off water has been seen flowing directly into the fissures during a recent downpour. In addition, water was being channelled into the head region of the landslip on the foreshore.

Plate 3. *Tension crack developed along western edge of sports ground.*

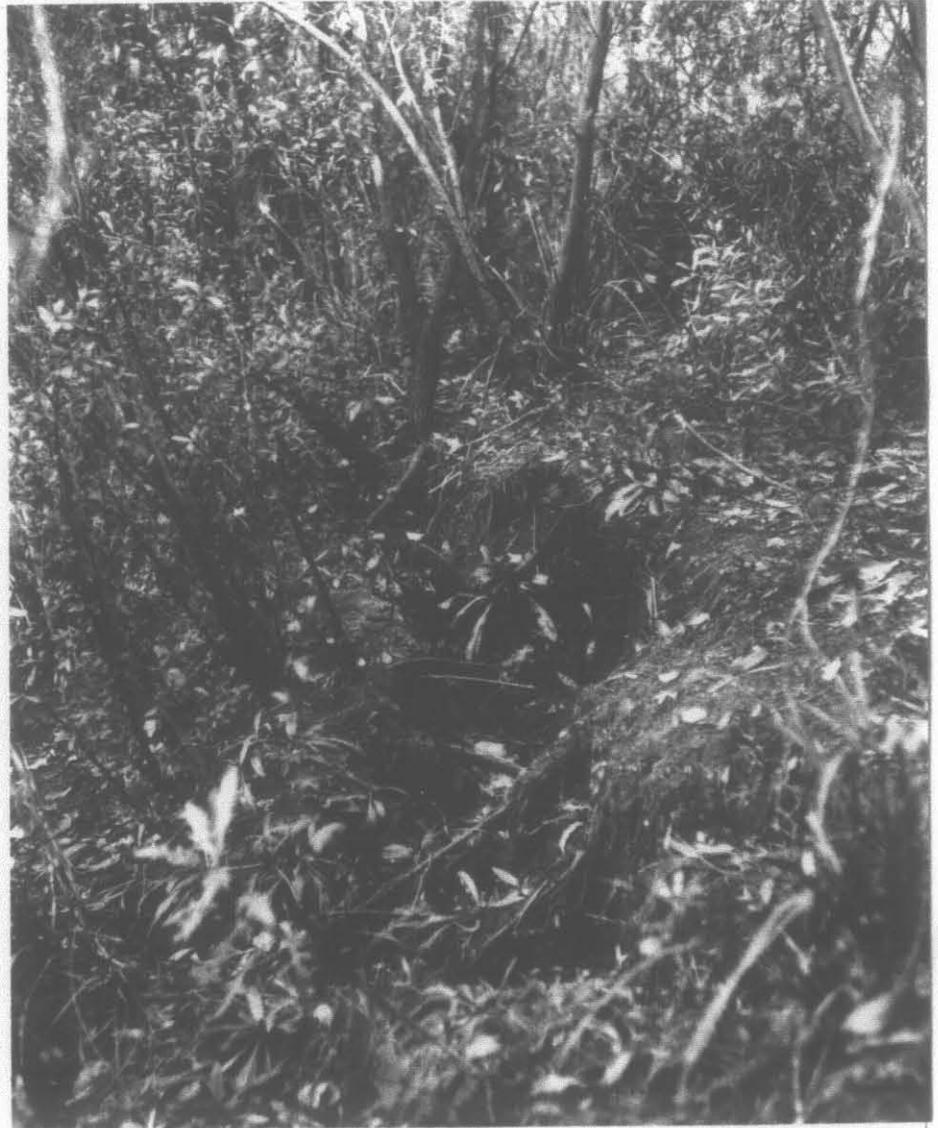
Plate 4. *Fissure in zone of tension behind main head scarp. Stretched tree roots indicate active movement.*
