1977/45. Test pits on Chugg's property, Evandale.

W.L. Matthews

Six test pits were dug by back-hoe on A.G. Chugg's property at Evandale [EQ248018]. The pits were located on Lot 2 of the proposed subdivision (fig. 1).

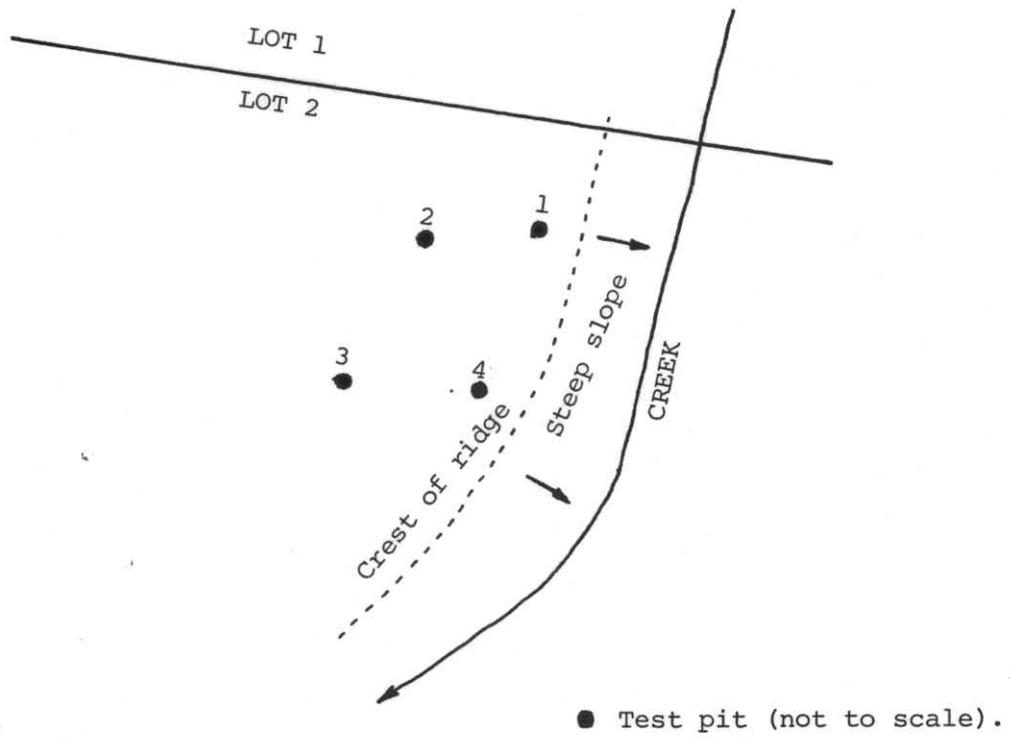
Figure 2. Sketch of test pit positions - Area C.

The results of the test pits were:

Hole 1

Depth (m)	Description
0-0.5	Brown soil.
0.5-1.2	Weathered red compact silty sandstone.
1.2-1.4	Harder silty sandstone.

Hole 2

0-0.3	Brown soil.
0.3-0.8	Weathered and broken siltstone.
0.8-0.9	Harder siltstone.

Hole 3

0-0.3	Dark brown grey soil with a concentration of pisolitic iron oxide fragments at the base and containing some moisture.
0.3-0.8	Grey and brown plastic clay with some iron oxide pisoliths.
0.8-1.5	Fairly hard silt with iron oxide pisoliths up to 10 mm across but usually smaller in size.
1.5-1.7	Pink mudstone and sandy silt fragments in silt and clay.

Hole 4

0-0.3	Brown soil.
0.3-0.6	Soil and broken siltstone fragments.
0.6-0.7	Harder siltstone with leaf impressions.

These test pits indicate that consolidated Tertiary sediments occur at shallow depth, particularly in the three easterly holes. It is not known whether the hardening has been caused by basalt baking the sediments or by lateritisation. There are no definite old landslips in the immediate vicinity and a small area of land can be reclassified as Class III on the landslip zone map. A house could be built on this site with reasonable safety. It should be sited on the south westerly sloping portion of the land somewhere between test pits 1, 2 and 4. If building proceeds, it should be built as near as possible to the code of building that applies to Landslip B land. Household drainage should be piped away from the house site in a westerly or south-westerly direction for at least 50 m and dispersed in the soil.
