A landslip investigation on the toe area of an old landslip at McEwans Road, West Tamar.

C.J. Knights

1977/47. A landslip investigation on the toe area of an old landslip at McEwans Road, West Tamar.

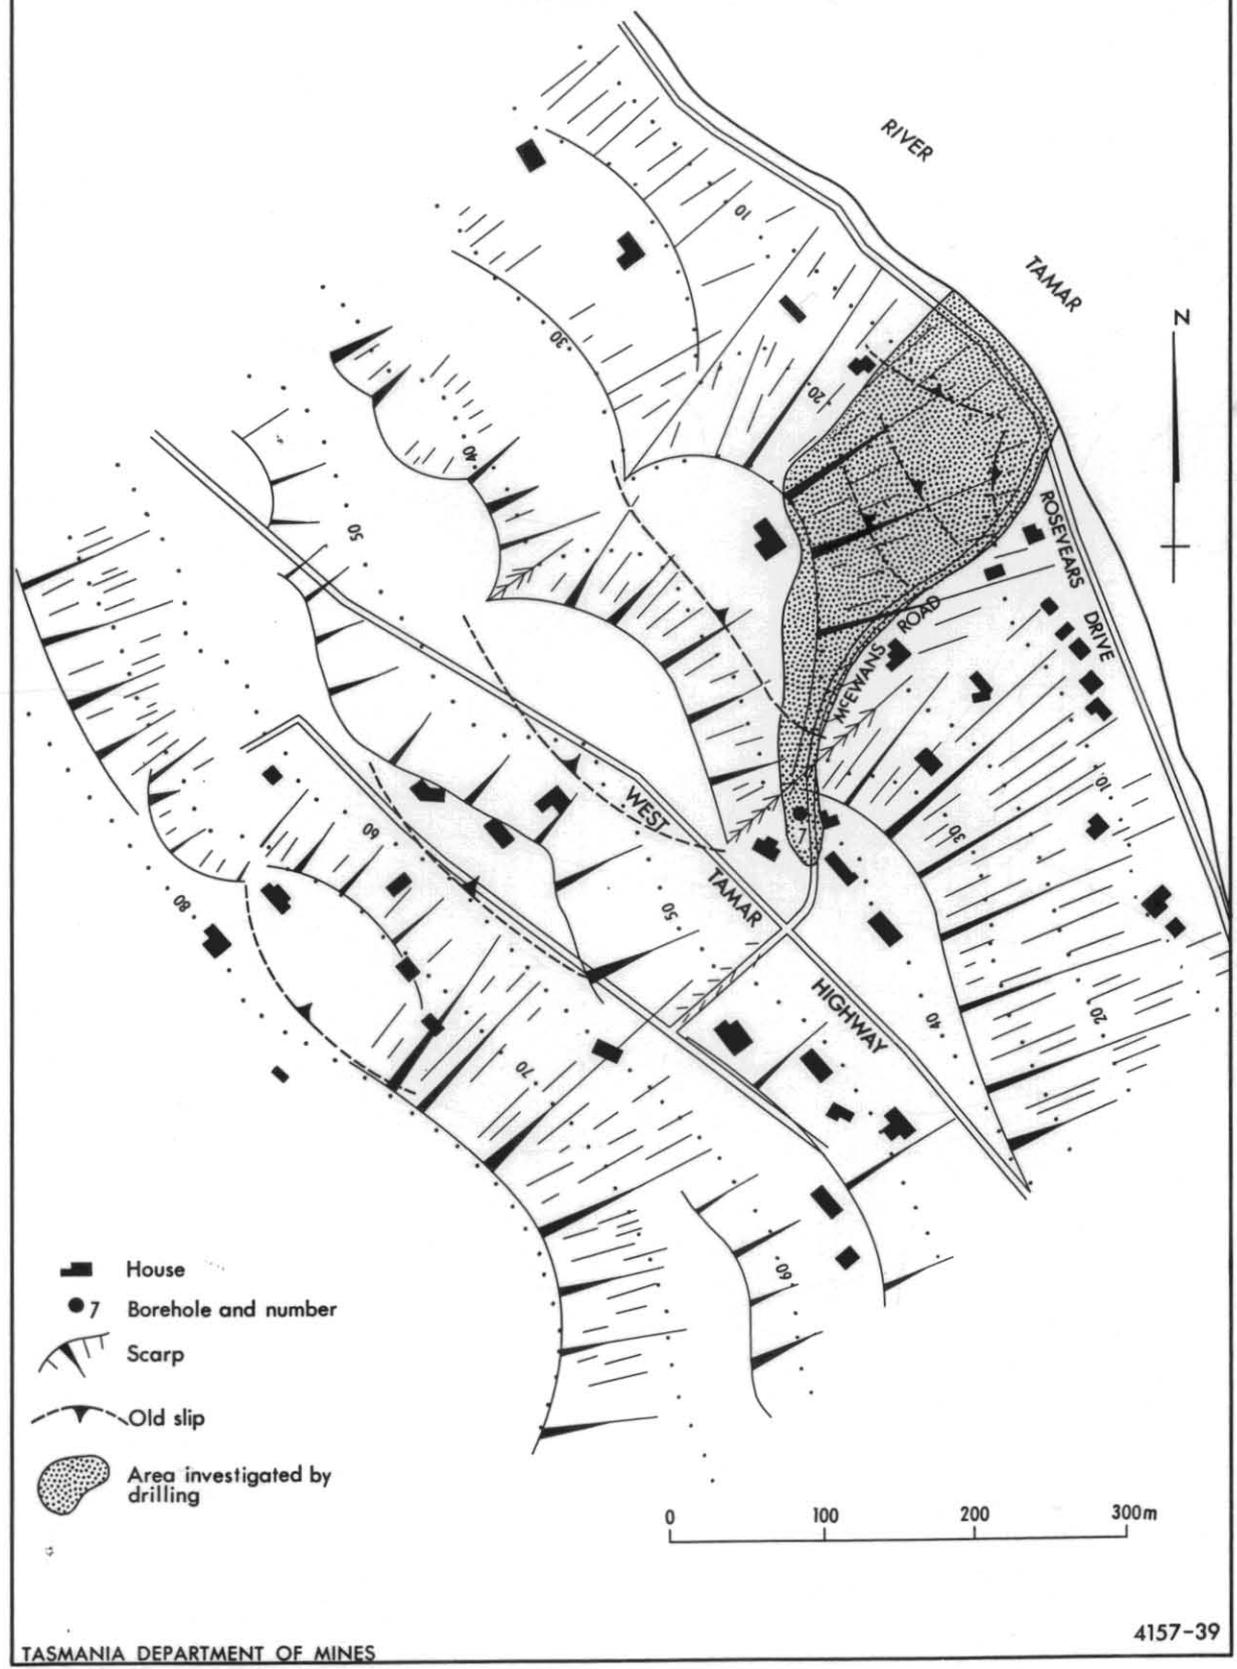
Figure 1

McEwans Road is situated on a valley slope which extends from the basalt plateau at 160 m to the shoreline of the River Tamar. It probably extends 30-60 m below the present water level, although in recent times this has backfilled with silt. The valley is eroded in Tertiary lacustrine sediments which are capped by a layer of basalt. Talus overlies much of the slope, and there may be small intrusions of basalt in the sediments. Large landslips have been active throughout this valley slope, but they are very old, and appear to be stable in the present environmental conditions. Smaller landslips, shallow slumps and cutting failures occur to-day on sections of the old landslips, where there are oversteepened slopes, and on the previously weakened zones of slippage. The old structures form steep scarps and hollows (fig. 1). The area investigated by drilling, and which is on the toe of a sequence of large old landslips, is outlined in Figure 1.

LANDFORM MAP SHOWING OLD LANDSLIP STRUCTURES ON THE HILL SLOPE NEAR M'EWANS ROAD

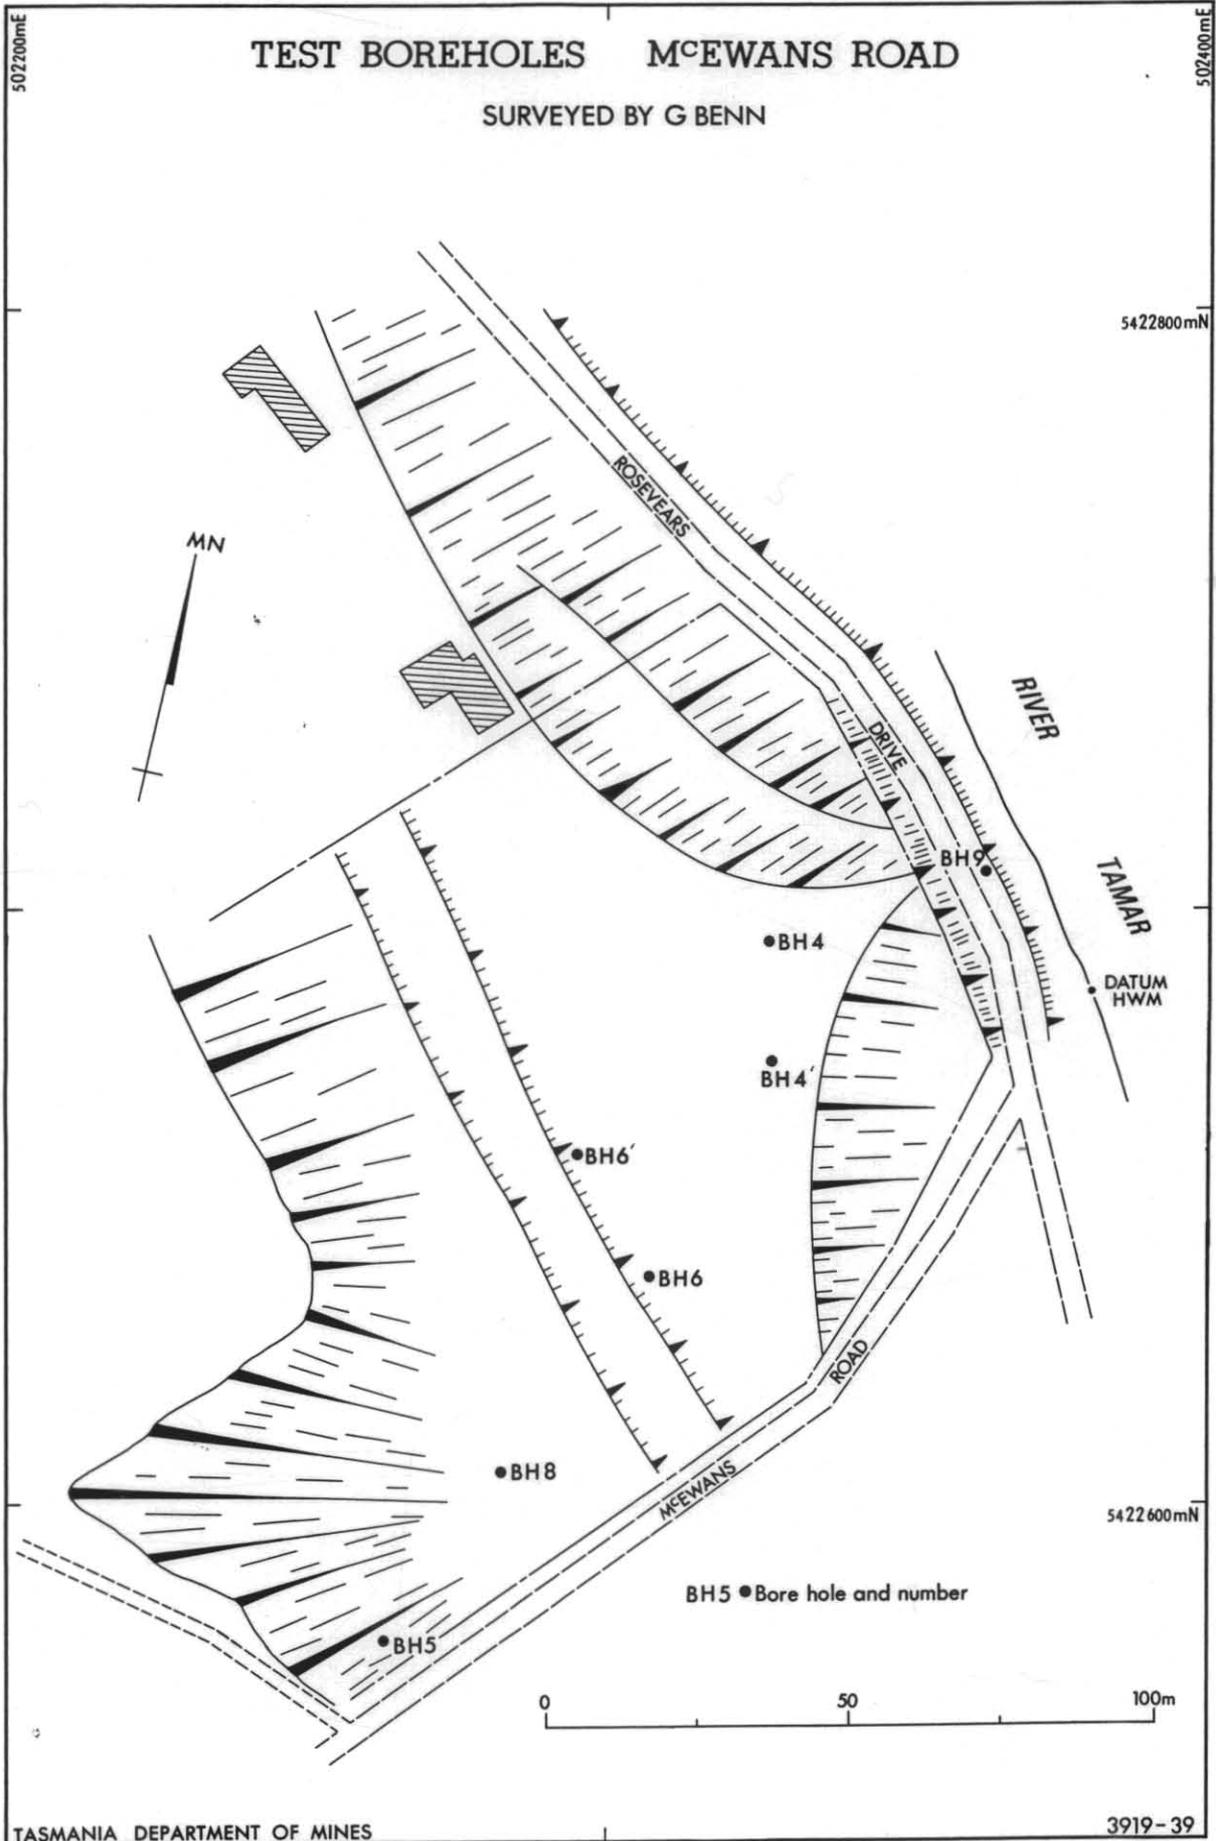
Figure 2

There are a number of minor scarps which are particularly evident in aerial photographs (fig. 2). At the time of drilling (1974) there was no evidence of recent instability, but subsequently the road along the Tamar foreshore (Rosevears Drive) has failed extensively.

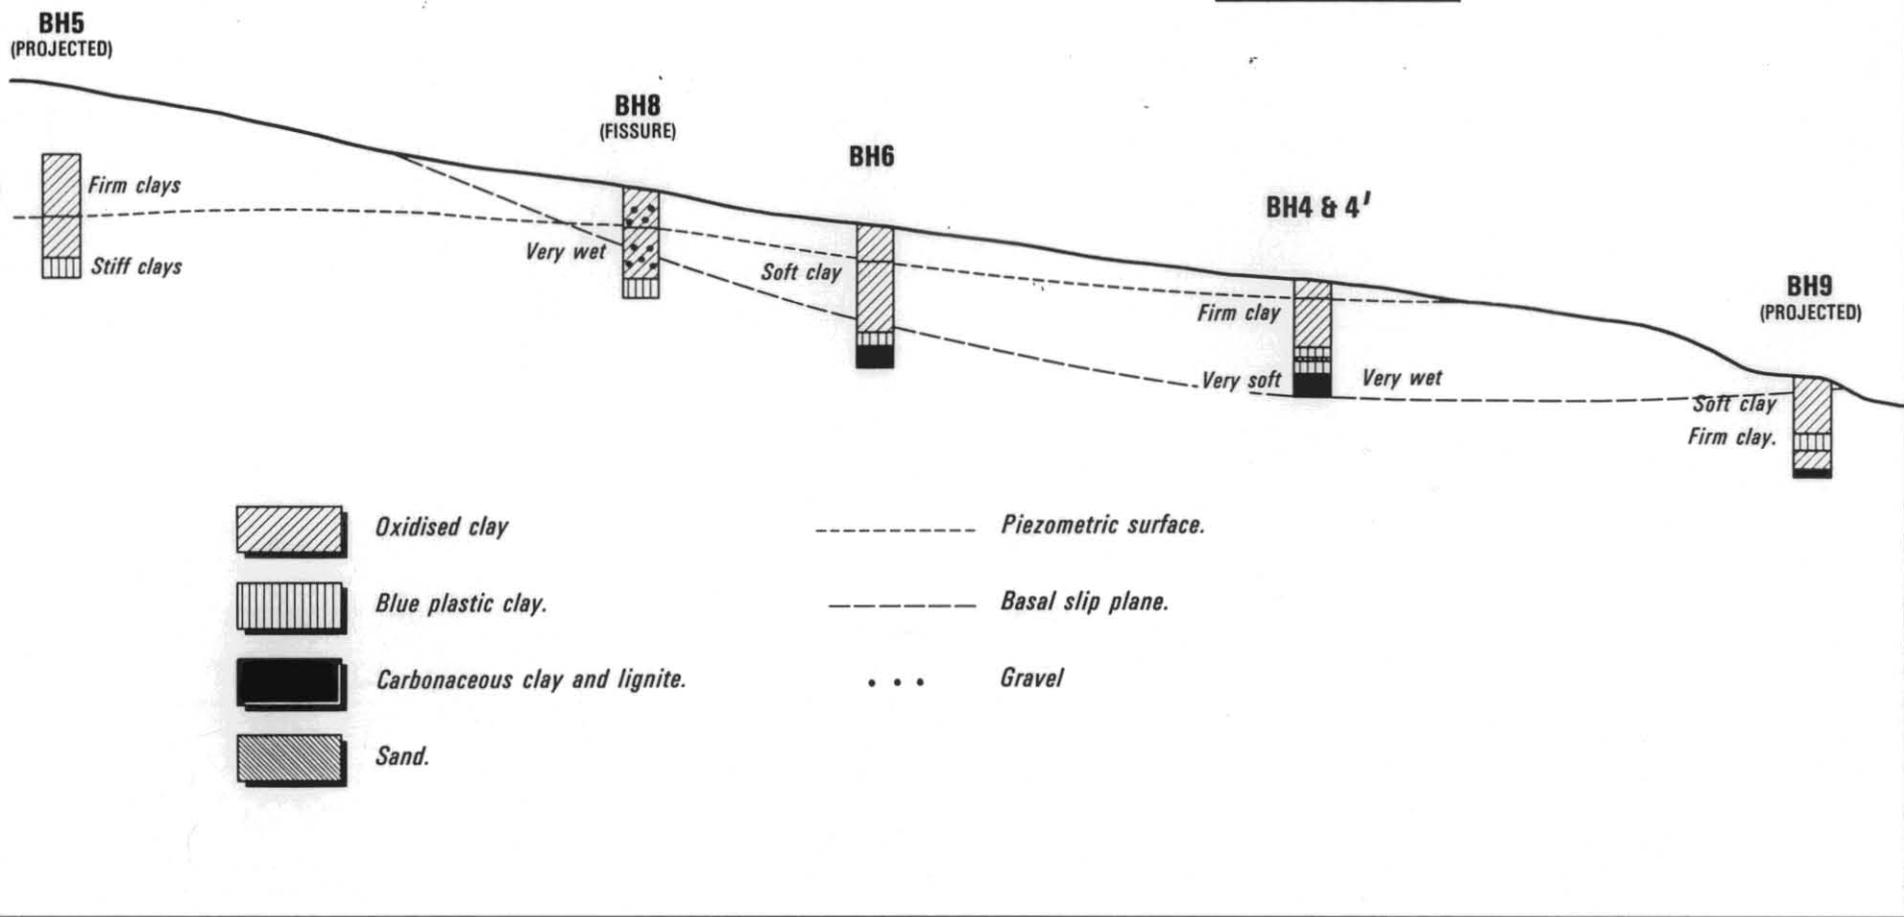
Figure 3 Section, Lower McEwans Road.

The results of the drilling are summarised in Figure 3 and detailed bore logs are given in Appendix 1. In general there is a variable sequence of oxidised clay, with a minor grey clay, overlying grey plastic clay. Black carbonaceous clay and lignite underlie this sequence.

The sediments dip downslope: there is a particularly rapid drop between Holes 4 and 9, which may be due to dip, or to a failure or fault scarp. Hole 8 has a totally different sequence of materials. From the surface to 5.5 m very wet red clay and gravel were encountered yet only 2 m away these are absent. Below this depth oxidised clay, overlying grey plastic clay was found. The wet gravelly material is interpreted as being the infilling of a fissure, the fissure probably being formed during landslip movement.

The near-liquid carbonaceous clay and lignite found in Holes 4 and 4' strongly suggest that there has been slip movement, and that this is the disrupted material near the basal slip planes. Such very soft sub-surface material may also indicate that dispersion processes are active. Deep, localised wet gravels in Hole 8, which have been interpreted as a fissure infilling, also suggests past landslide movement. The form of this landslide is shown in Figure 3.

The sediments dip downslope. There is a sub-surface zone of soft to very soft material which indicates previous disturbances and slip movement (fig. 3). In the soft material saline water under a high piezometric head reduces the effective frictional strength of the clay. Stability analysis indicates that stability of the site is tenuous.
