1977/49. Test pits on Crowden's property at Kelcey Tier, Devonport.

W.L. Matthews

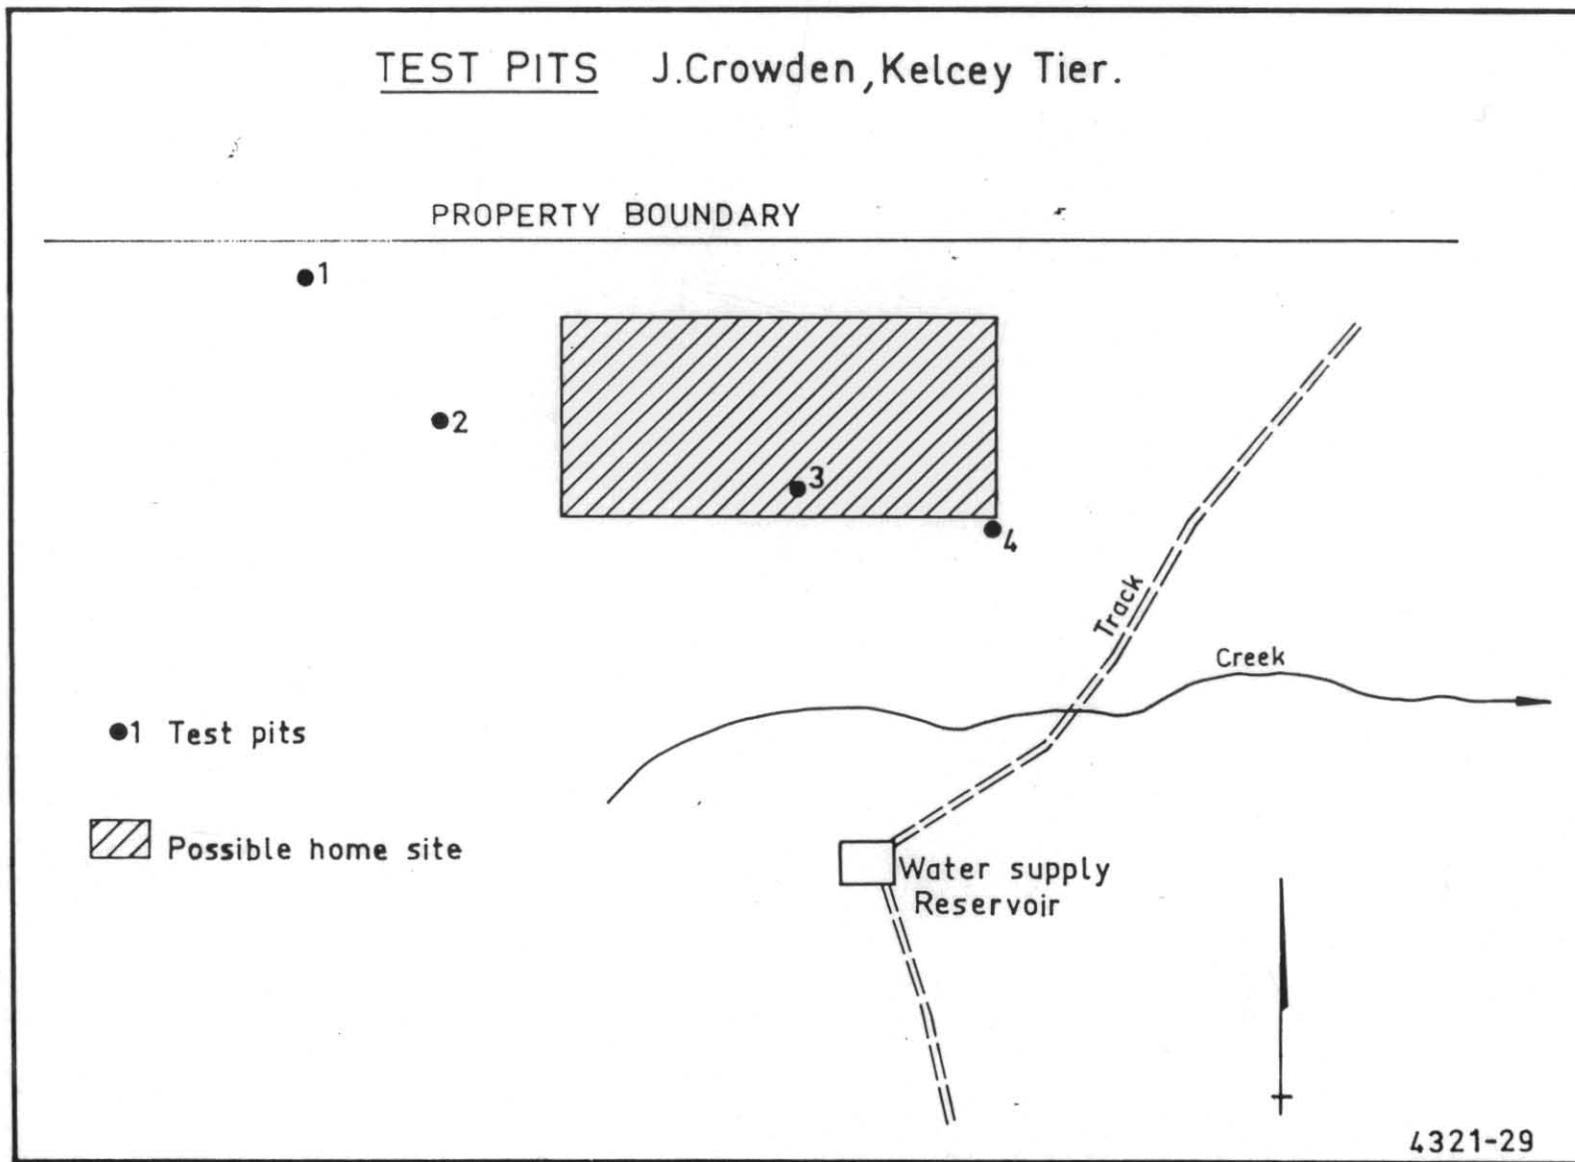
The approximate positions of the test pits are shown on Figure 1.

It is apparent from the occurrence of dolerite boulders in the test pits that some landslip material from higher up the slope has been deposited on the ridge where the holes were dug. This material has a shallow depth in holes 3 and 4 and is thicker in holes 1 and 2. Although the ridge is fairly narrow, there seems little risk of unstable conditions affecting a house sited in the stippled area on Figure 1. Some measures should be undertaken to minimise the risk. A house built within the area outlined should be constructed as near as possible in accordance with the code used for the development of landslip B land. Household water should be piped east along the ridge for about 50 m from the house site and allowed to disperse down the south side of the ridge. Trees should not be removed from the steeper surrounding slopes or, if the larger ones are, others should be replanted.
