1977/53. Investigation of the Lawrence Vale landslip.

C.J. Knights

*Abstract*

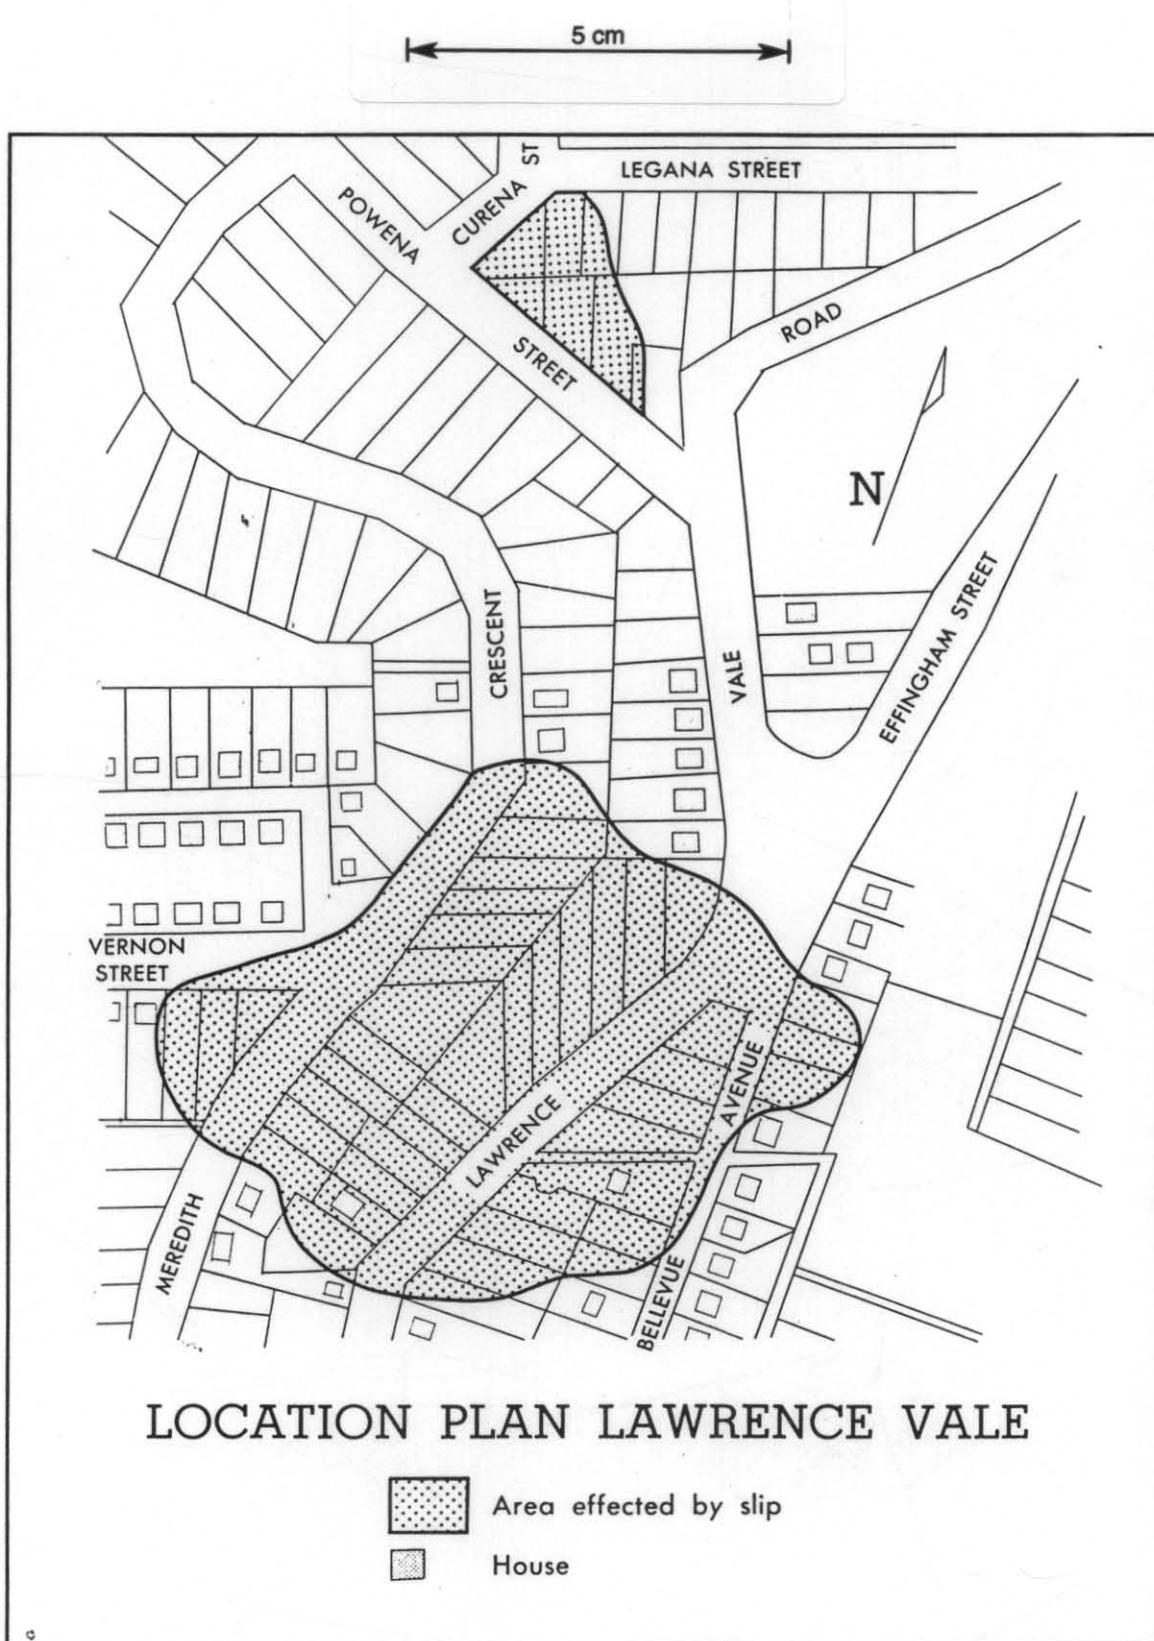
Figure 1

During 1956, slope instability occurred in the Lawrence Vale area of Launceston [EQ127107] and during the following 15 years about 30 houses were destroyed. Most of the movement occurred below Bellvue Avenue and in Lawrence Vale Road and Meredith Crescent, with a lobe of instability extending down Vernon Street. A lesser zone of instability destroyed five houses on the corner of Powena and Curena Streets (fig. 1).

The area in which active movement has recently occurred is shown in Figure 1. The main complex has an uneven shape and has flowed out over Meredith Crescent on many occasions. Drainage trenches dug through the steep bank below the road encountered lithic sand and show that this bank has not been affected by the slip.

The southern side of the slip extends in a lobe across Meredith Crescent and down Vernon Street. The affected section of Meredith Crescent has repeatedly subsided. These two sides of the slip correspond to the lobes discussed by Carey (1958).

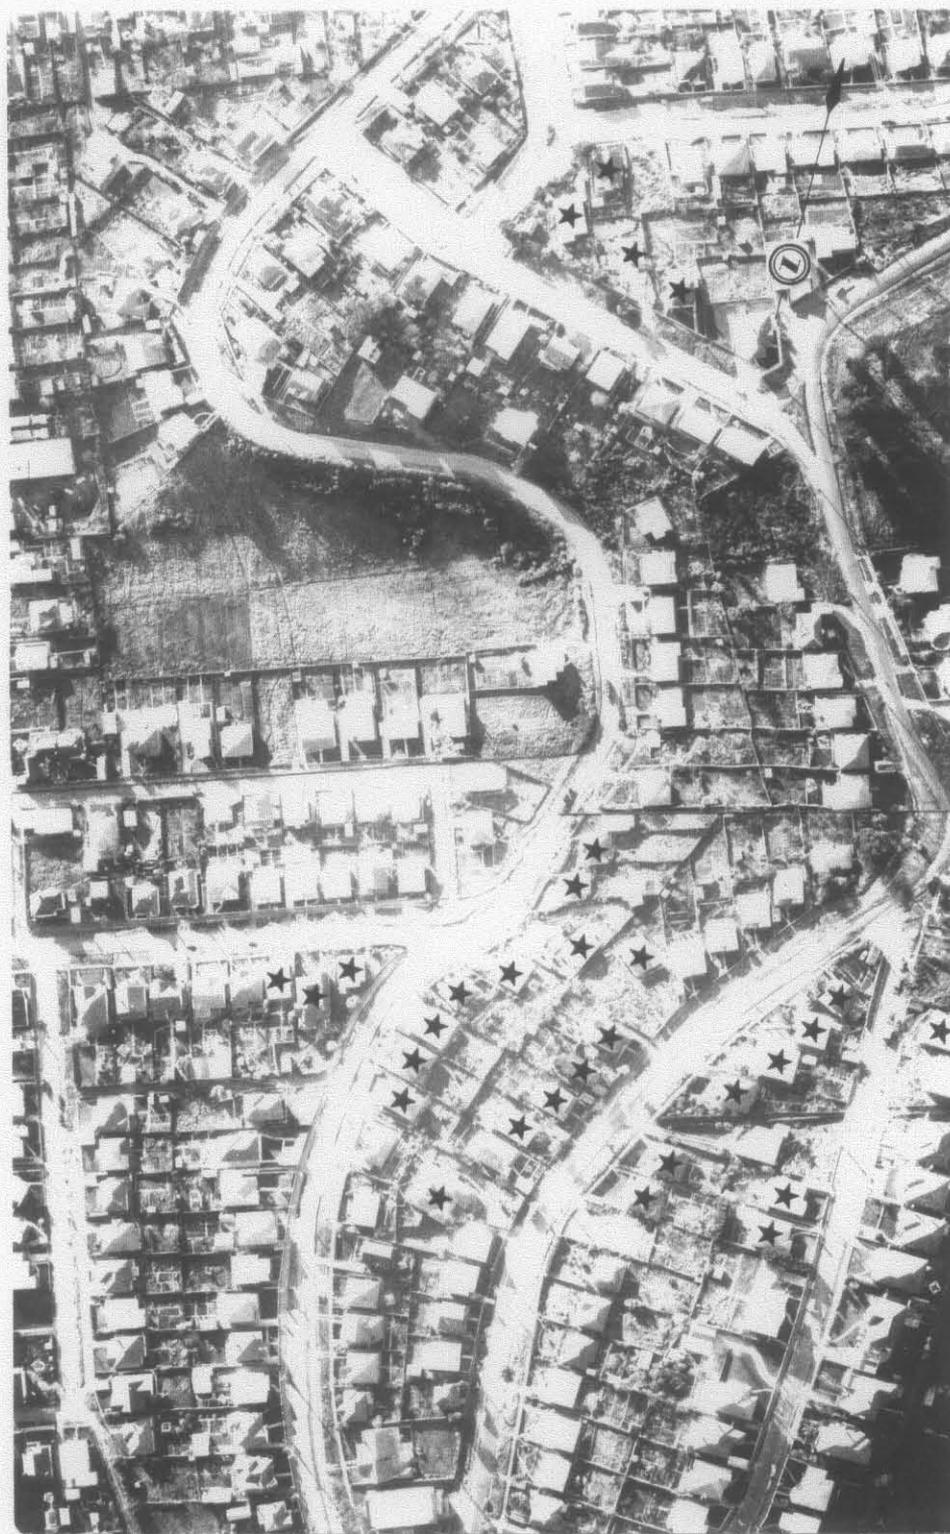
Aerial photograph of slip area, September 1960. Stars indicate houses subsequently demolished.

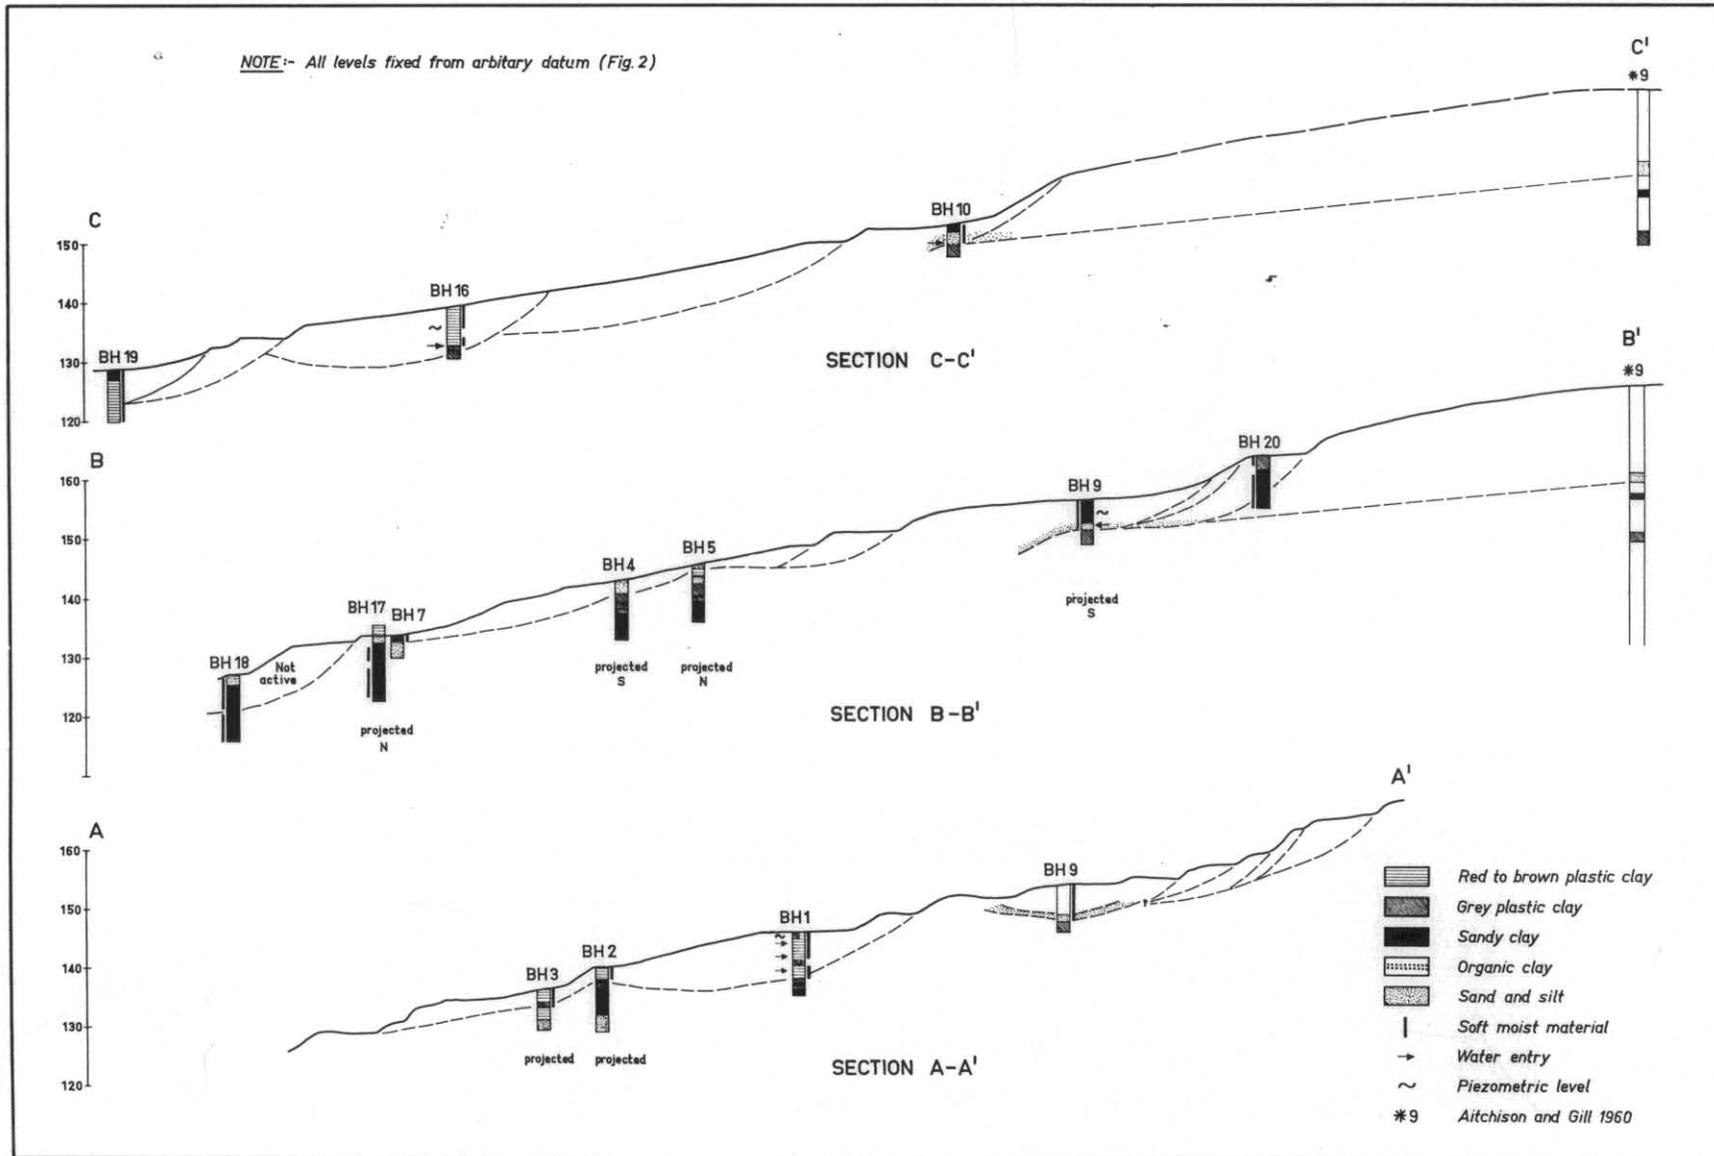
Figure 3a. Sections through landslide.

The southern lobe is less extensive in surface area, but is deeper. It was reached by holes 16, 17 and 19 and appears to be about 7 m deep (Fig. 3, Section C - C' and D - D'). The more extensive northern lobe does not affect the embankment below Meredith Crescent and appears to be largely translational and only 2 - 3 m in depth. This lobe was drilled by holes 2, 3, 4, 5, 6 and 7 (Fig. 3, Section E-E'). Hole 1 encountered a deeper soft section, which suggests that this is shallow rotational and that downslope of this is a shallow flow. (Section A-A').

Section B-B' shows that the slip is shallow above Meredith Crescent and does not affect the embankment below, although hole 18 intersects a considerable depth of moist or damp, soft sandy clay. A fairly soft and damp clay below the moist, soft layer occurs in holes 17 and 1. Soft moist clay was also present in hole 13, suggesting that a deeper and more extensive slip has existed in that part.

A sandy aquifer which is very wet and has significant pore pressure occurs above Lawrence Vale Road. This horizon is believed to form a basal slip zone of low strength and relatively high pore pressures on which the upper slopes can fail. (Fig. 3, Sections A-A', B-B', C-C'). Thus the slip is able to eat back into the hillside.

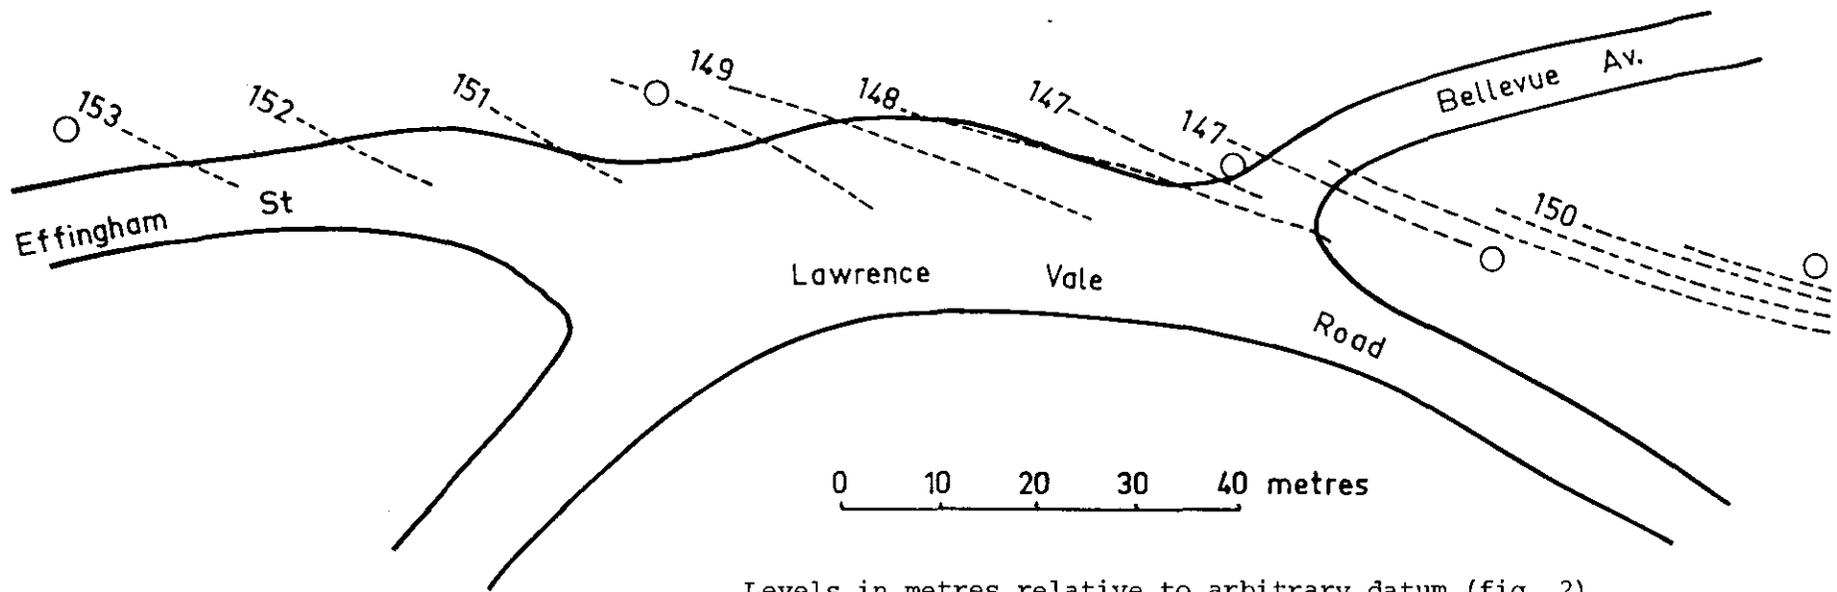
Figure 4. Levels to base of sandy aquifer.

By contouring the depth to the base of the sand and the piezometric surface (figs. 4, 5), a channel flowing along Effingham Street and Lawrence Vale Road at about 6 m below the present ground surface can be recognised. A sandy bed was located in bores 8 and 9 of Aitchison and Gill (1960). This is shown in sections B-B' and C-C' in Figure 3. This sandy aquifer is considered to be an horizon within the Tertiary sediments and the "channel" below Lawrence Vale Road is a downwarp in the aquifer.

The sand aquifer does need some form of drainage. Drainage in this aquifer would reduce pore pressure, thus increasing upslope stability and would also lessen infiltration of water into the material downslope.
