1977/54. Slope stability in the Bell Bay port area.

R.C. Donaldson  
C.J. Knights

The Port of Launceston Authority requested an investigation of the Bell Bay port area [DQ885460] following several stability problems that have arisen during the course of development. Instability is prevalent on both the natural and artificially constructed slopes, and in areas associated with fill material, causing concern to existing and proposed development (fig. 1).

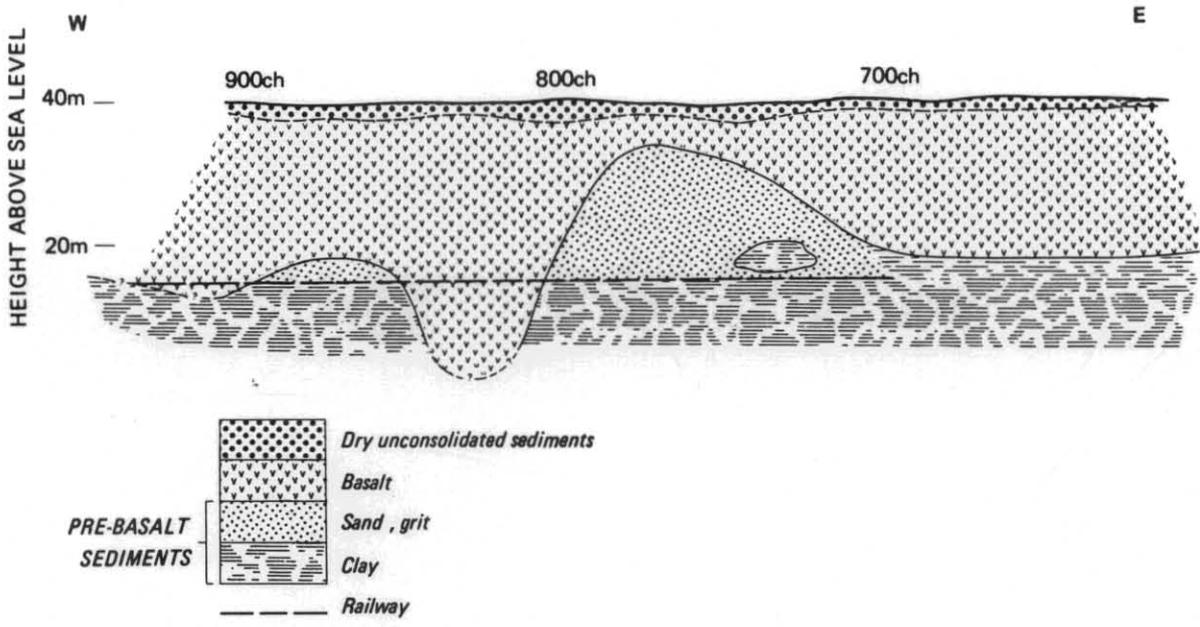
FIGURE 2

The geological conditions considered to exist west of the quarry, are shown in Figure 2. The locally high relief of the pre-basaltic sediments exposed in the escarpment between Ch720 and Ch780 forced the basalt to flow around either side, infilling a narrow channel at about Ch800.

From Ch820-Ch900, there is reasonable evidence to suggest that a similar set of geological conditions to that occurring in the quarry will be encountered. At the bottom of the escarpment [R.L. 16.0 m], basalt crops

out in the northern embankment of the railway line, while it overlies sediments in the southern embankment and defines the base of the basalt flow. This indicates that the base of the basalt, although locally irregular and undulating, can be expected to occur at about this altitude during excavation.

A second interpretation of the geology west of the quarry must warrant consideration. The topography of the escarpment between Ch820 and Ch900 suggests a past history of mass movement in the form of landslip. The features are subdued by the extensive undergrowth and talus deposits. If one accepts that movement has taken place, then one may equally well argue that the basalt exposed in the railway cutting represents a massive block of displaced basalt. Thus the sediments may in fact be present at a higher elevation than suggested, and perhaps similar to the landslip situation represented at Ch1170.

It is also possible that the basalt forms a shallow flow down the slope and over the clayey sands, in which case any excavation is likely to cut back through a veneer of basalt into the underlying sediments.

Due to the extensive basalt float obscuring much of the underlying geology, it is recommended that a short drilling programme precede any proposed excavation in order to verify the actual situation.

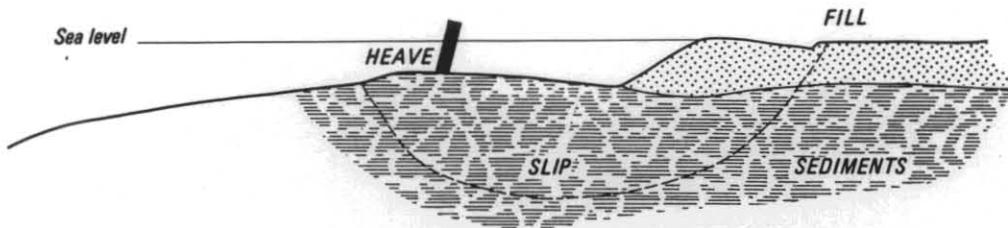
FIGURE 3

In this zone, the mooring dolphins, which are founded in Tertiary sediments about 13 m below river level, are tilted inward towards the shore. This movement suggests a deep seated failure of the substratum, as the direction of tilt is opposed to that which would be caused by the pulling of ships.

The fill material which makes up the reclaimed land shoreward of the moving dolphins has also failed. These two factors are probably connected (fig. 3). By this mechanism, loading by the fill causes gradual displacement of the underlying sediments and a consequent heave in the adjacent zone. The rate of displacement increases as embankment failure is approached, but with time, pore pressures are able to dissipate and the situation becomes more stable.

If the movement continues, the best remedial method is to load the heaving toe area around the dolphins with boulders.

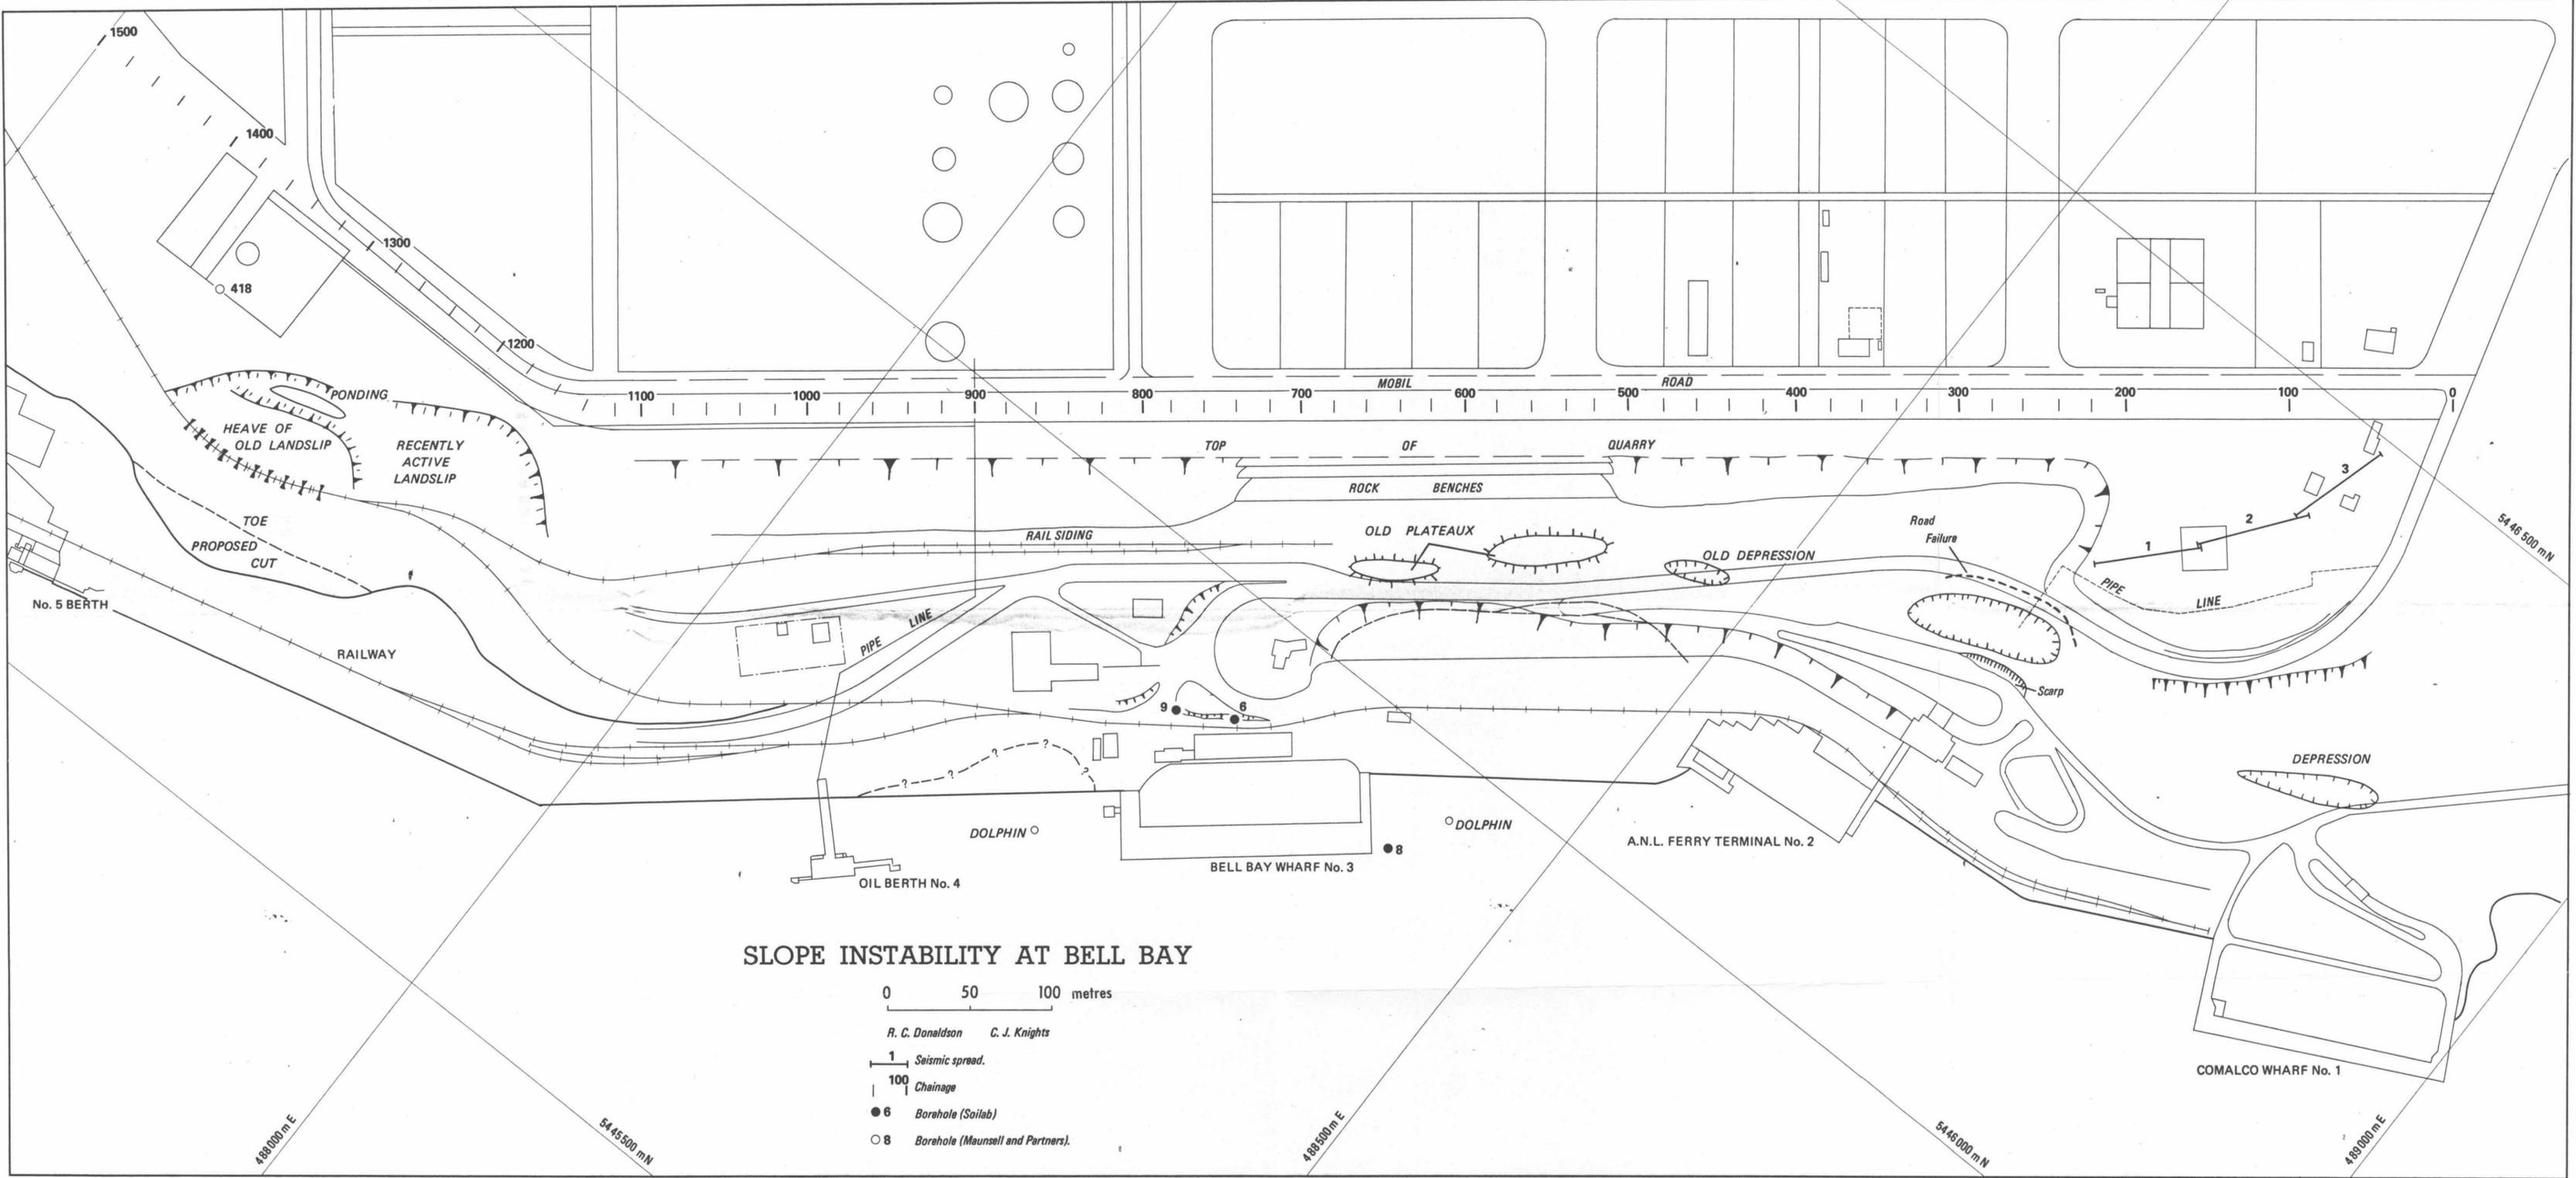
FIGURE 1

Large old and recently active landslips which extend from the shoreline back to the rear escarpment occur in this area (fig. 1). The eastern part of this area has been active within the last few years, when it damaged the road to the George H. Evans berth. ~~Work on this area was undertaken by~~

The western part of this area consists of a large old landslide, with the typical features of a heel, a back sloping heave area and a toe. There are no signs of recent movement and the slip may have been stable for a considerable period of time, possibly thousands of years. The proposed excavation will cut back into, and therefore unload, the toe of this slip, and may well reactivate a very large area.
