**TASMANIA DEPARTMENT OF MINES
UNPUBLISHED REPORT 1977/56**

**Inspection of a proposed subdivision
at Craythorne Road, Rosevears**

by D. J. Sloane

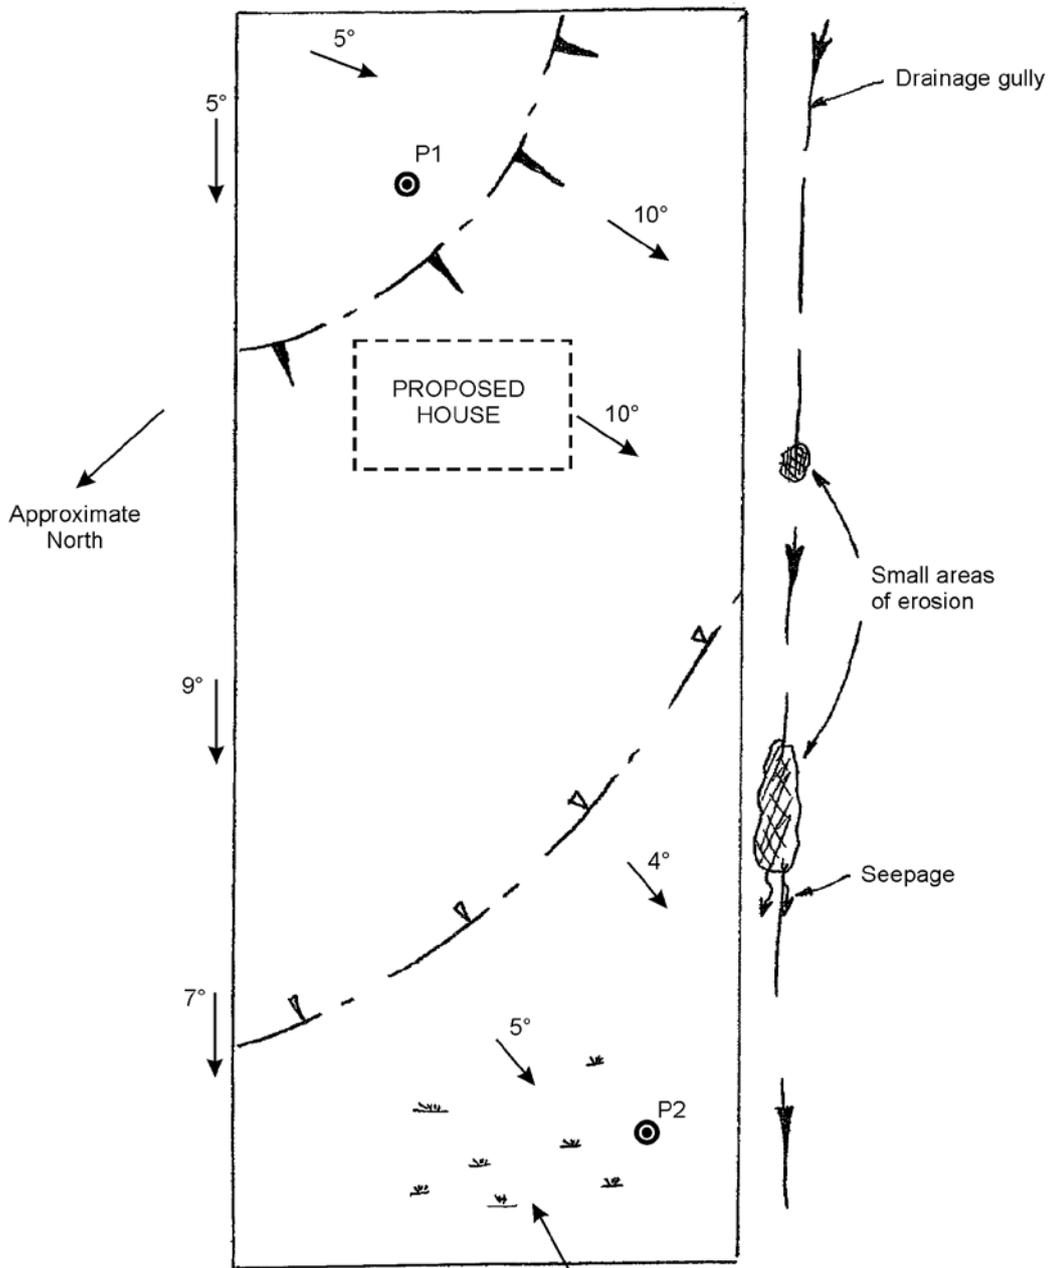
Figure 1

The slope and drainage conditions present on the proposed site are shown on Figure 1. There is evidence of seepage from a small gully along the south-western boundary of the block and the western corner of the block becomes very swampy during winter. The Beaconsfield Council apparently will not allow a septic tank system to be installed in this area.

These pits show that clay is present at shallow depth and exhibits low to moderate plasticity between depths of 2.9 and 3.0 metres. In view of this, together with the fact that the septic tank system will have to be located on the 10° slope segment, it appears unwise to approve this subdivision. The surrounding area in general has morphological features indicative of old landslips and is similar to the Bradys Lookout region where landslips are currently active. Inspection of the remainder of the property could be conducted upon request, with the view of selecting a more suitable building block. Such an area would be required to have a region of shallow slope (less than 7°) large enough to accommodate the house and septic tank sewerage system. The area just to the south-west of the present proposal may be suitable.

Swampy area — winter conditions
N.B Council will not approve septic tank
installation in this area (pers. comm.)
