## Stability Investigation of a Proposed Subdivision at Swan Bay.

D.J. Sloane

At a request from Investment Nominees Pty Ltd, a stability investigation was conducted on a proposed subdivision at Swan Bay [EQ015300], near Dilston.

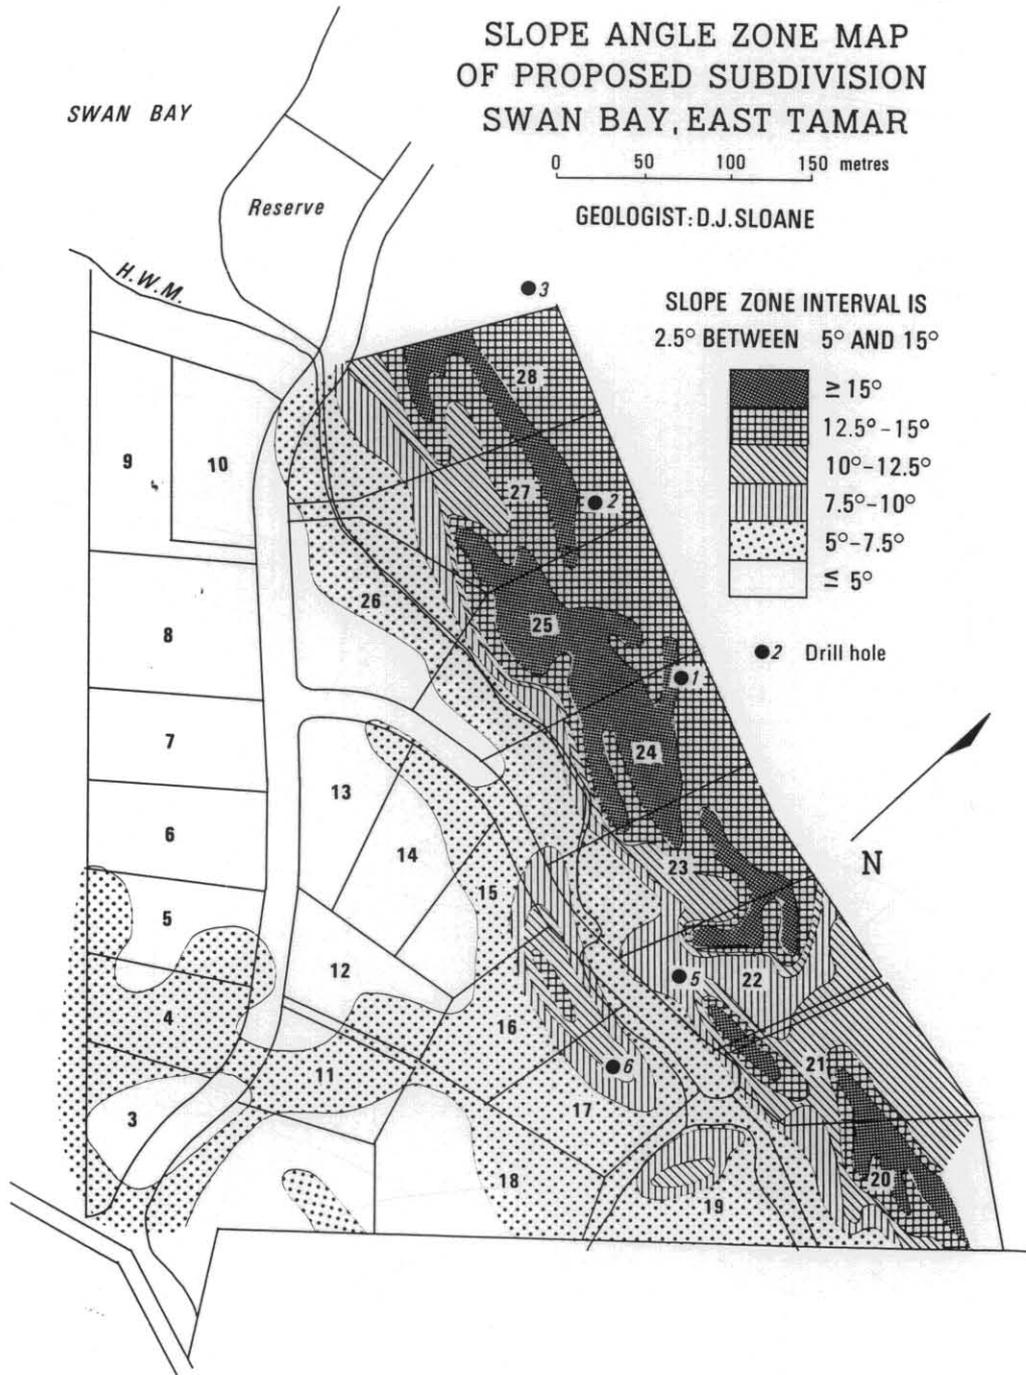
Figure 1.

The majority of the area has slopes of between  $2.5^{\circ}$  and  $8^{\circ}$  and is underlain by Tertiary sediments. Some of the 2-3 ha allotments (Fig. 1) are steeply sloping (up to  $20^{\circ}$ ) and the suitability of these areas for development is in question. Six Proline auger holes were drilled on the steeper slopes to determine the nature and condition of the underlying Tertiary clay, four on the proposed subdivision and two on an area to the north which is to be subdivided at a later date. A slope zone map was prepared (Fig. 1) based on contour information from the subdivision plan. The zone map is based on  $2.5^{\circ}$  intervals and outlines the steeper slopes to the north-east. Slope zones less than  $7.5^{\circ}$  are generally considered to be stable.

sloping segment on lots 22 to 28 should not be built on. The disposal of septic tank effluent in this region should not be permitted. The same conditions are likely to apply for the continuation of this segment to the north, beyond the present subdivision and extending to Hole P4.

Lots 2 to 15 inclusive and lots 18 and 19 can be developed without restrictions. Building and septic tank installation is not recommended on the northern half of lots 16 and 17 and the south-western half of lots 20 and 21. That portion of lots 25 and 26 to the north of the watercourse is also considered unsuitable for development. Lots 22, 23, 24, 27 and 28 are considered unsuitable for development. These allotments could be altered by extending the north-eastern boundary at least 50 m towards the north-east. This additional area would be considered suitable for building development. In view of the lack of a contour map of this region, and also the area to the north-west of the subdivision, any modification of the subdivision as outlined above would require preparation of a contour map and re-inspection.

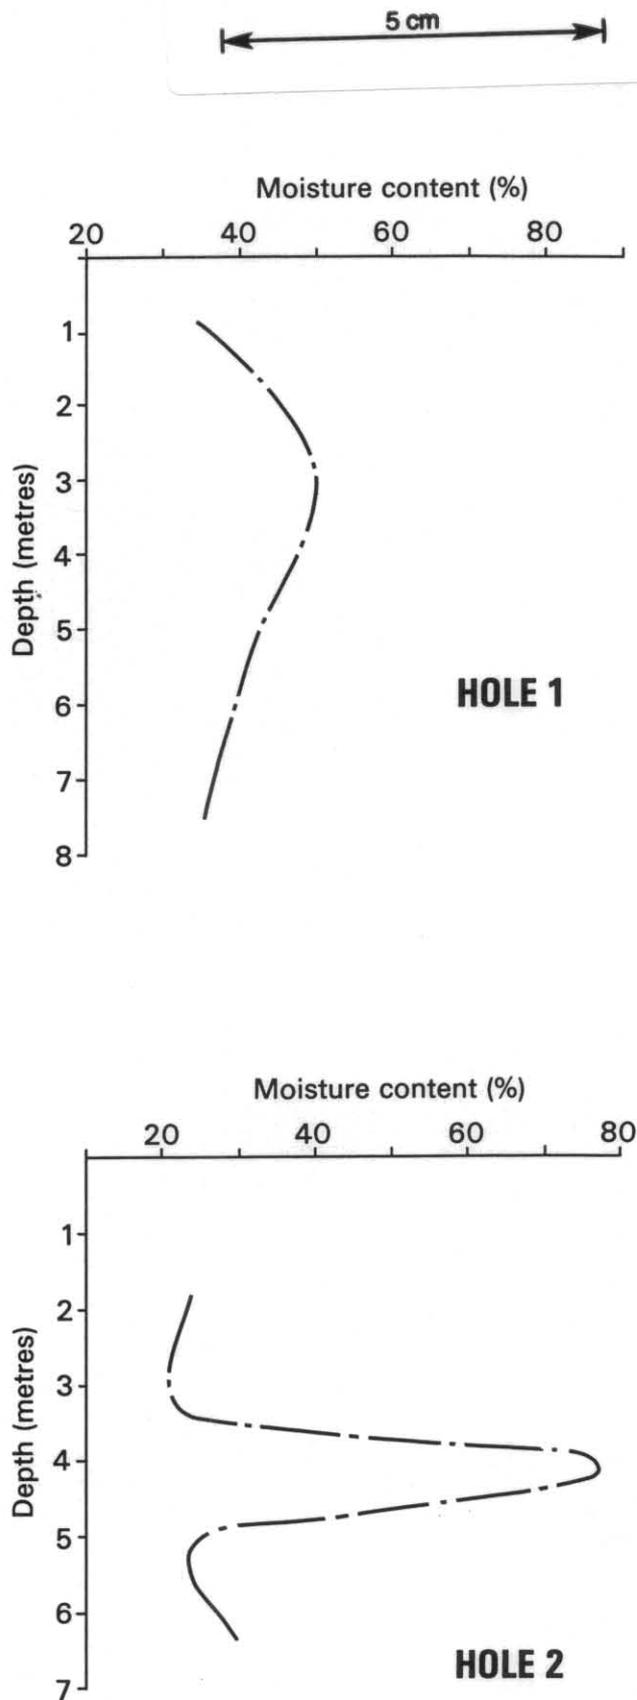
All steep slopes of allotments 22 to 28 inclusive are underlain by Tertiary clay and clayey sand. Borehole logs for the Proline auger holes are given in Appendix 1. Clay encountered in the holes has a moderate to high plasticity and low to high moisture content. Clay from Holes P1, P2 and P3 have the highest plasticity and moisture content; Hole P2, located near the boundary of lot 27, has the highest values. Free water was present after drilling in all holes except P1. The groundwater appears to be present in fissures in the clay, although Hole P2 has a clayey sand aquifer. Water movement is occurring through the clay at a depth of between 4.3 and 6.4 m. Water levels were recorded immediately after drilling and 24 hours after drilling. Closure occurred in Hole P2 at a depth of 3.04 m and in Hole P4 at a depth of 3.58 m indicating the highly plastic nature of the clay.

Figure 2. Moisture content expressed as a percentage of dry weight.
