Subsurface investigation and slope stability of Haack's sub-division at Underwood, Lilydale Municipality.

W.R. Moore

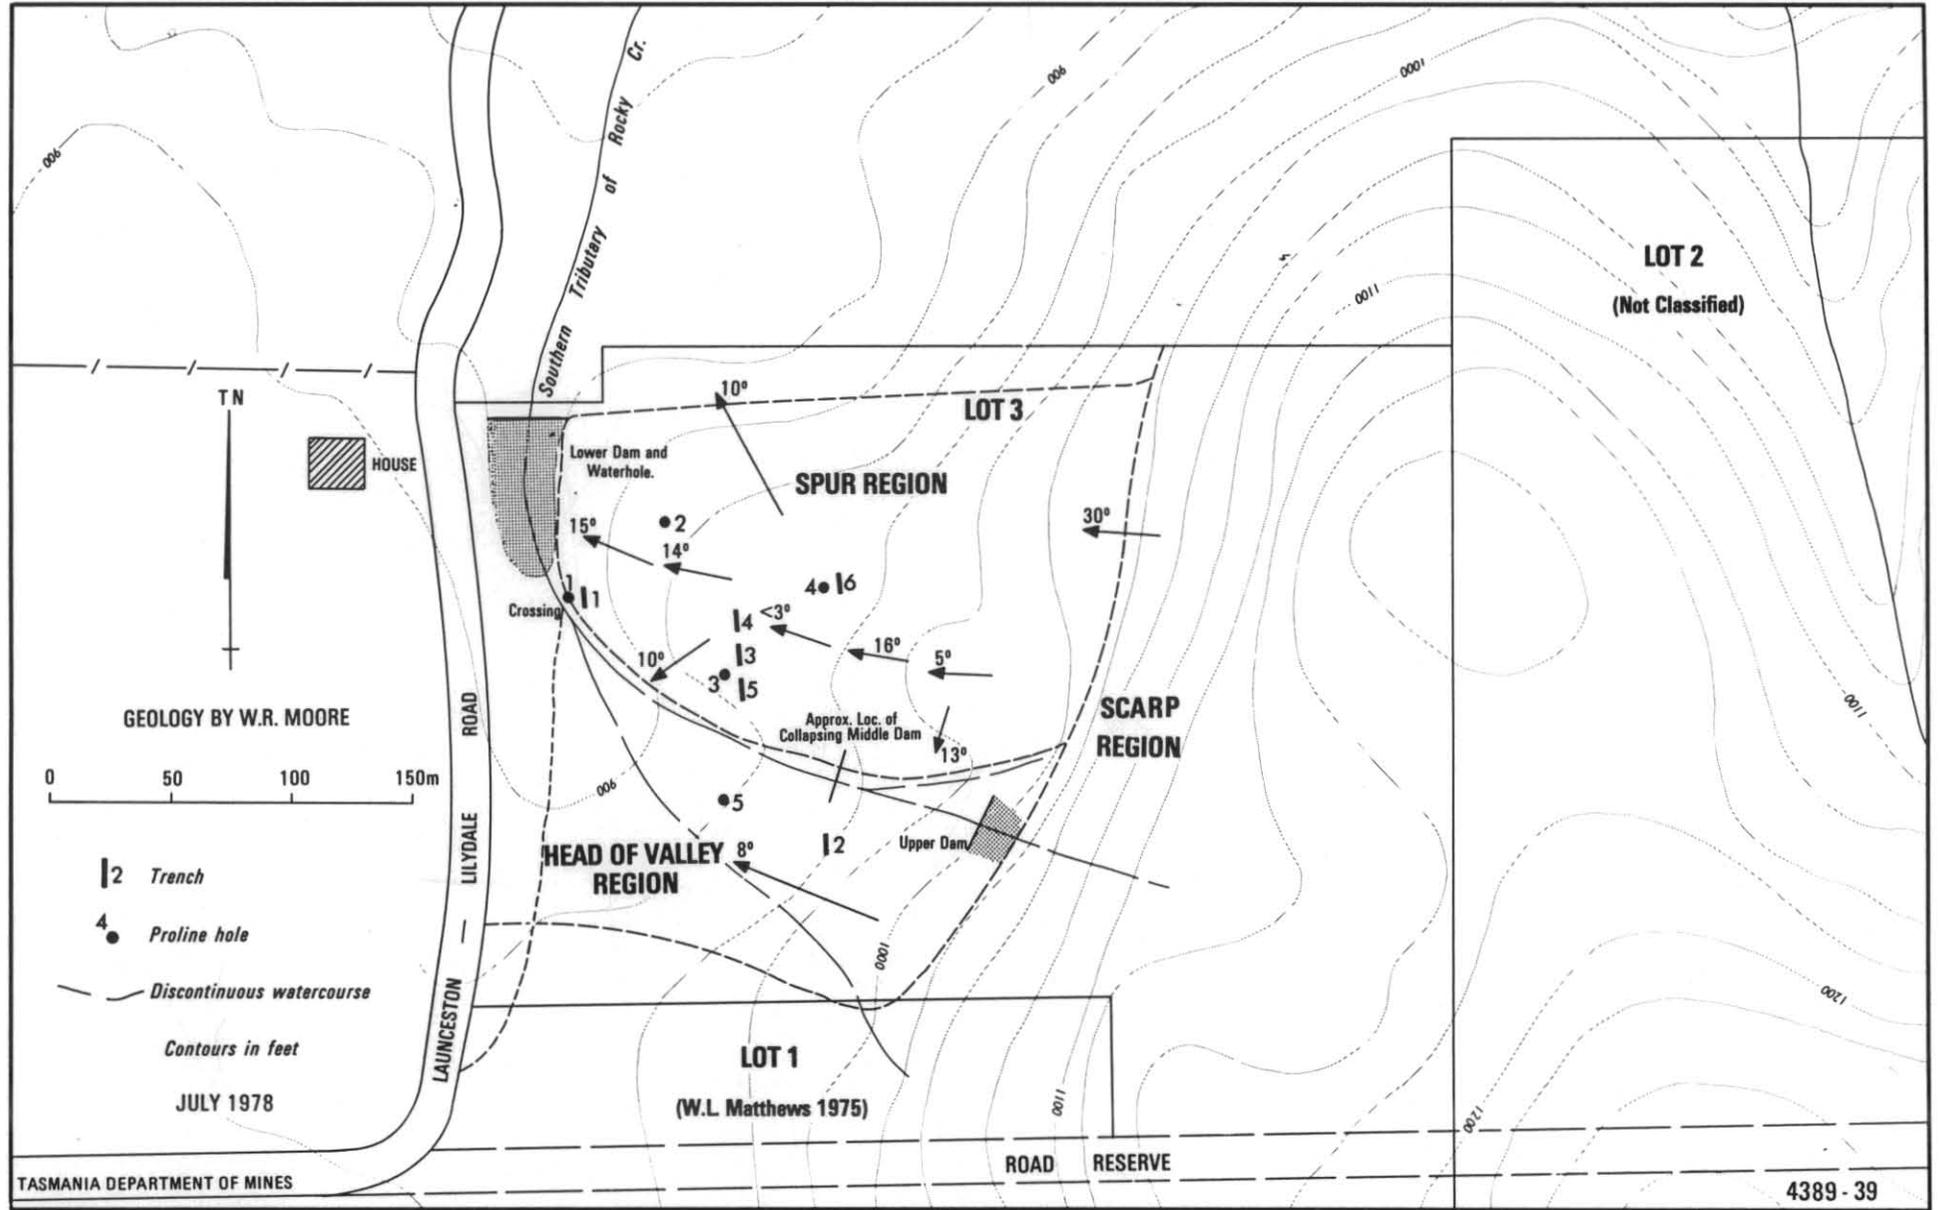
Figure 1. Location of test pits and auger holes

This area comprises a heavily bushed steep face which rises 46 m then flattens to a spur ridge at its eastern border. No attempt has been made to locate this eastern boundary on the ground and its position has been plotted from the survey plans (fig. 1).

At the eastern end of the benches, toward the toe of the higher bench and at the foot of the scarp face, are two marshy hollows. These hollows give the benches the appearance of tilting backward towards the east. The contours of these benches show a marked discordance from the scarp face contours (fig. 1). No rock outcrops were visible, but dolerite boulders are scattered all over the benches and spur slope. Small active landslips on the southern margin at the abutments of the small middle dam expose a yellow clay and mudstone which appears to be derived from Triassic sediments.

This topographic region is the curved wide headwater area of the Rocky Creek tributary. Above the dam located in the narrow stream valley at the northern boundary of Lot 3, the stream subdivides into several small streamlets (fig. 1). The valley widens and changes direction and the slope flattens, forming a shallow, amphitheatre shaped basin.

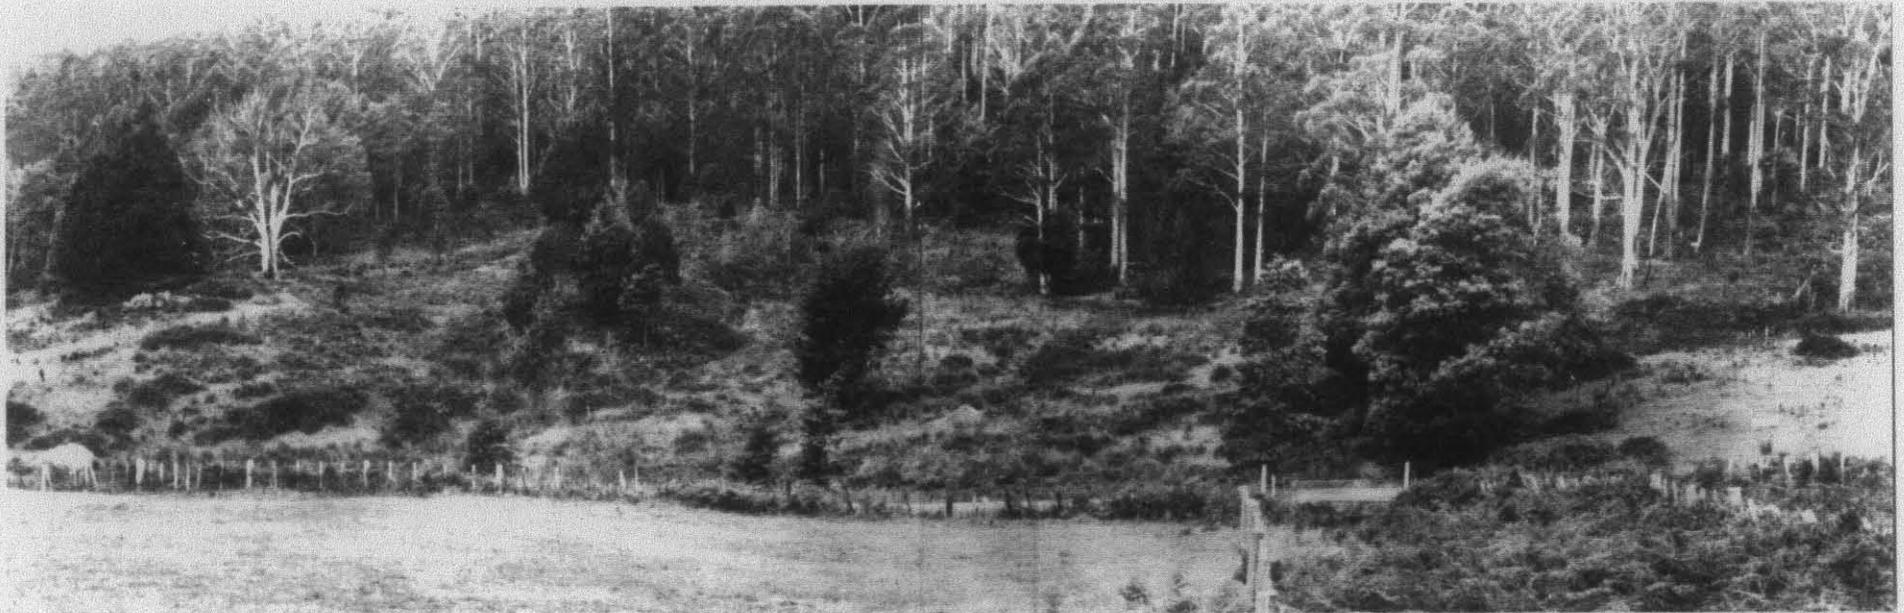
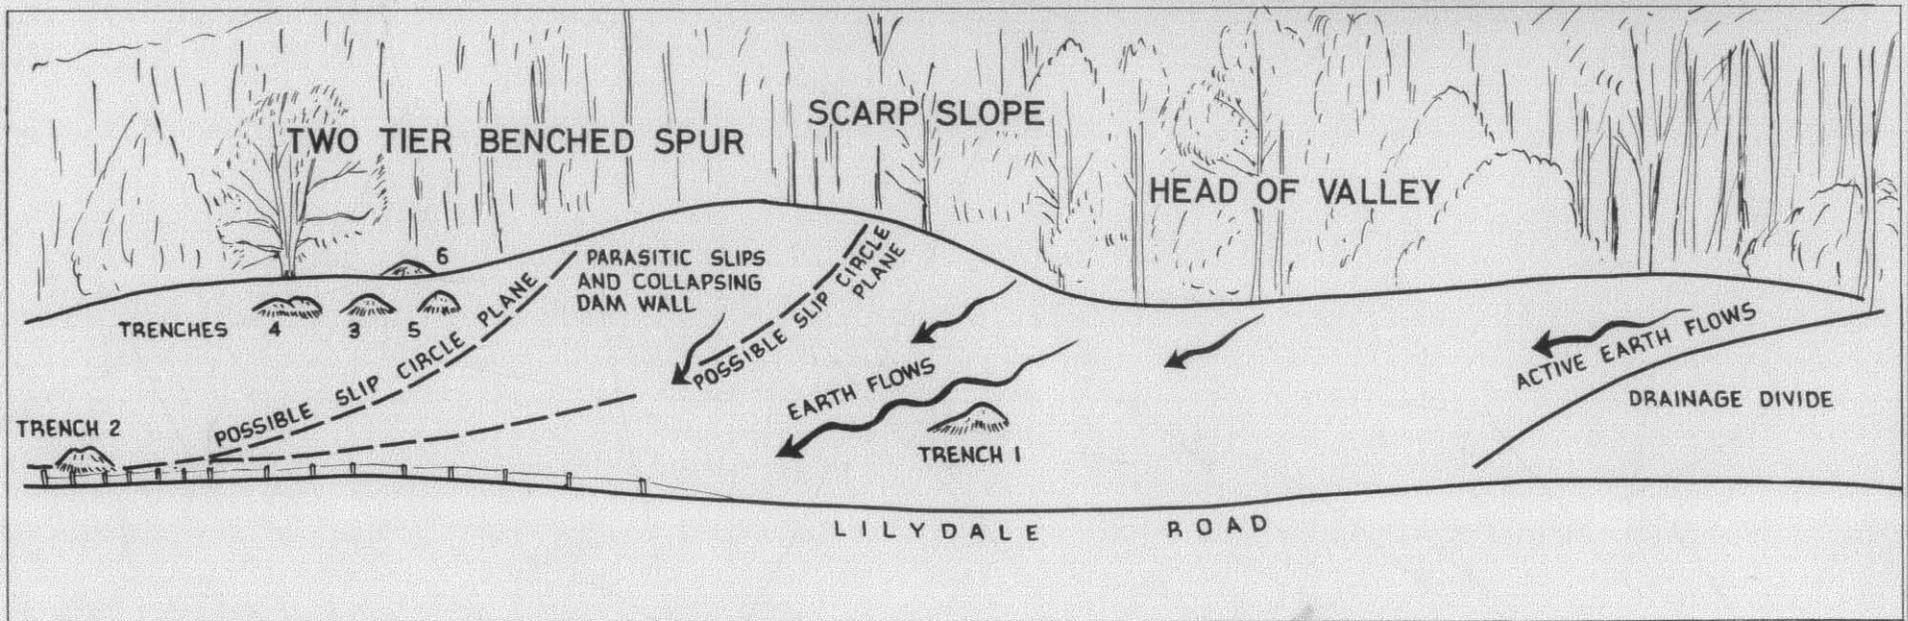
Plate 1. Panoramic view of area under investigation

Lot 3 can be subdivided into three distinct topographic regions (plate 1, fig. 1).

- (1) Steep scarp slope
- (2) Two tier benched spur.
- (3) Shallow curved head of valley.

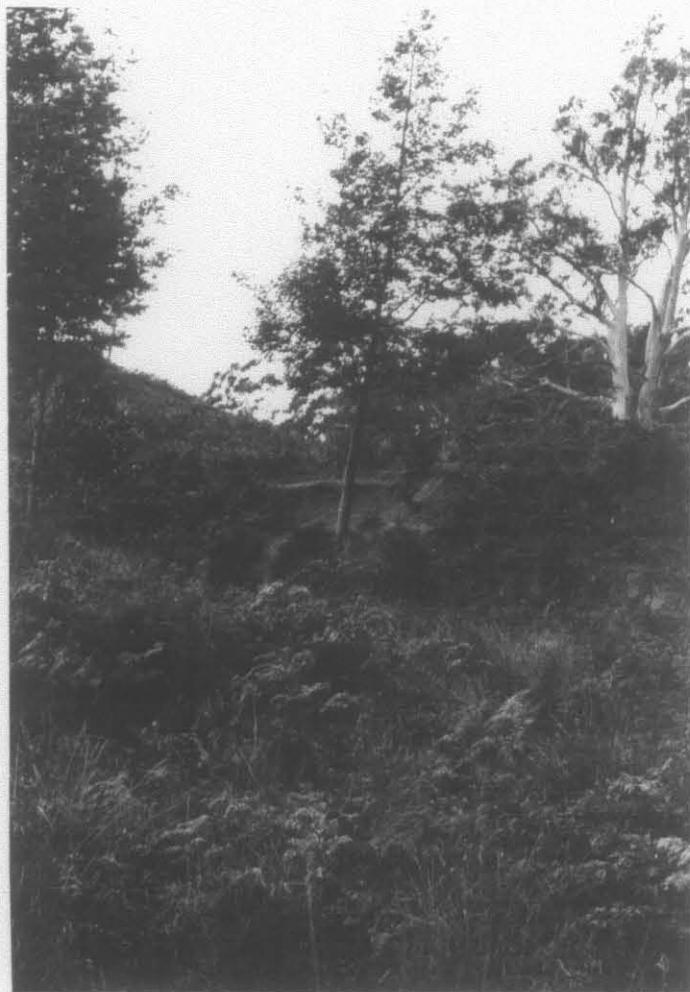
In this area, the streamlets are a series of small, shallow, narrow discontinuous gutters connecting a series of marshy hollows. Small dams have been constructed on two of the streams. The upper dam near the bush line at the foot of scarp slope holds little water and is almost completely silted up and overgrown. The middle dam has a small shallow pool of water behind it, but the bank at the southern end has collapsed and an active slump area is present at the other end (plate 2). The overall slope on the valley floor is 7°-8°.

The number of trees in the headwaters of the valley is not great; some have been recently tilted and are associated with the small active areas (plate 2). These shallow slumps or parasitic landslips are continuing to extend the valley by headward erosion into the spur and scarp areas. Elsewhere in the headwaters, there was no obvious tilting of large trees. The age of the shallow flow in the valley floor is uncertain but appears to be recent. No tension cracks were found.

Any housing developed on this area would increase the amount of groundwater from sullage and septic tanks and would probably cause local failures, as has occurred at the small dams. The risk of reactivation of the existing slip appears high and a conventionally constructed house would be unlikely to survive such movement. Therefore on the surface evidence alone, the valley head area should be classified as an active landslip zone. As a subsurface investigation was required for the spur area, some subsurface investigation was undertaken in this area.

Plate 2. *Middle dam with active parasitic slump and collapsing embankment.*

The head of the valley region and the scarp region should both be classified as active landslip zones where no buildings should be sited.

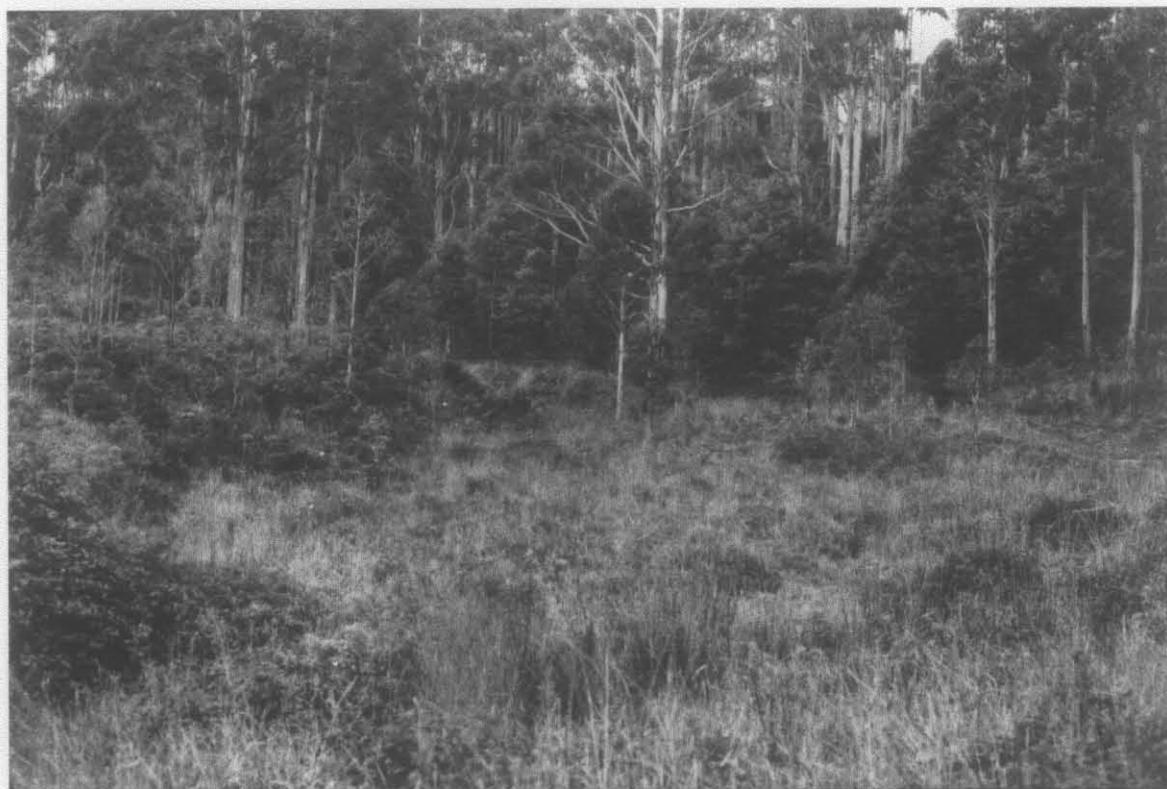
The most conspicuous feature of this area is a series of small discontinuous pressure ridges (plate 3). These features are characteristic of the shallow planar landslide or earth flow that occupies most of the valley and extends into the neighbouring Lot 1. It is difficult to know if the area is all one large flow or a series of small earth flows around the valley margins that have coalesced, filling the head of the valley. Dolerite boulders occur in this area but are not as obvious and appear scattered compared with the spur area. Small outcrops near the middle dam indicate that the area is underlain by clay, sandstone and mudstone of Triassic age.

Plate 3. *Small pressure ridges in amphitheatre shaped head of valley area*

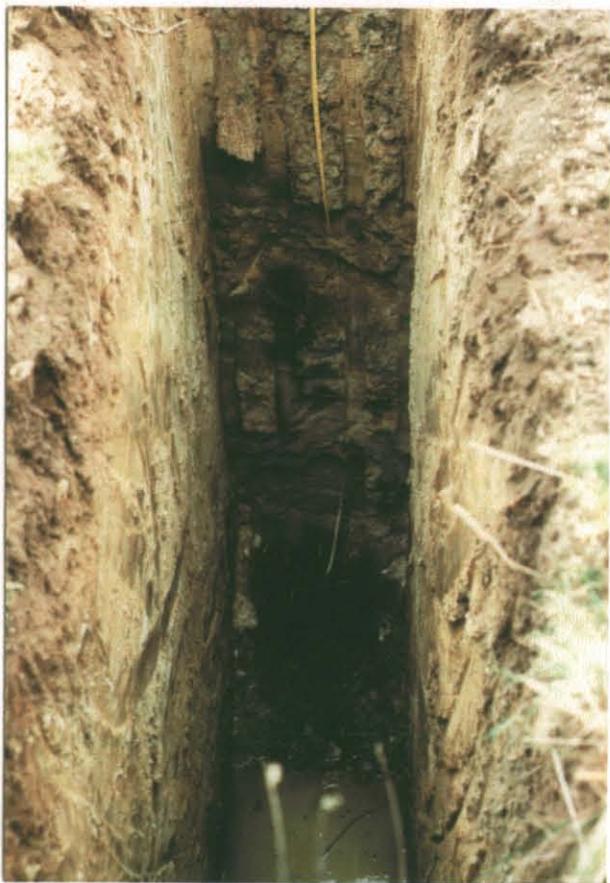
sequence of clay to sandstone and mudstone of Triassic age (plate 4). The clay layer was 3.5 m thick in the landslip area compared with 1.5 m at the foot of the spur (Appendix 1, 2). The water table was at approximately the same level below ground surface for both trenches and the trenches made very little water in the time they were left open. Any subsurface movement is likely to be confined to the upper horizon of the clay and the upper weathered zone of the mudstone-sandstone sequence. Any future movement is likely to be shallow and at depths no greater than 3.5 m. No slip planes, slickensides, or shear polish were found in the trenches to indicate the level of any past movement.

Plate 4. *Clay overlying Triassic sandstone-mudstone - Trench.2.*

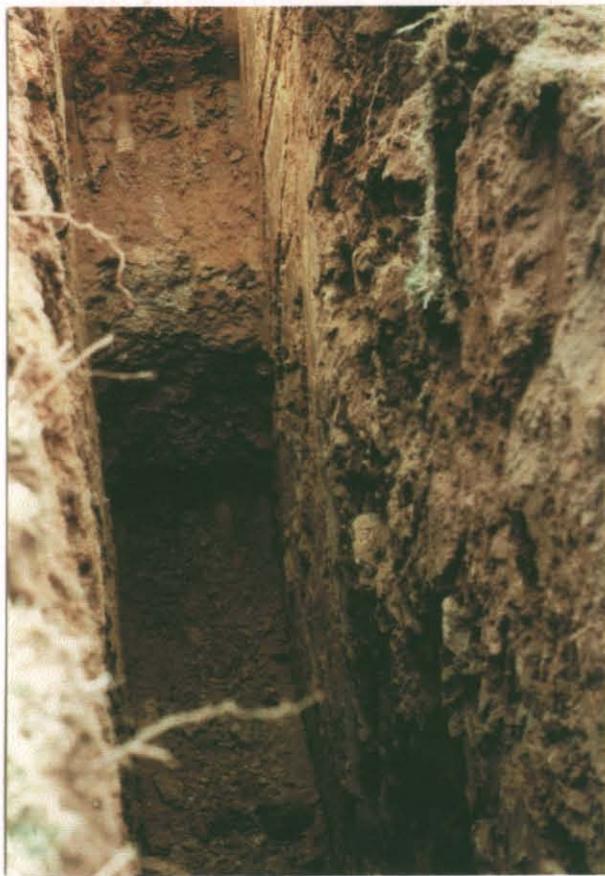
As the data obtained from this drilling were not considered sufficient, a back-hoe was used to dig four trenches on the lower bench. Unfortunately time did not allow for any investigation of the higher bench. Trench 3, excavated on the site of Hole 3, showed a yellow clay overlying weathered, bedded Triassic mudstone at the southern end of the trench. No boulders were encountered. A contact between the yellow clay and a boulder bed was exposed in the northern end of the trench; the contact dipped 60° from the surface to a depth of 2.8 m below the boulder bed (plate 5) where it became flat. The boulders comprised iron stained and fresh dolerite, irregular in shape and up to one metre in size in a mottled grey-brown clay matrix. This clay is frequently found above dolerite and differs from the yellow clay derived from the Triassic mudstone. A thin, discontinuous horizontal iron pan layer was present in the boulder bed at 1.1 m depth. This layer could not be traced in the yellow clay and mudstone at the southern end of the trench.

Plate 5. *Gravel overlying mudstone with dipping interface - Trench 3.*

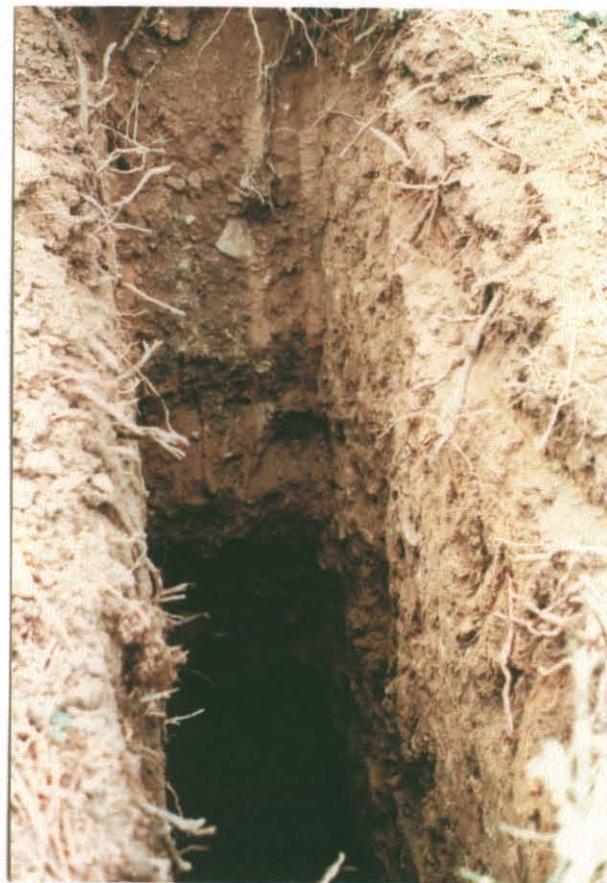
Plate 6. *Soil horizon developed on gravel - Trench 6.*

Trench 6 was excavated at the foot of the second bench in the marsh area. A boulder bed was exposed to a depth of 2.3 m but no iron pan layer was seen. A well developed soil profile was exposed at the surface indicating the area had been stable for a long time (plate 6).
