Slope stability in the Mt Punter area, eastern Tasmania.

D.J. Sloane

Abstract

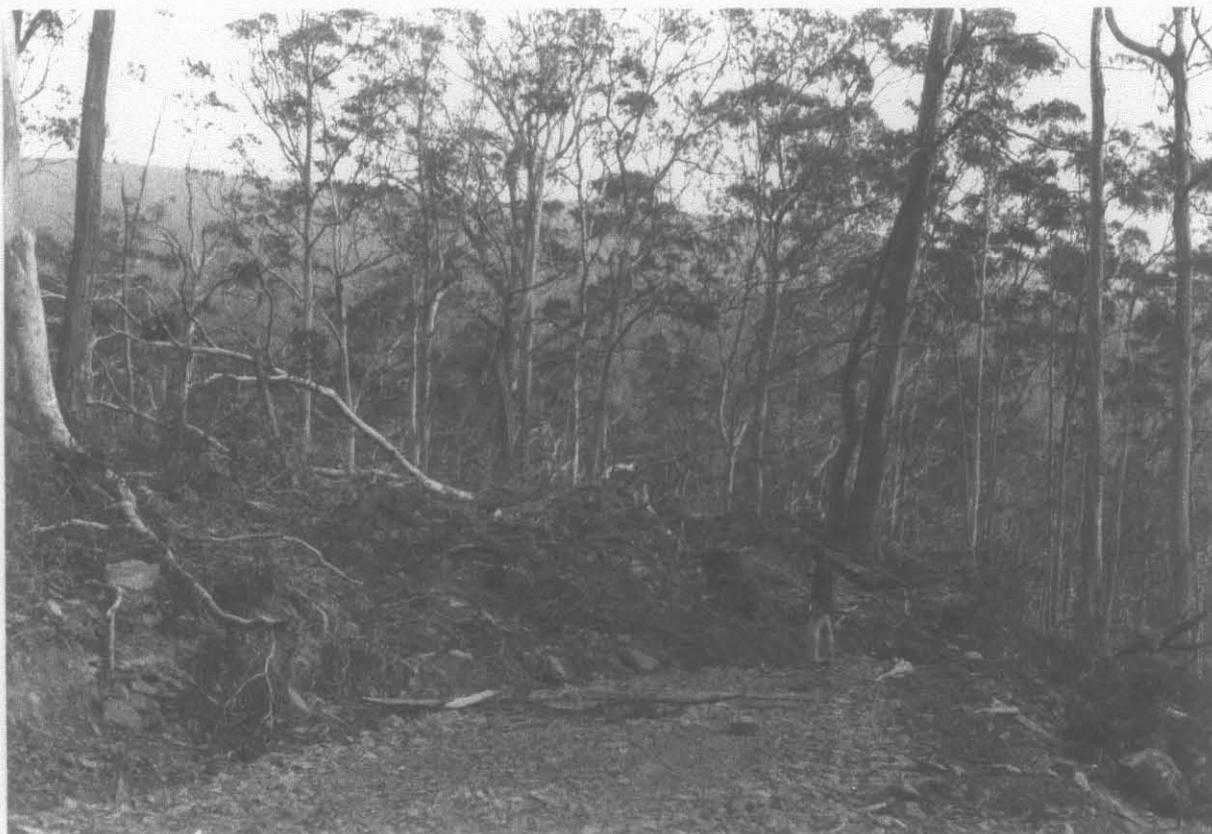
Plate 1. *Toe area of main landslide blocking the MG22 access road. Note large tree still upright after being transported some 15m from its original position.*

One large landslide has occurred which has blocked the MG22 access road (plate 1). The landslide is approximately 25 m wide by 75 m in length and between 4m and 5 m in depth. The head and side scarps are almost vertical and show good exposures of the talus material which has failed. In the head regions of the landslide small patches of the underlying Triassic rocks are exposed and evidence can be seen of patches of weathered Triassic rocks that have been included in the landslide material as it moved over the bedrock. From the talus exposures along the MG22 road the landslide occurs where the talus is thickest. Elsewhere along the MG22 road talus thicknesses range between 1 and 2 m. In the region of the main landslide the road is benched into a small hillside spur. This spur may in fact be the toe area of an old landslide. A short distance upslope from the active landslide morphological features belonging to an old landslide can be recognised. A small arcuate steeper slope segment can be seen while downslope from this is a flat section which is sloping back towards the regional hill slope. This 'back-slope' area also has trees which lean back towards the hill slope. Since this feature appears to be an old landslide and its presence explains the existence of a greater thickness of talus in the region of the active landslide as this area is probably the toe of the old slip. A previous history of failure may also be indicated by an exposure of talus material just to the north of the landslide. Here a small stream has eroded to the bedrock adjacent to the road and the talus has also been cut during road construction. The talus overlying the bedrock can be separated into a lower and upper deposit (plate 3). The lower deposit is composed largely of weathered dolerite derived silty clay containing about 5% to 10% of angular dolerite fragments. At the base of this unit there is a predominance of large dolerite boulders up to 0.5 m in diameter. The upper deposit is largely silty clay with less than 10% of dolerite fragments. At the interface of the two deposits discolouration has occurred indicating a possible hiatus between the deposits with weathering and incipient soil profile development occurring on the lower talus deposit before the upper solifluction, or possibly landslide material, was deposited.

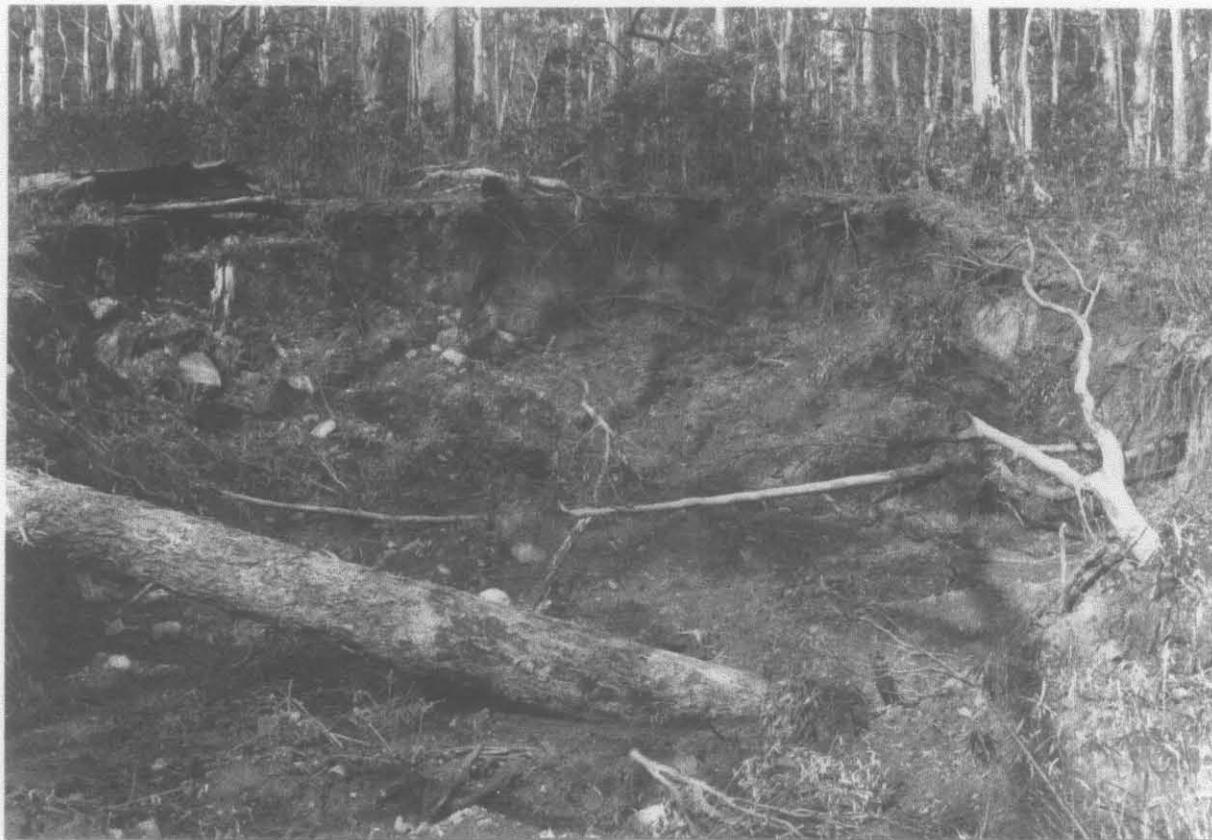
Plate 2. *Head scarp of main landslide. Note shallow tabular nature of slip with near vertical head scarp and side scarps.*

The main landslide is tabular in nature, the base of the landslide approximately parallelling the ground surface slope of 12°. Water flowing at the base of the talus material has provided lubrication at the base of the landslide which is located at the bedrock-talus interface. The water has also caused saturation of the talus in this region. Once disturbance has occurred it is likely that water moves up into the material due to increased pore pressures and the talus may even become thixotropic.

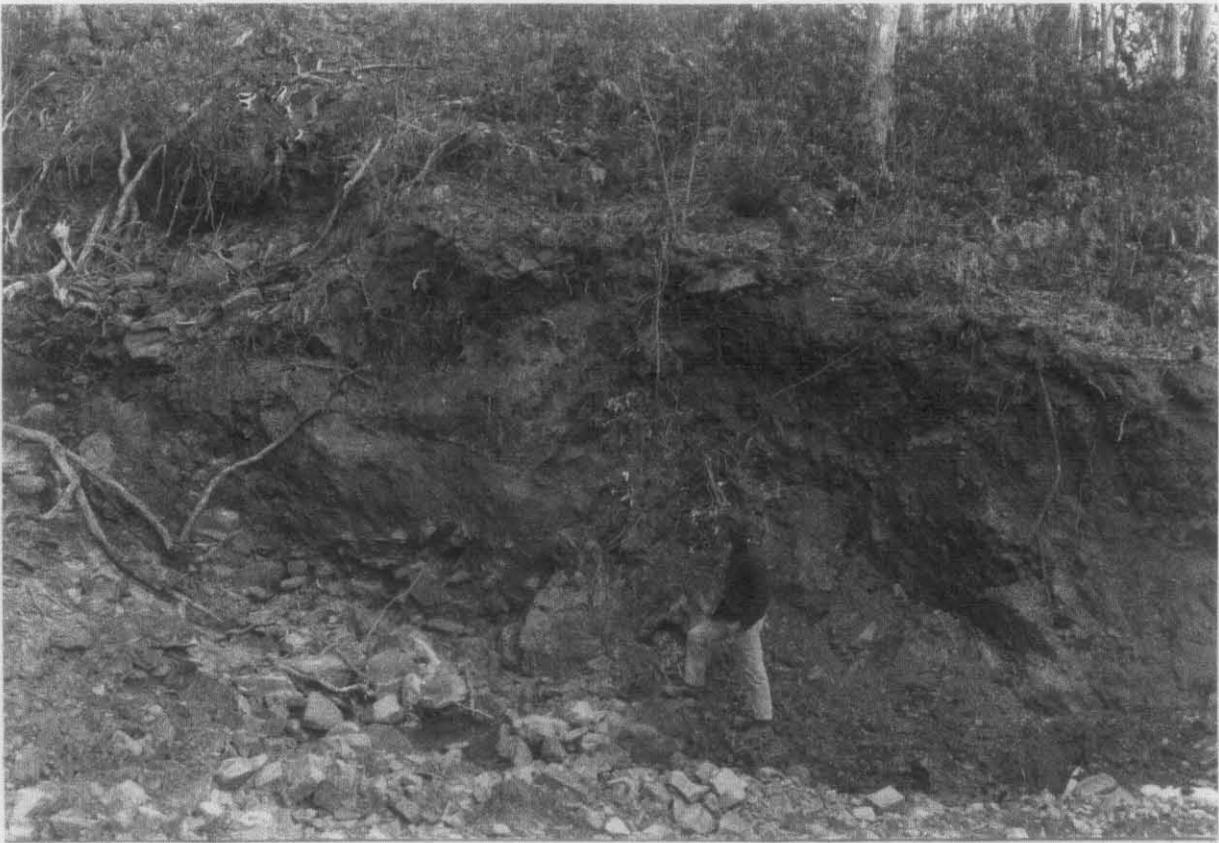
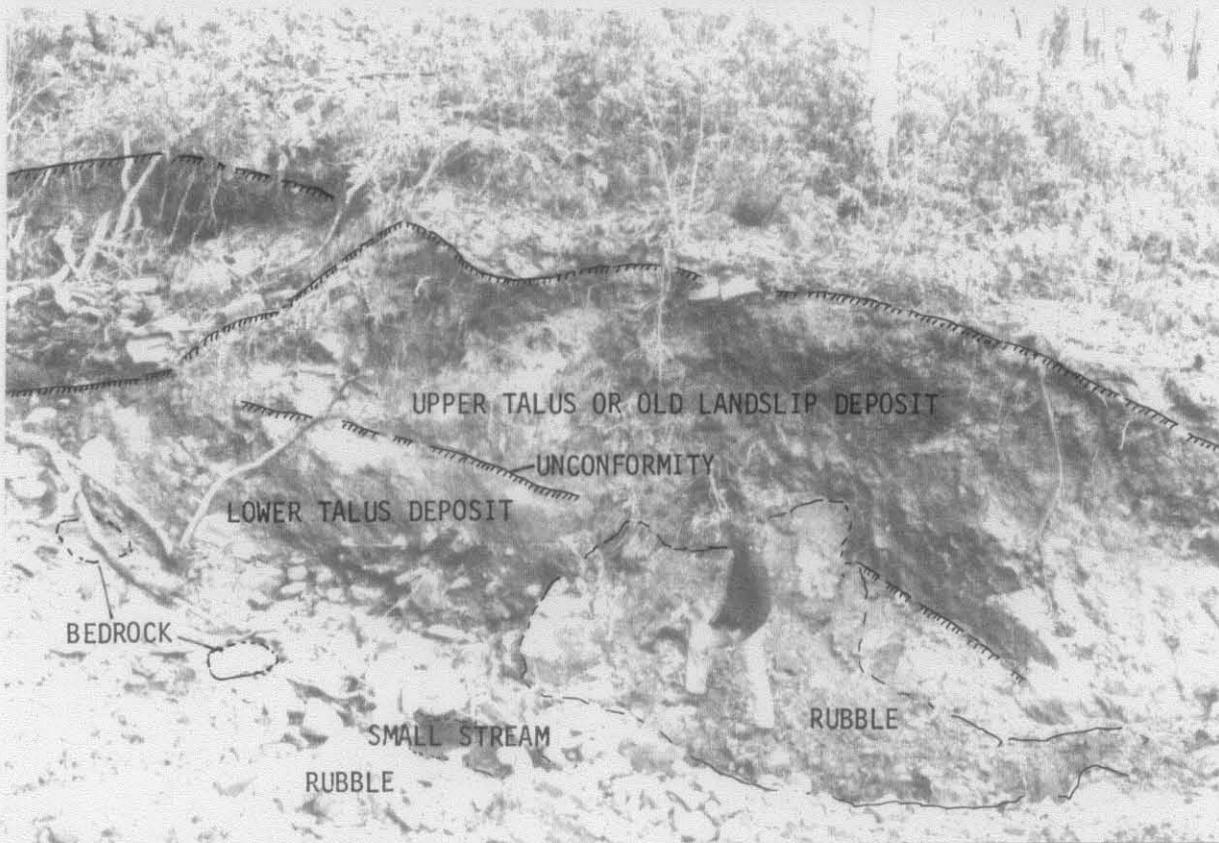
Plate 3. Talus exposure adjacent to main landslip MG22 road.

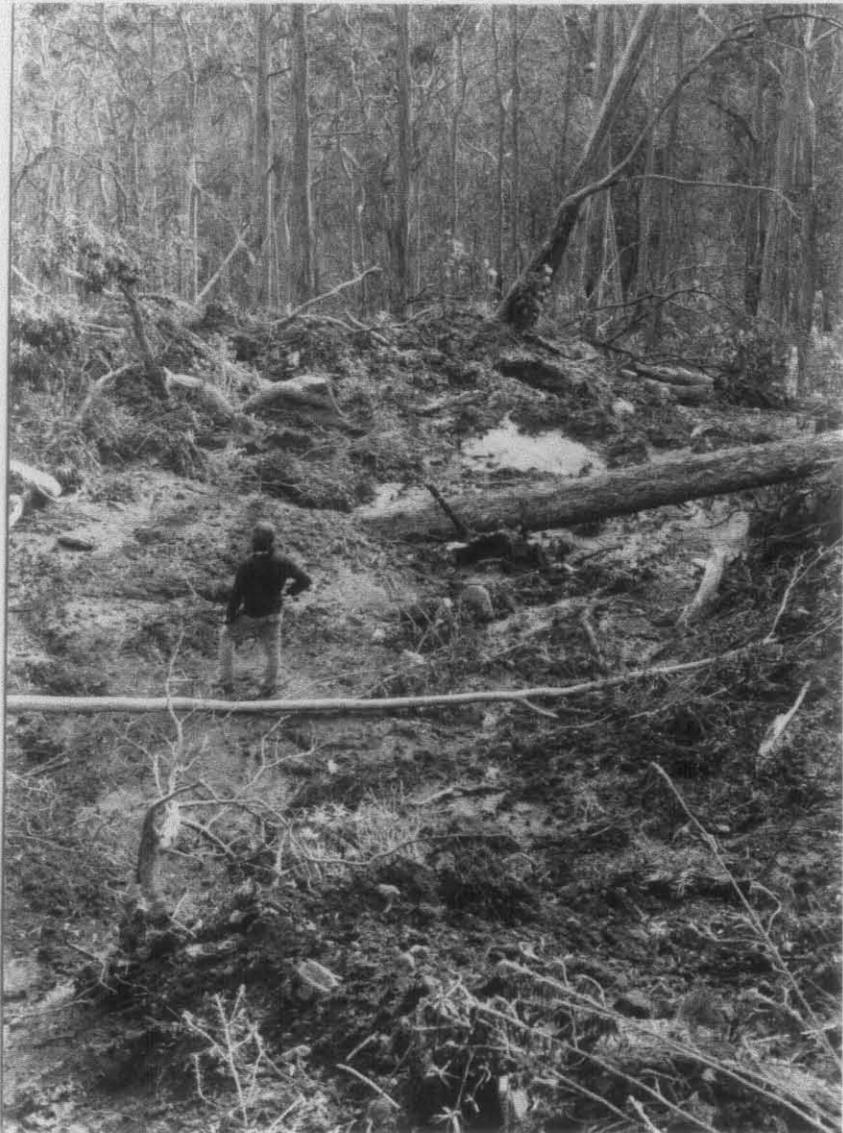
Plate 4. *View of main landslide looking from the headscarp towards the toe area; note prone tree in centre.*

The large landslide which has blocked the road could be classified as a tabular debris slide. Its main features have been described previously. The debris material appears to have been water saturated during failure. This is indicated by the completely disaggregated appearance of the failed material (plate 4) compared to landslips in other areas where progressive failure has resulted in a series of 'slices' in the head region of the slip. A large tree has remained upright during failure and is now sitting on the debris toe at the edge of the original road indicating a displacement of at least 15 m.

Some idea of the speed of the landslide can be obtained from inspection of a large tree carried down with the debris. The tree is lying perpendicular to the direction of movement the butt becoming buried in the water saturated landslide debris (plate 4). Movement of the landslide has resulted in the tree striking another tree on the stable area adjacent to the landslide. The force of impact has shattered the tree carried by the landslide (plate 5). This is indication of rapid failure of material which was probably fairly liquid.

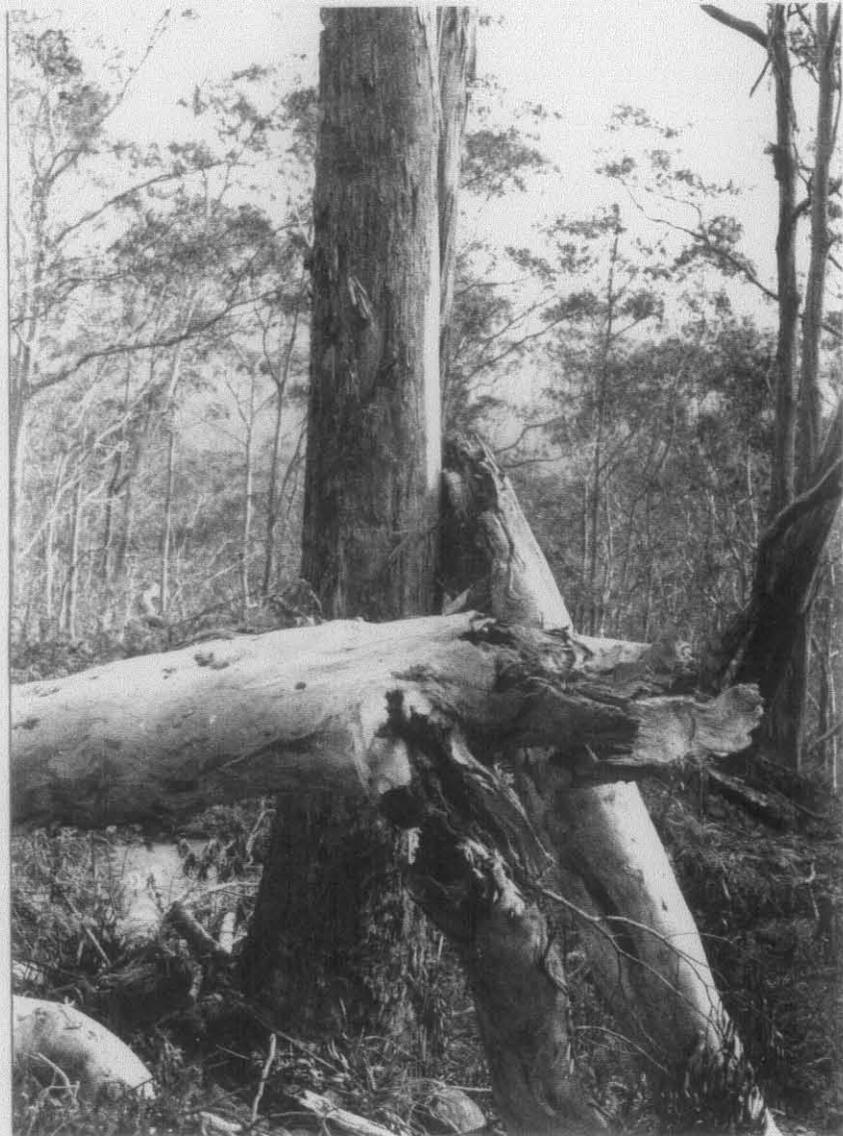
Plate 5. *Prone tree carried by landslide has shattered against an upright tree on the stable area adjacent to the main landslide.*
