**TASMANIA DEPARTMENT OF MINES
UNPUBLISHED REPORT 1978/45**

Inspection of land near North Riverside

HEWITT'S SUBDIVISION — LOT 5
Geologist: D. J. Sloane

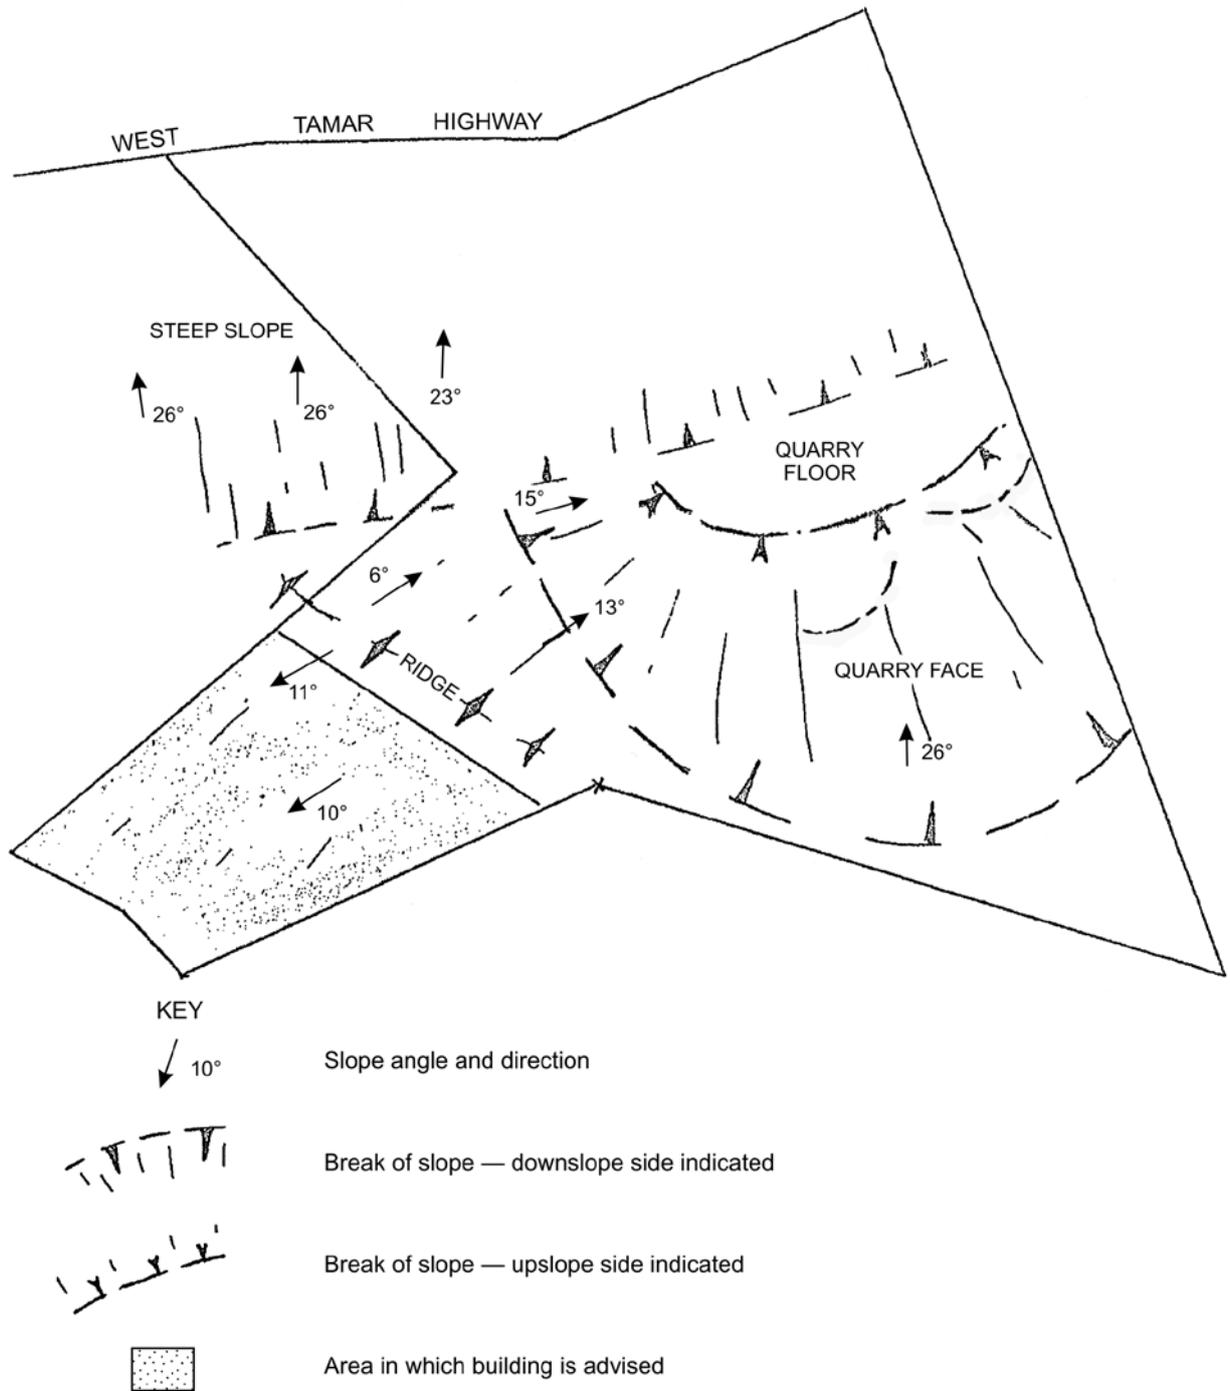
A block of land, adjacent to the West Tamar Highway approximately two kilometres north of North Riverside, was inspected. The plan of the land supplied appeared to be not quite correct. Figure 1 shows the approximate position of the small hill top and also indicates the slope sections in the area. The sketch map was drawn by taking compass bearings and approximate distances from the corner peg, and the house location was slightly out of position.

The area is classified Zone IV, an area described as 'Old landslips and adjacent areas', on the Tamar Valley Landslip Zone Map. A large section of the allotment includes a former quarry. Problems have been encountered in stabilising this steep quarry face. Inspection indicated that stabilisation has not been completely successful as minor gully erosion and two areas of failure have occurred. These failures are likely to progressively worsen. The only area considered suitable for development is that area of the block which is shaded on Figure 1. This area slopes towards the west at 10°. It is also advised that any building be subject to the *Building Amendment Regulations (No. 5)* of 1974. This Regulation ensures sensible building practice in areas of potential instability.
