1979/1. Geology of the area around a proposed damsite near Legana.

W.L. Matthews

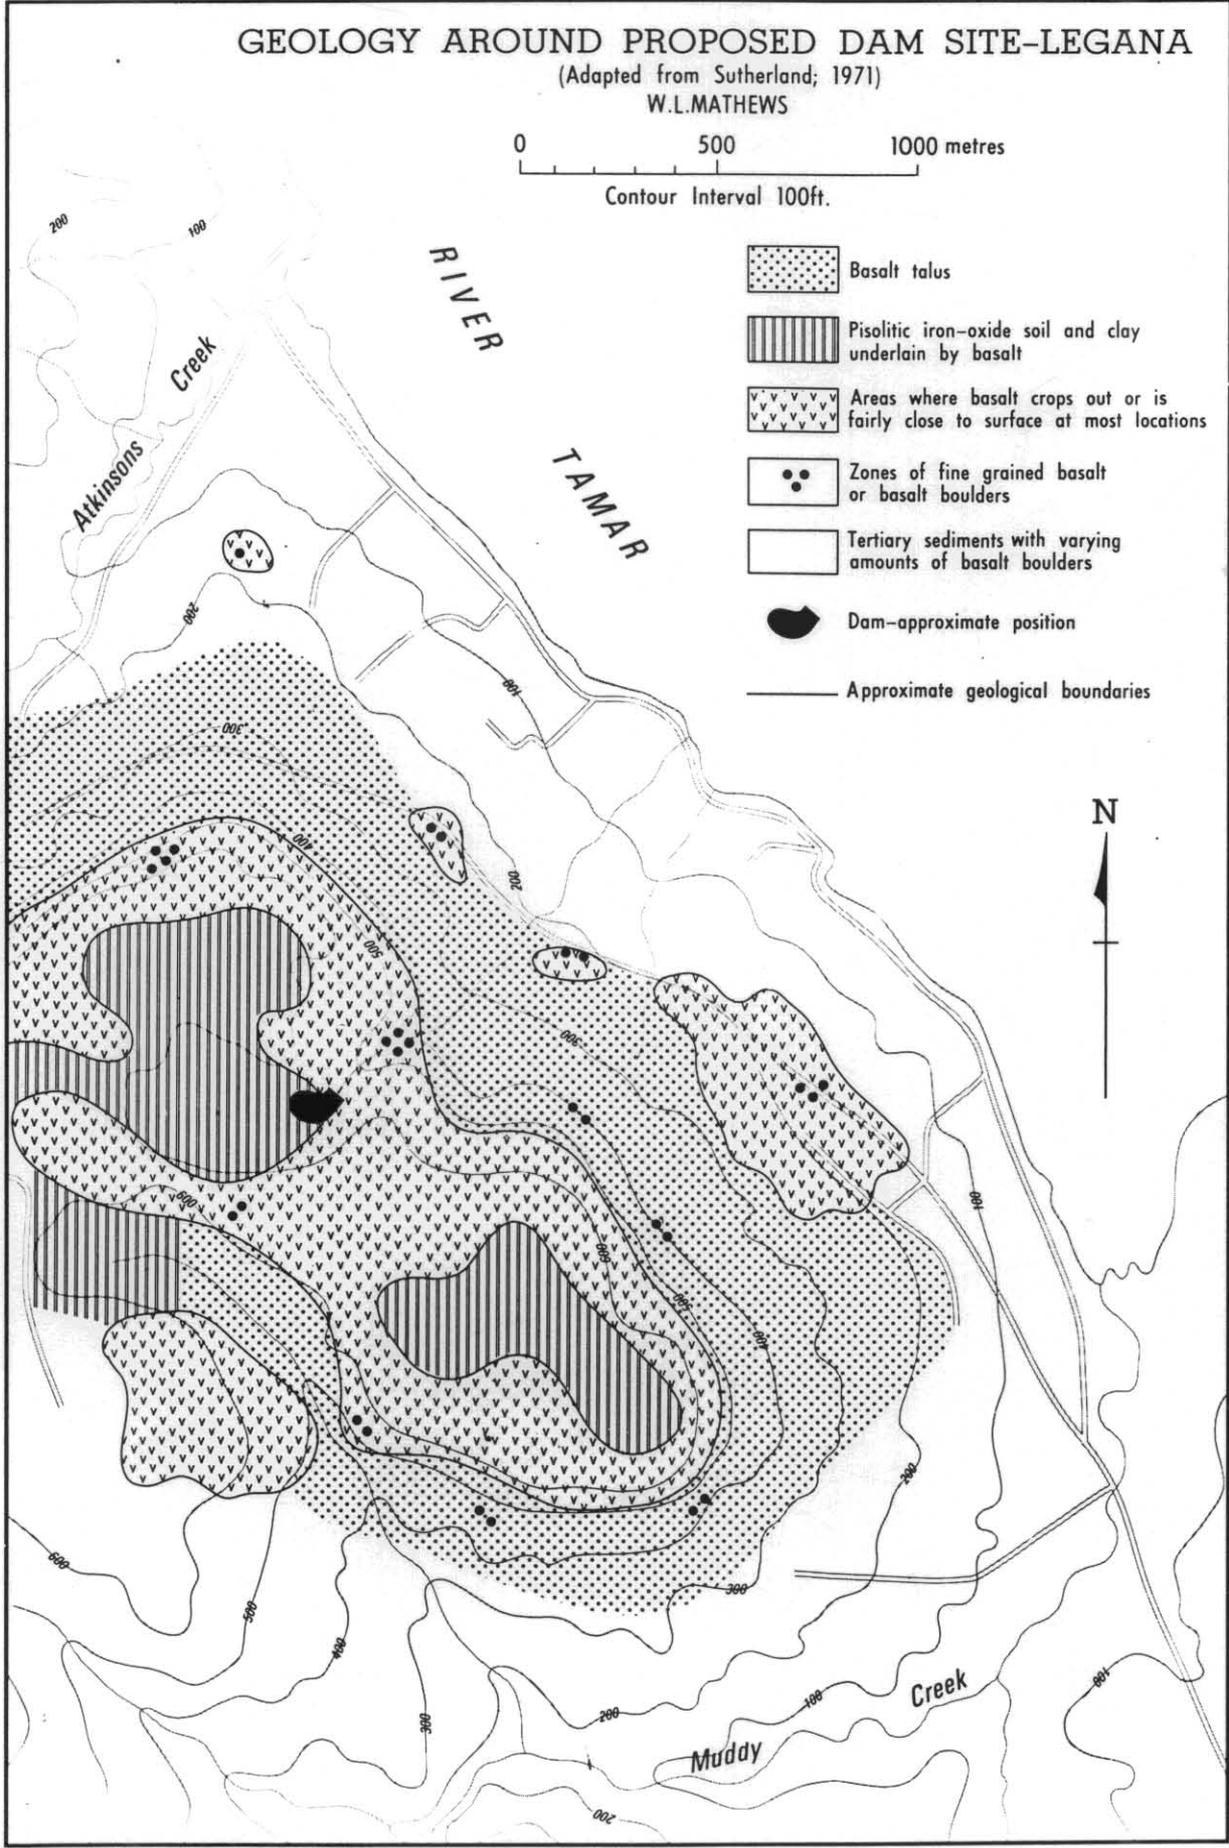
Figure 1.

The rocks underlying the area are Tertiary sediments composed mainly of clay and sand beds and Tertiary basaltic rocks. Much of the lower sloping undulating land is underlain by the sediments, although Sutherland (1971) has mapped areas of basalt in these areas (fig. 1). Much of the plateau and the scarp are underlain at depth by the basaltic rocks. Debris from old landslips (at some locations there are recently active landslips) has covered much of the area with basalt talus, so that the underlying material cannot be observed. Overlying the basalt in some places on the plateau are areas of pisolitic iron-oxide deposits and clay derived from the weathering of the basalt. Test pits examined by a consulting engineer in the damsite area suggest that these weathering products are at least 3 m thick.
