1979/18. Rock instability on The Nut, Stanley.

A.T. Moon
R.C. Donaldson

Abstract

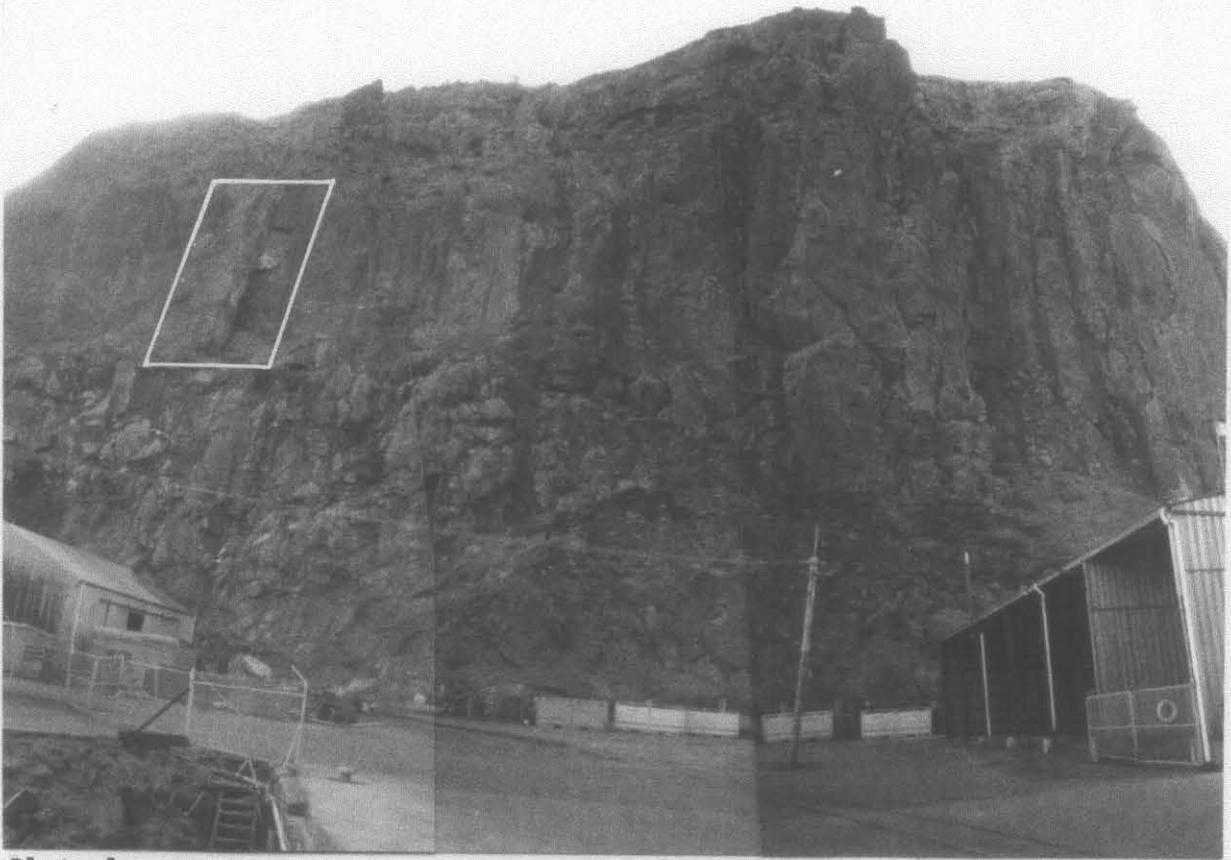
The Kauri Timber Company have their operations located at the base of an old quarry at the western end of the wharves at Stanley [CQ568856]. Near vertical cliffs 100 m high overlook the building and a railway line serving the wharf (plates 1, 2). The cliff has a history of instability, with previous falls of about 500 t in July 1968 and 100 t in April 1974. Smaller falls, consisting of single boulders up to one metre diameter, have also occurred. Most of the previous falls appear to have originated from a near vertical slab about 50 m above the base of the cliff. This slab is about 20 m in height. The instability appears to be caused by a continuous joint parallel to the face of the slab and about 2 to 3 m from its surface. Fragments of the slab have broken off, causing the face to retreat by 2 to 3 m.

Plate 1. The Nut viewed from the south. Face is about 100 m high.
Unstable area marked.

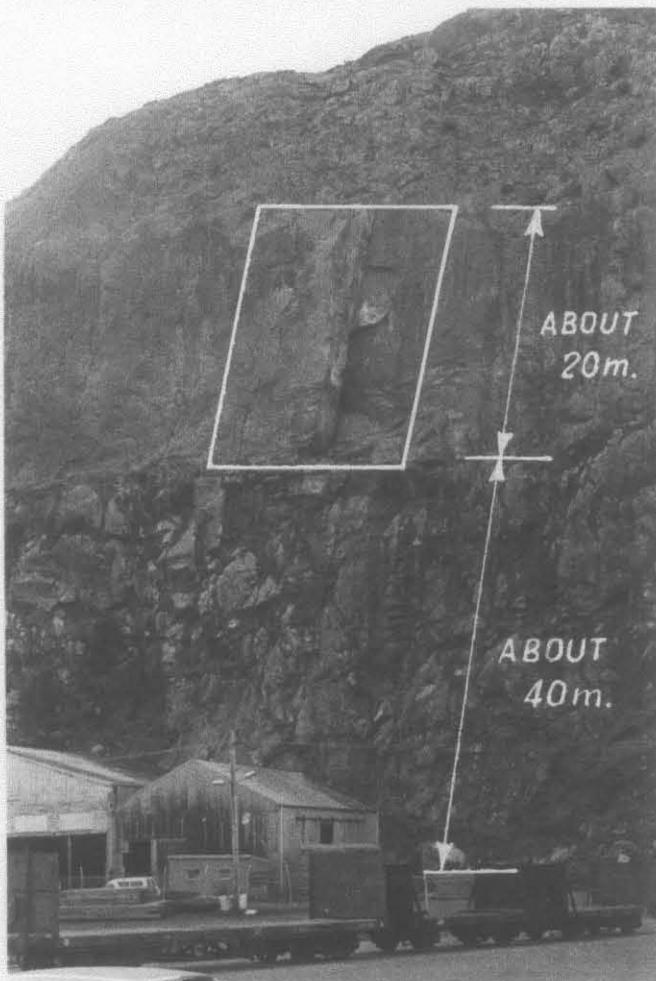
Plate 2. Unstable face and
Kauri Timber Company build-
ings.

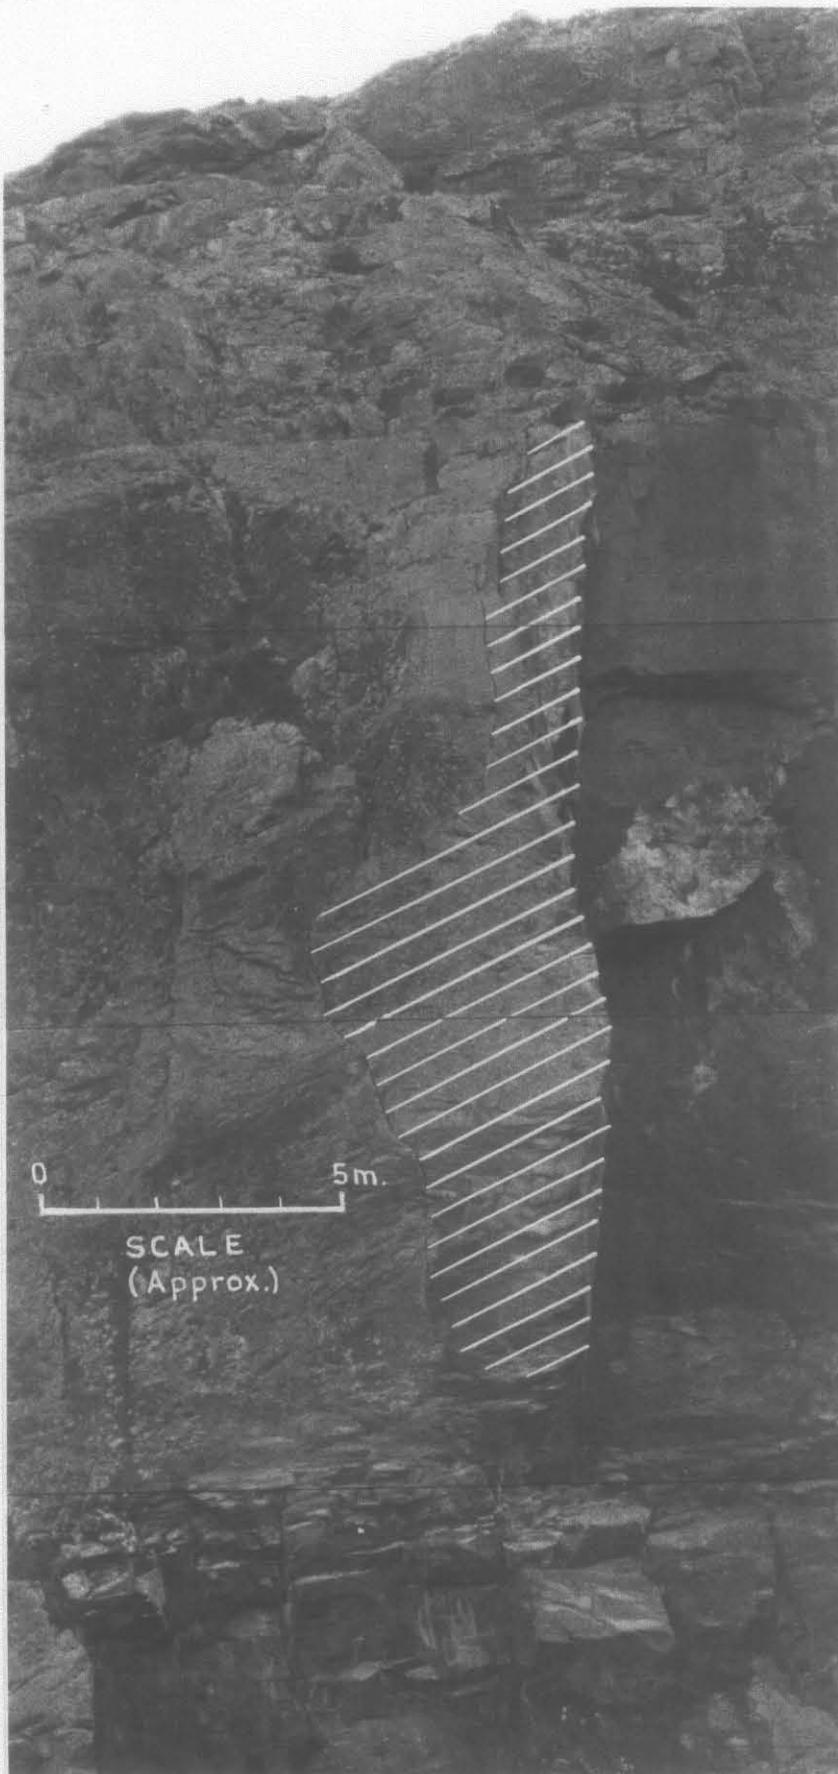
The face was inspected on 30 April and a continuous open crack was observed running from the top to the bottom of the slab close to the edge of the most recent fall. This crack defines a mass of rock about 20 m in height, 1 to 5 m wide and 2 to 3 m thick, weighing about 500 t (plates 3, 4). This unstable mass appears to be held up by the lack of any continuous joint or crack across its narrow base. However it is considered likely that further movement of the mass (movement has already occurred causing the crack to open; plate 5) will cause cracking at the base of the slab and total failure. In view of the relatively few joints crossing the slab, the mass may break up into large individual boulders, some of which could weigh more than 100 t. After a near vertical fall of about 50 m, these boulders will be potentially highly destructive.

Such a fall could be triggered by vibrations caused by the passing of a train, a minor earthquake or heavy rain. It is not possible to predict accurately when the fall will occur, but in view of the history of failures, it is considered more likely to occur within a matter of weeks or months rather than years. After the fall, further instability is likely to develop in the slab to the west of the present crack.

Plate 3. *Detail of unstable area from south. Unstable face (shaded) is about 20 m high and up to 5 m wide.*

expense and danger involved in remedial measures, it is recommended that the area under the cliff be evacuated. This would involve closure of the railway and the Kauri Timber Company's operations at Stanley. The area should then be fenced off, allowing no access to the public. At present there is real danger to the lives of people working below the cliff.

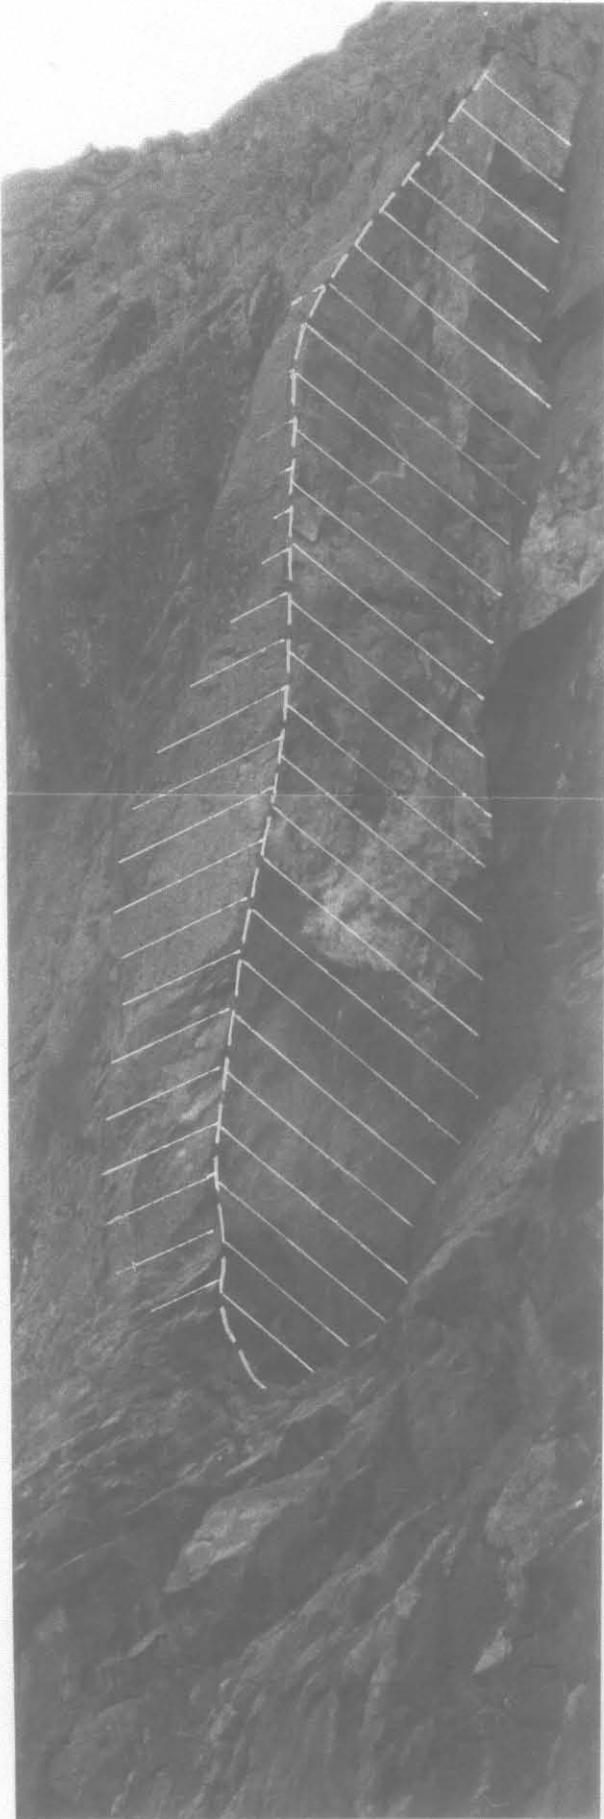
Plate 4. *Detail of unstable area from south-east. Unstable face is 2 - 3 m thick.*

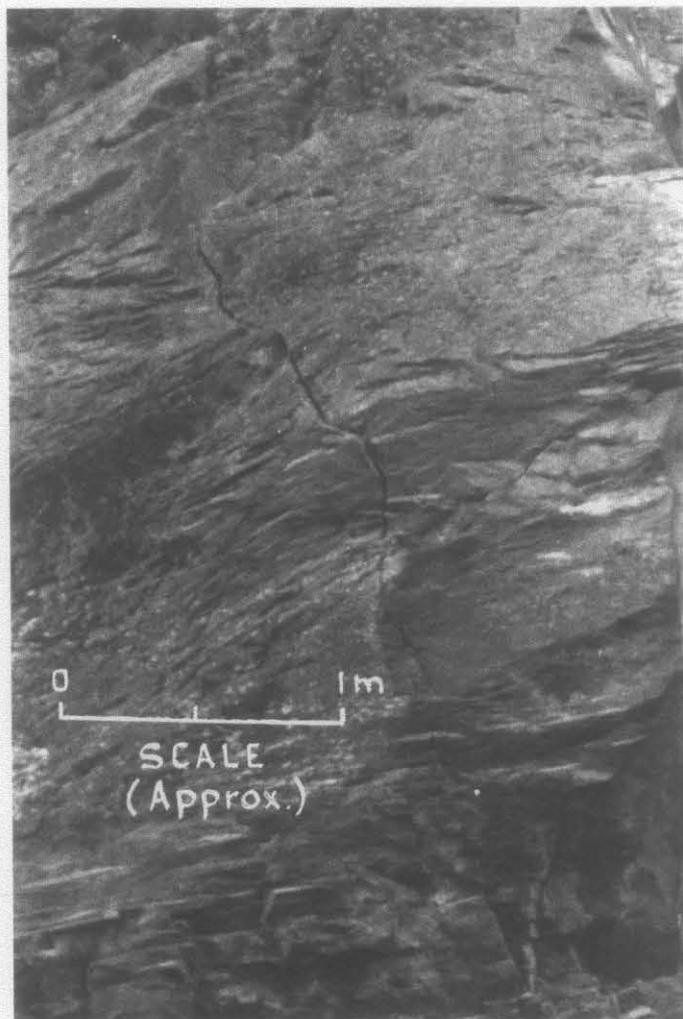
Plate 5. *Detail of open crack.
Crack width about 20 mm.*

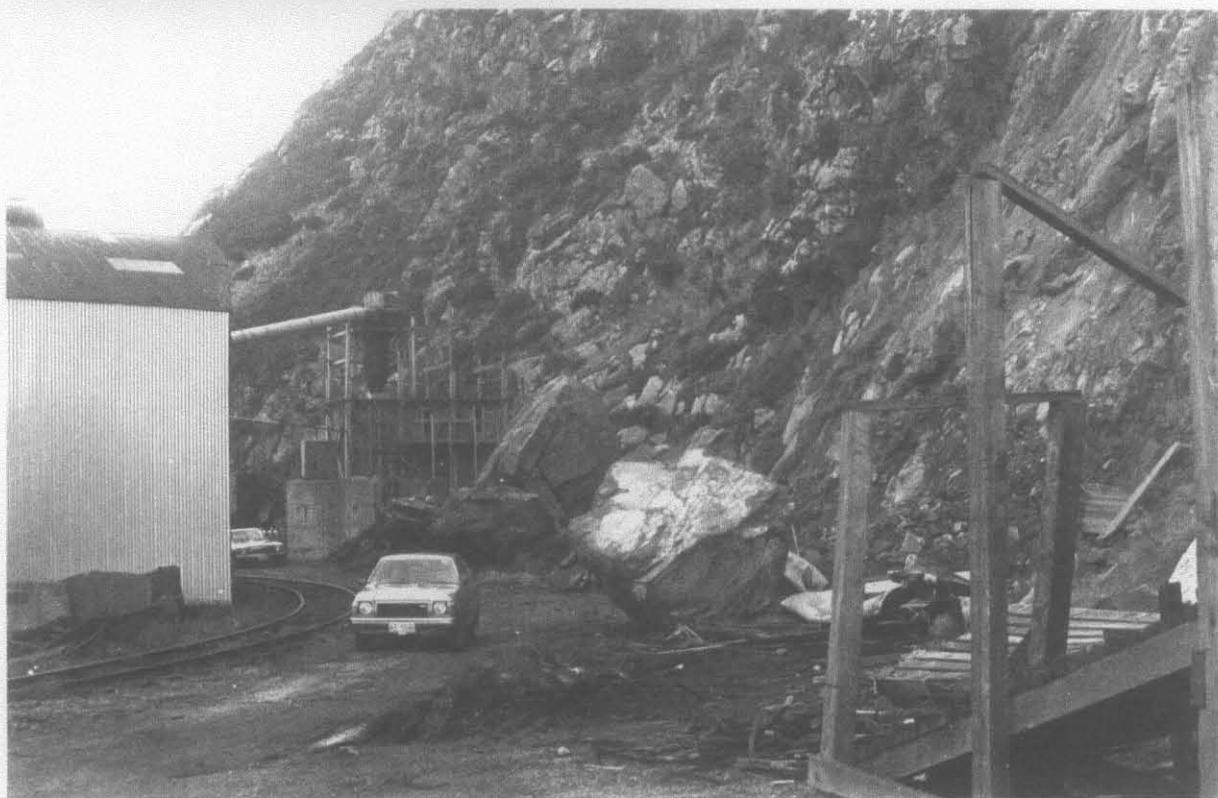
Consideration has been given to long term remedial measures, but they are likely to be both dangerous and extremely expensive. In view of the size of boulders likely to fall, a fence or ditch at the base of the slope will be ineffective (plate 6). The long-term stability could be improved by the installation of many rockbolts combined with the use of heavy netting, but this dangerous operation could easily cost in excess of \$100 000 and still not guarantee complete safety.

Plate 6. *Base of cliff below unstable area showing large boulders (up to 50 t) and proximity of warehouse and railway.*
