1979/36. Drilling at a proposed damsite on R. Vos' property, Legana.

W.L. Matthews

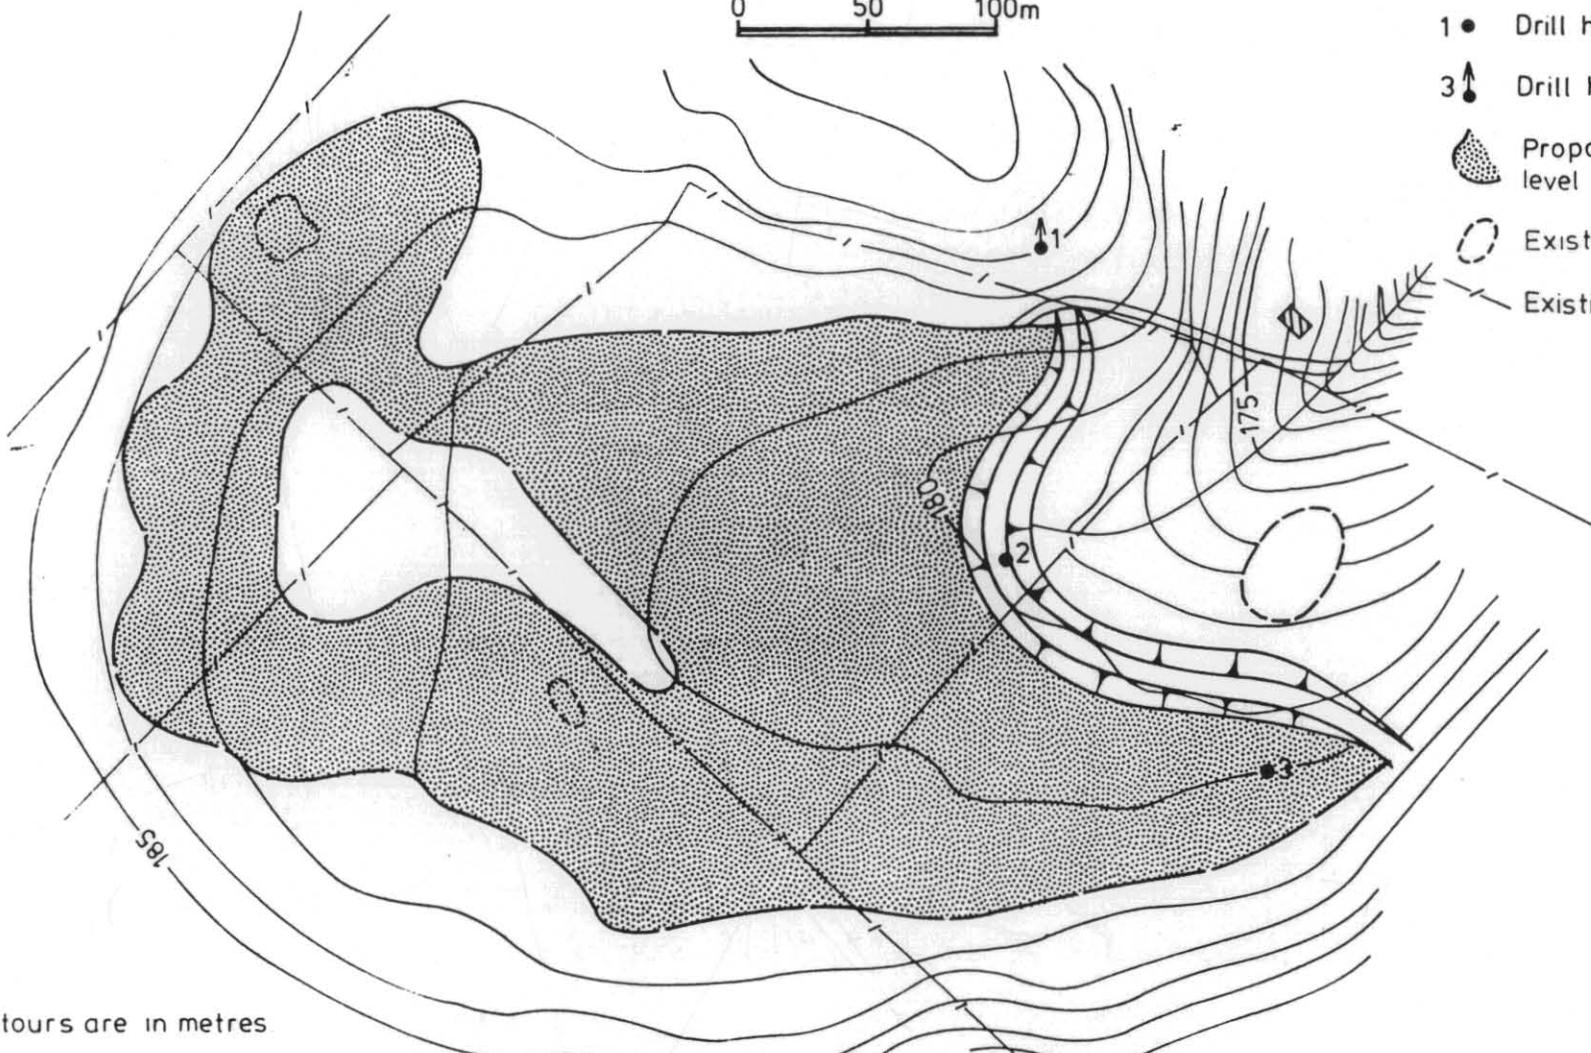
The logs of the three holes are given in Appendix 1 and their positions are shown on Figure 1. Hole 1 was drilled at 60° to the horizontal so that near vertical joints, if they occur, would be intersected. The other two holes were vertical.

LOCATION OF DIAMOND DRILL HOLES, PROPOSED DAMSITE, LEGANA
